# AMESBURY PUBLIC LIBRARY

## Facilities Needs Assessment Report

September 10, 2024

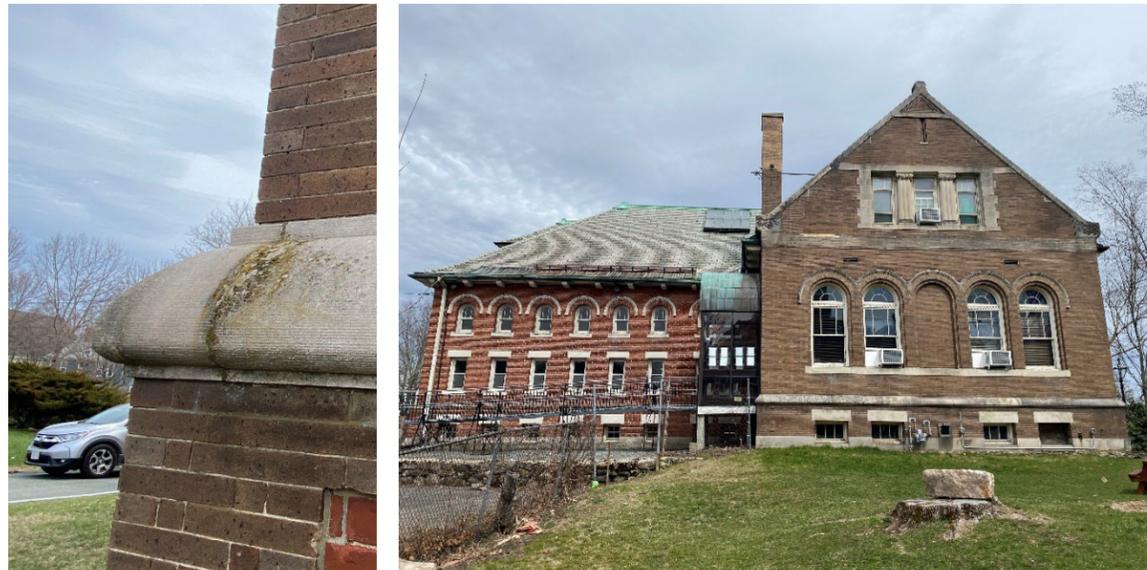
There are visible signs of masonry deterioration and locations that require investigation to determine how water is seeping into the walls. The southeast corner of the foundation is experiencing water infiltration. Water is actively visible during heavy rainstorms at the intersection of the basement slab and foundation wall. One possible reason is because the site walls at the exterior create a bathtub condition and the downspout does not drain away from the foundation. The second location of water infiltration is the north elevation below the dormer. Repair the dormer trim and flashing and investigate where the water is entering the building.

Brick mortar is missing from a few locations and there are areas where the bricks are bulging and displaced. The east chimney is missing mortar on the rebuilt top half. The exterior walls and limestone trim have biological growth, dirt, and staining at locations around the building.

Foundation areas where brick is located underground show signs of deterioration due to perimeter water. Missing mortar and spalling brick are observed from rooms that the brick walls are not covered by finishes.

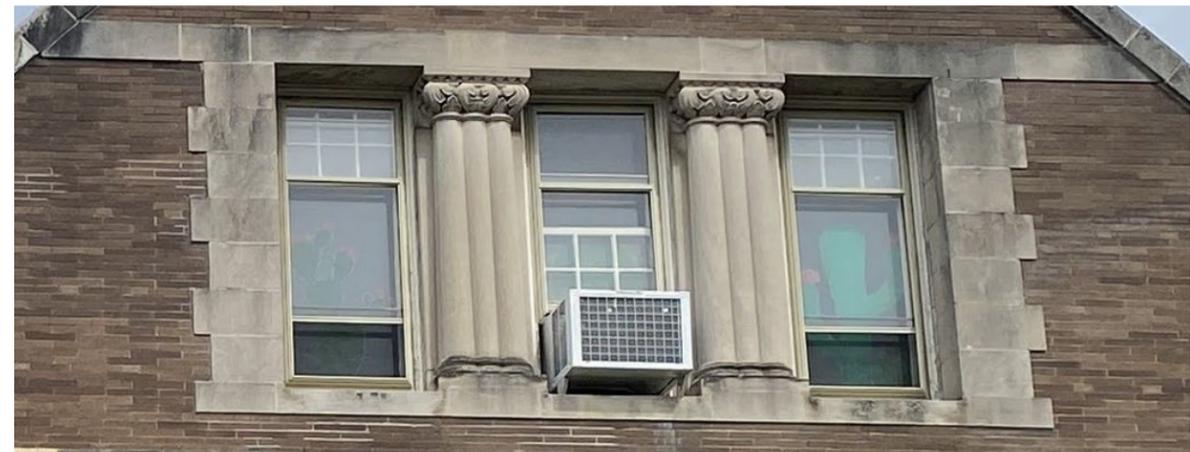
The decorative features on the exterior of the building are in good condition. There is black carbon staining on many of the stone. Stone requires cleaning and repointing many of the sky-facing joints.

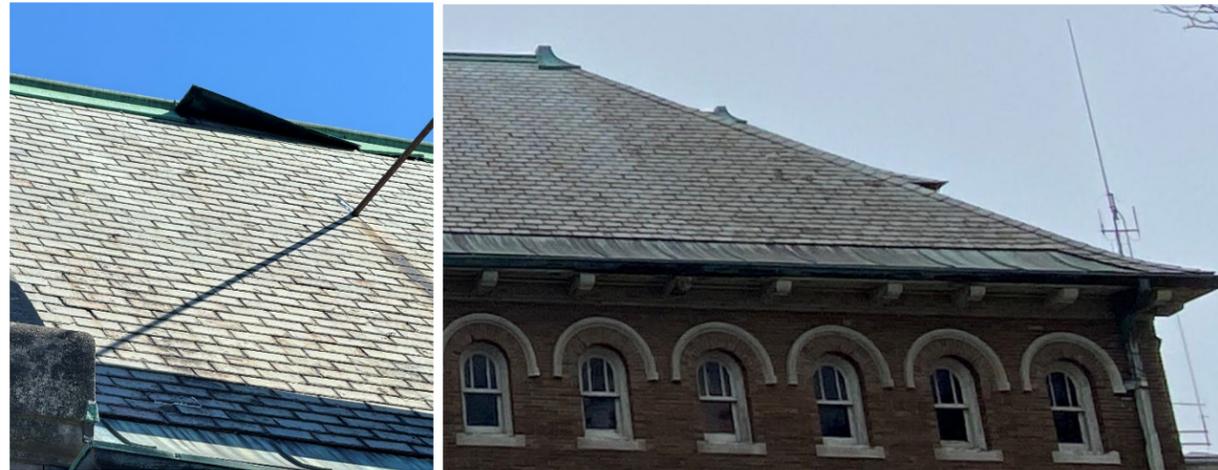
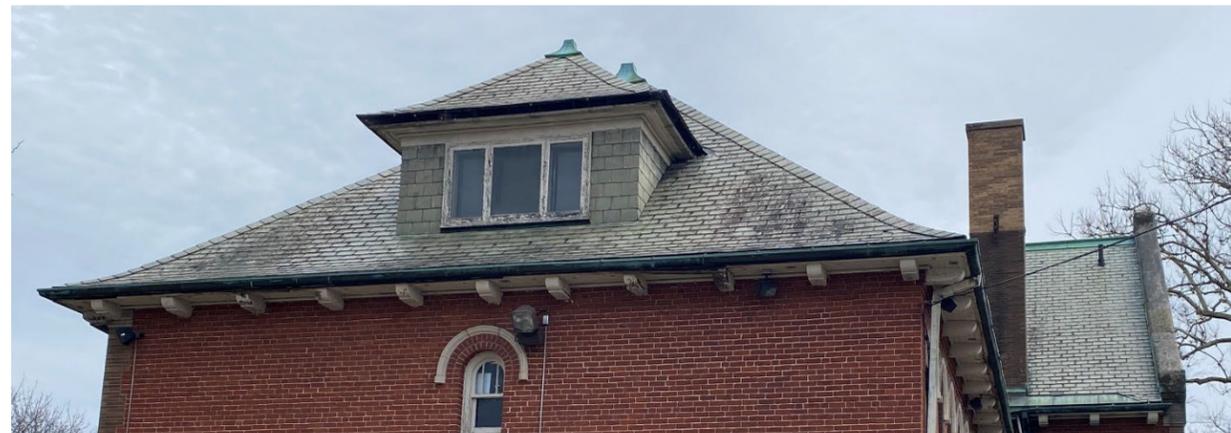
There are locations where slate is missing and damaged throughout the roof, but generally it is in fair condition. A ridge cap is not secured to the ridge and can blow off in the next large storm. A lift inspection can be performed to view the condition of the flashing and quantify amount of slate repair required. The wood rafters show signs of water staining. Ice dams are common at the valleys of the T-shaped plan and cause occasional water infiltration in the eaves.

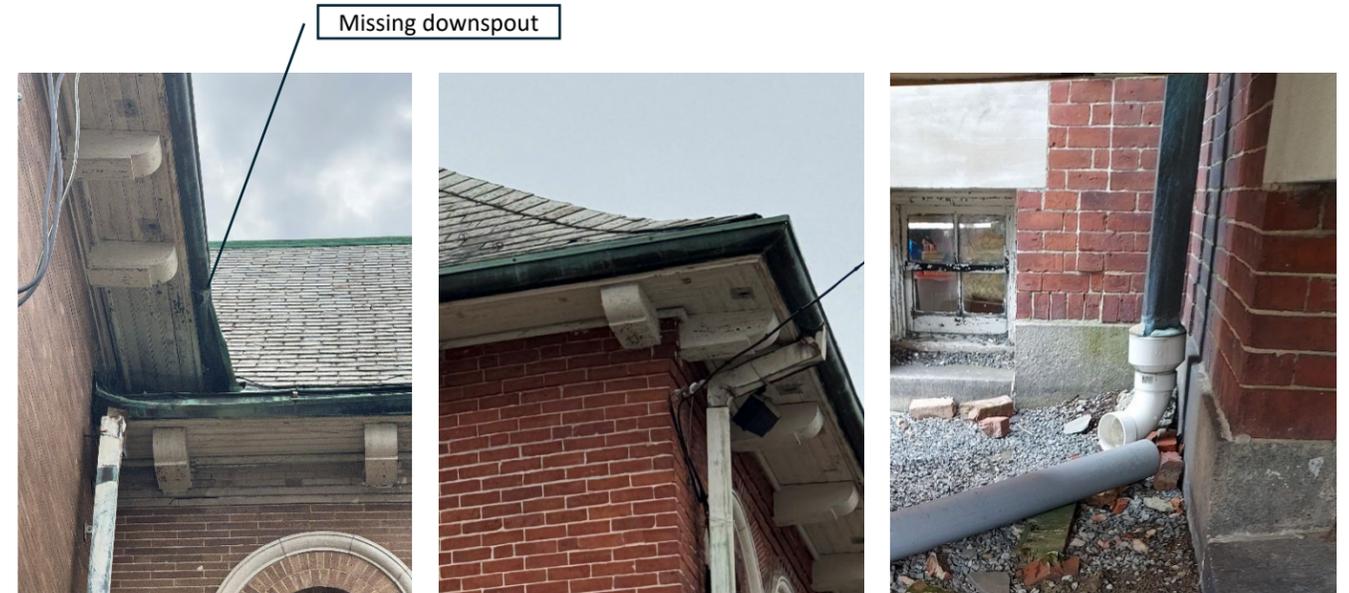
Gutters and downspouts are in poor condition with major deformation from ice and snow. The southwest gutter was replaced in the past but now is not draining due to a clogged downspout. Gutter straps are missing in various areas and gutters are not properly supported. Downspouts are missing at the connection of the wings to the main T roof. Downspout extensions and continued maintenance are required to divert water away from the building's foundation. Repair and replacement of the gutters for an effective water management system will greatly reduce water infiltration in the building's roof and foundation.

- \* Because of this report, the roof flashing was tacked down and the southeast downspout extension was installed to reduce water infiltration coming through the wall into the lower-level staff office.
- \* See Appendix for Downspout Immediate repairs

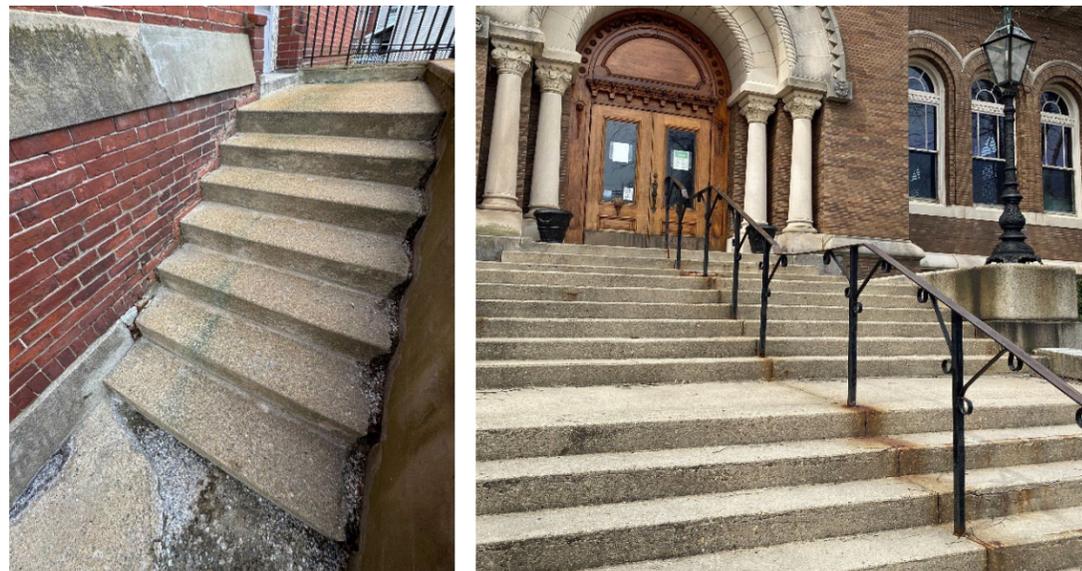
The main entry stair and both sets of back concrete stair treads and landings have multiple cracks and minor spalling. The center railing on the main entry stair is rusted and stained the stairs. The paint is chipping off the rusted railings. The railing on the emergency exit stair from the first floor is also rusted and has chipped paint. The north stairs do not have adequate landings from a code and drainage perspective – the landing at grade is not level, the lower-level landings at the north and east overflow and water seeps in at the door thresholds.

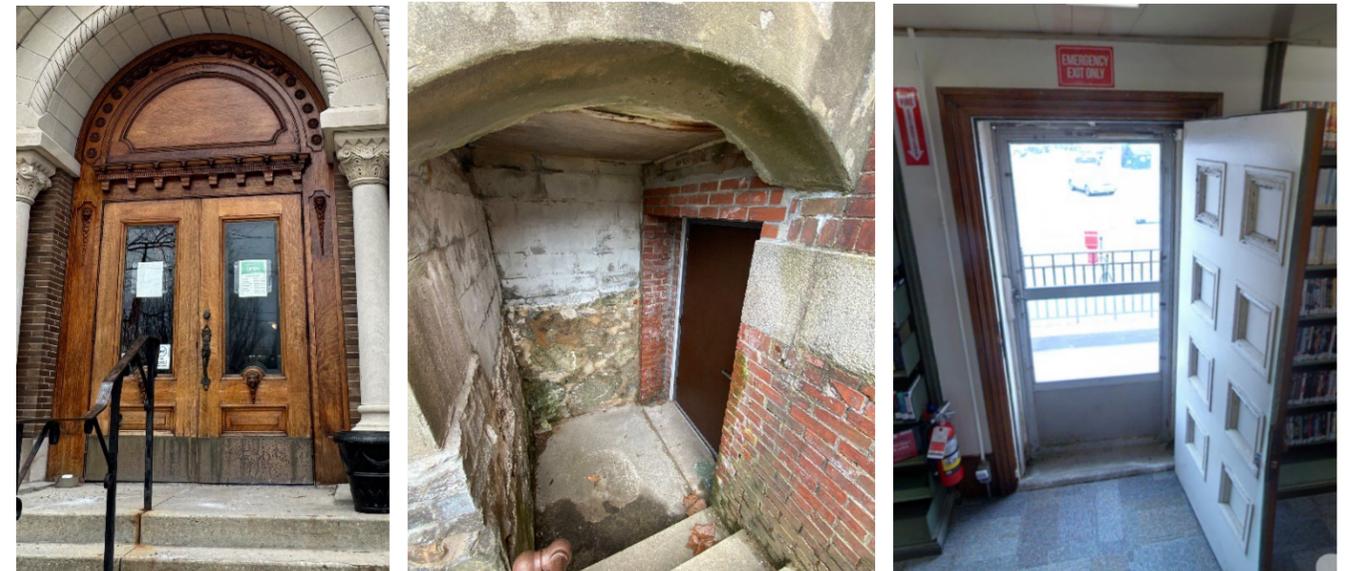
The main entry doors are in good condition and have recently undergone restoration in 2019 + 2024. The doors do not have code-compliant hardware, cited by the building inspector. The accessible entry door and glass vestibule are in fair condition and has not caused any water or air infiltration issues.

The emergency exit door on the first floor does not have panic hardware and opens inward with an outward opening screen door. The emergency exit door on the lower level has panic hardware, opens out and is in good condition. The delivery door does have a panic bar, opens out, and is in good condition. All doors serving occupant load greater than 49 people should be provided with panic hardware and swing in the direction of travel.

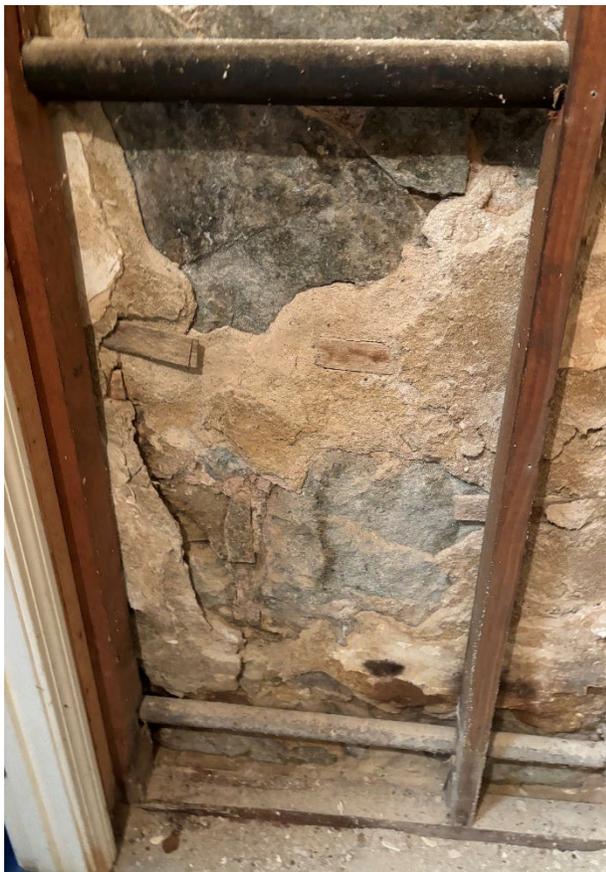
**Photo 2**

South foundation wall in Utilities Closet between the basement bathrooms.

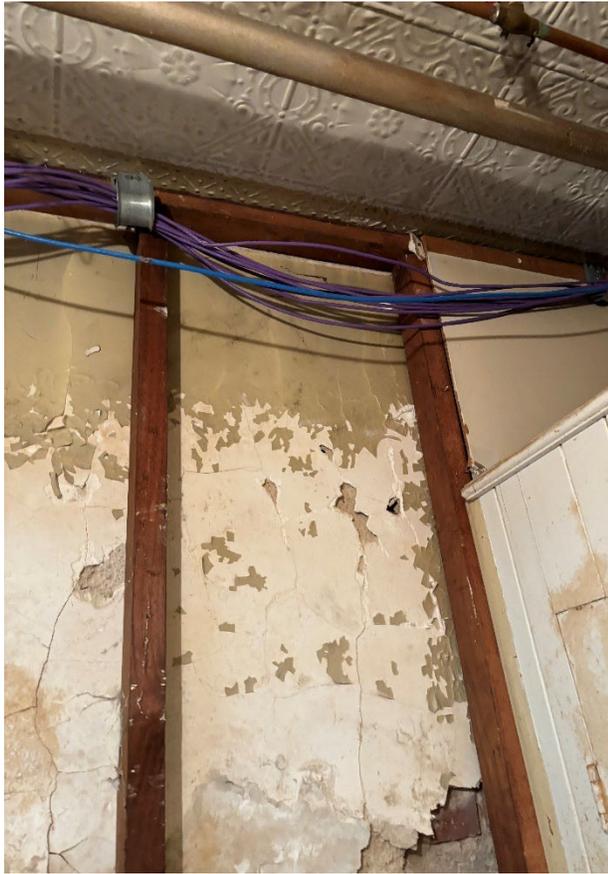
**Photo 3**

Plaster finish behind wood stud wall in Utilities Closet between the basement bathrooms.

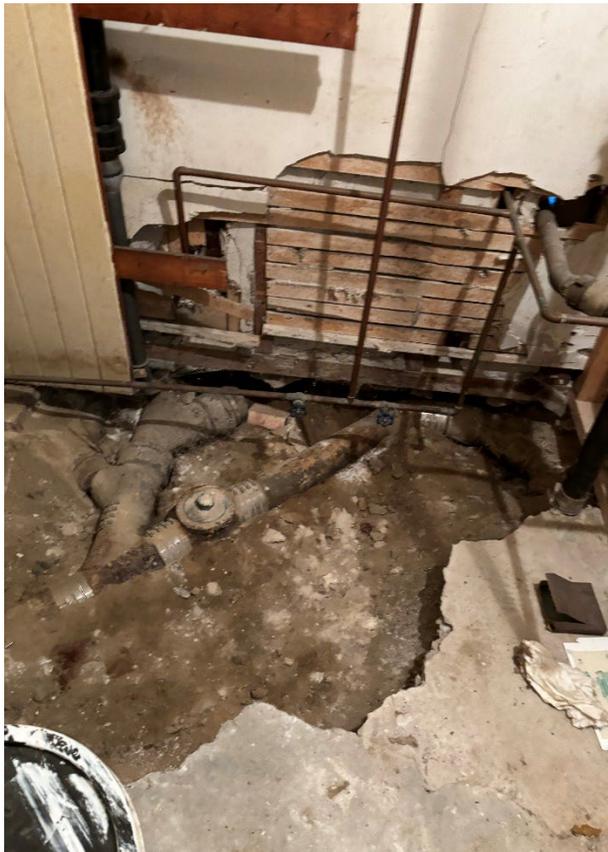
**Photo 4**

A portion of the slab-on-grade is missing in the Utilities Closet between the basement bathrooms.

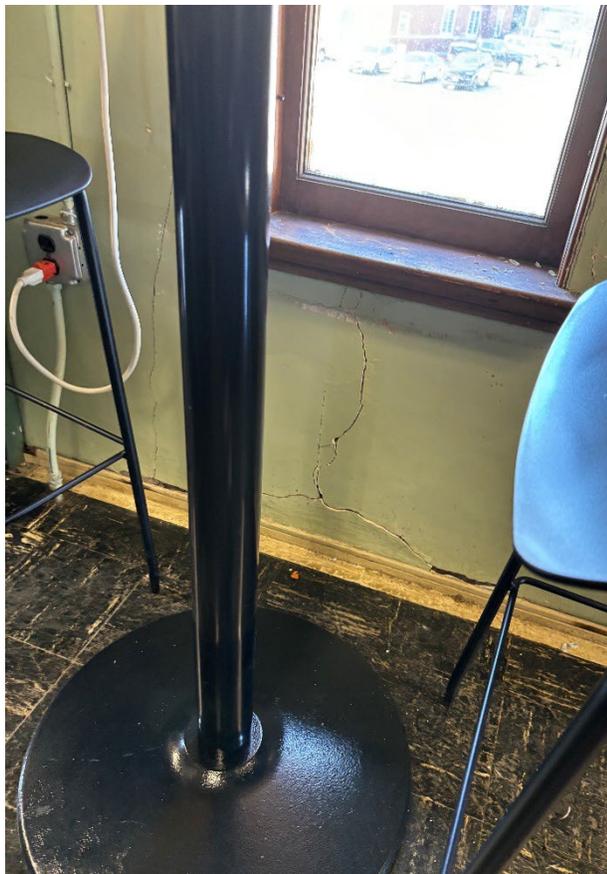
**Photo 39**

Plaster cracking at the center of the north wing.

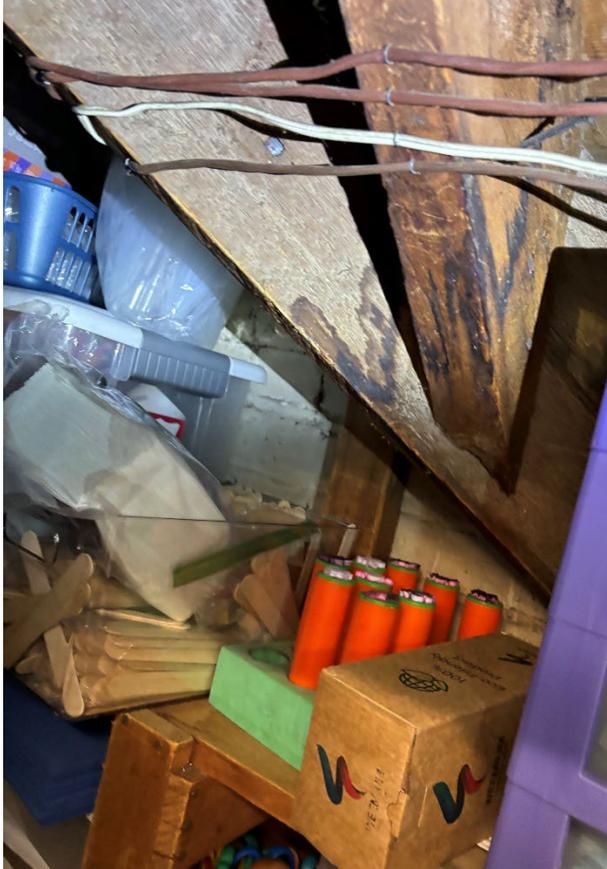
**Photo 43**

Staining on rafters consistent with water infiltration.

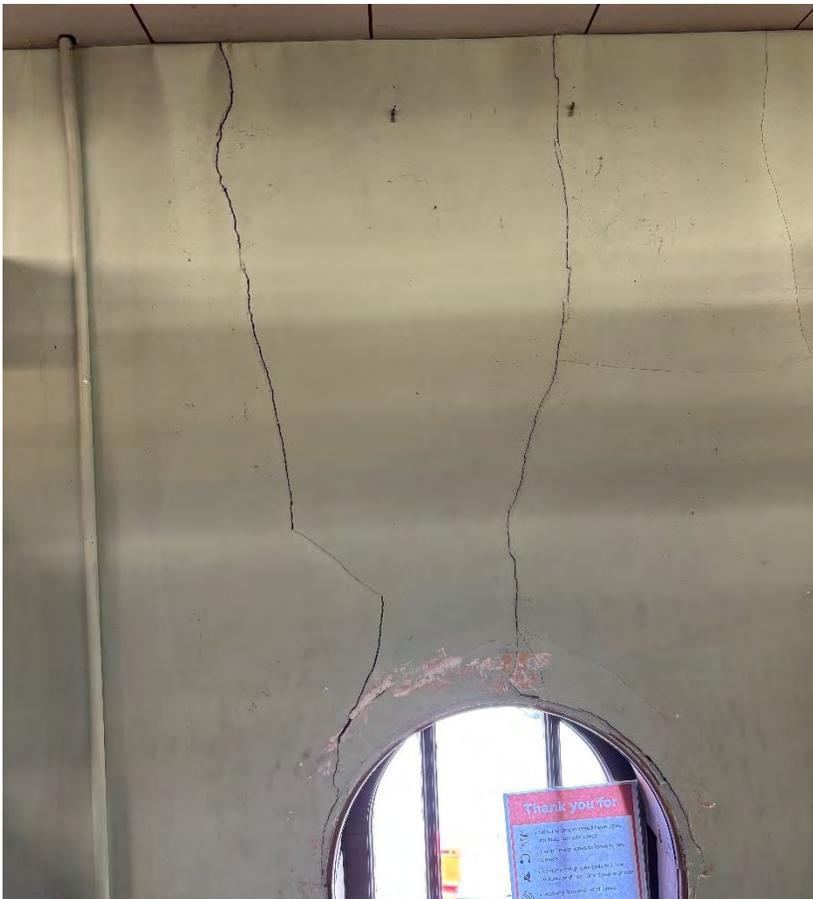
**Photo 30**

Cracked plaster at the interior of the north elevation (correspond with masonry cracking below rafter tail in area indicated in yellow, Photo 12).

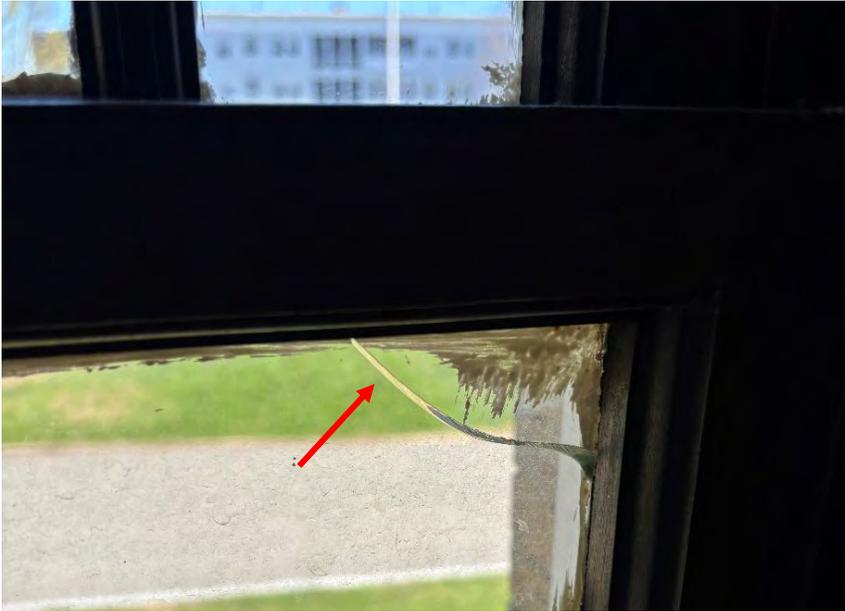
**Photo 31**

Example of cracked windowpane (red arrow).

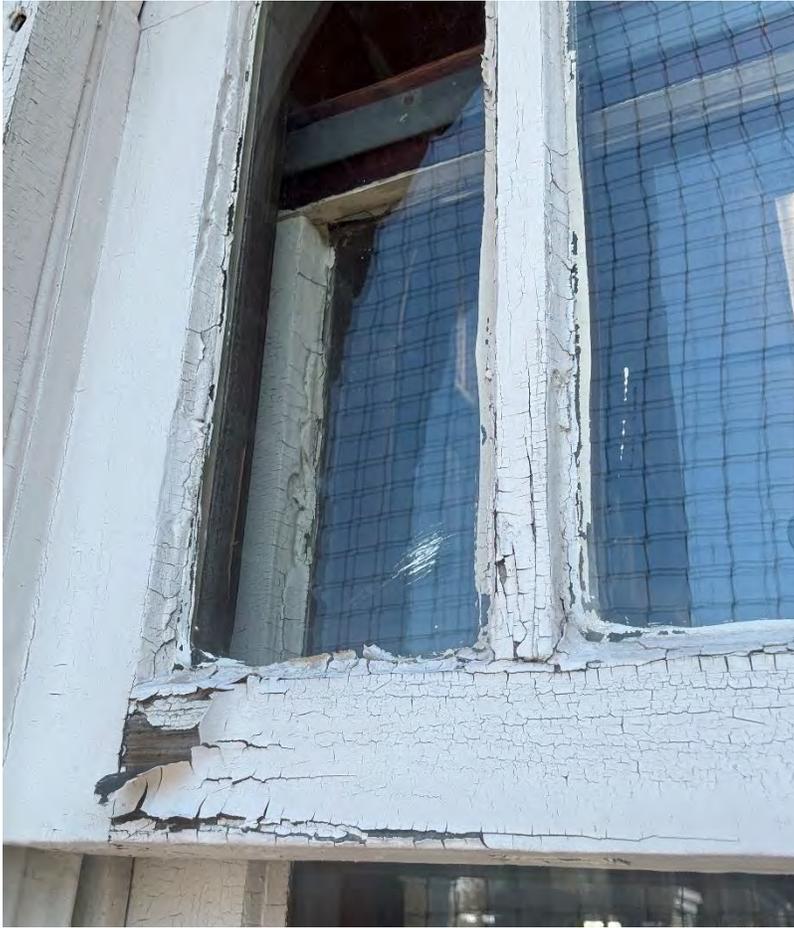
**Photo 35**

Example of exterior paint peeling at wood-framed windows. Note also putty deterioration (cracking, crazing and, in some cases, section loss).

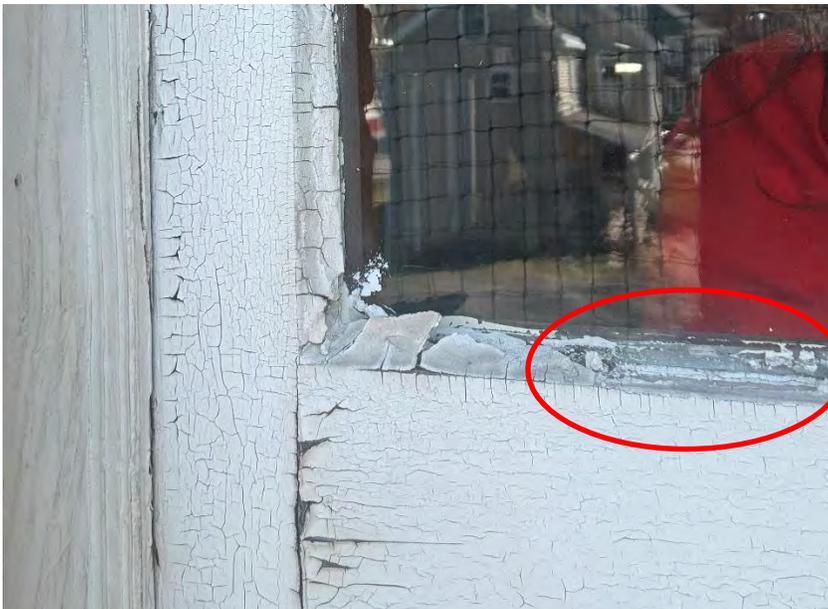
**Photo 36**

Up to 100% section loss of glazing putty in some areas (indicated in red).

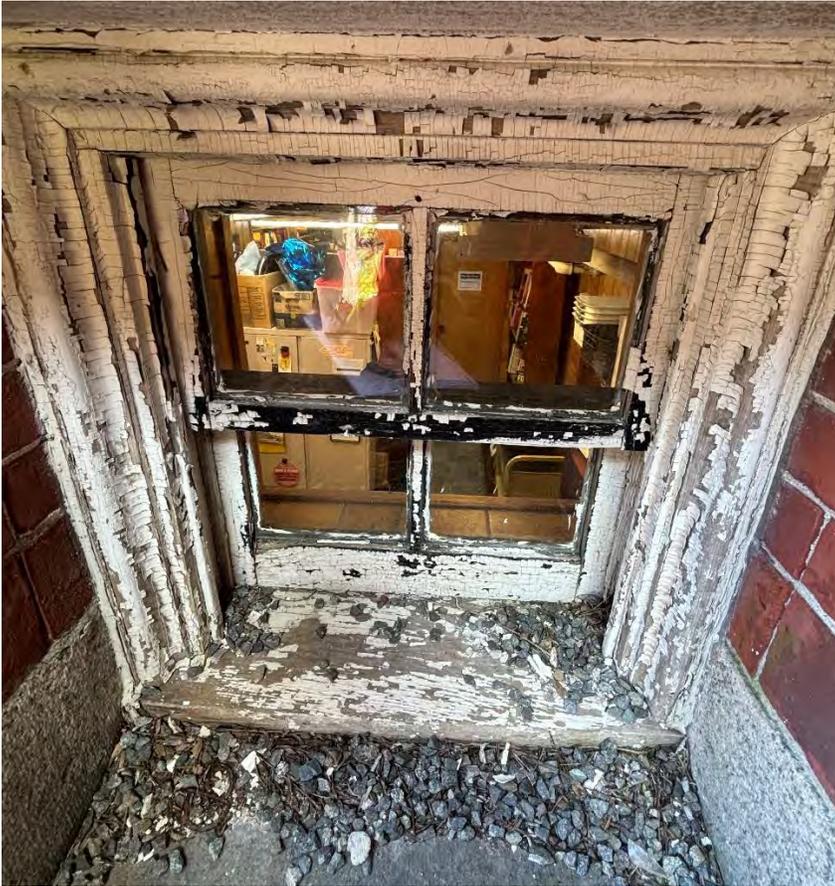
**Photo 37**

Overview of one of the two windows near grade at the west elevation where wood at the bottom 6 in. to 8 in. is significantly deteriorated. Refer to probe depths shown in Photos 38 and 39.

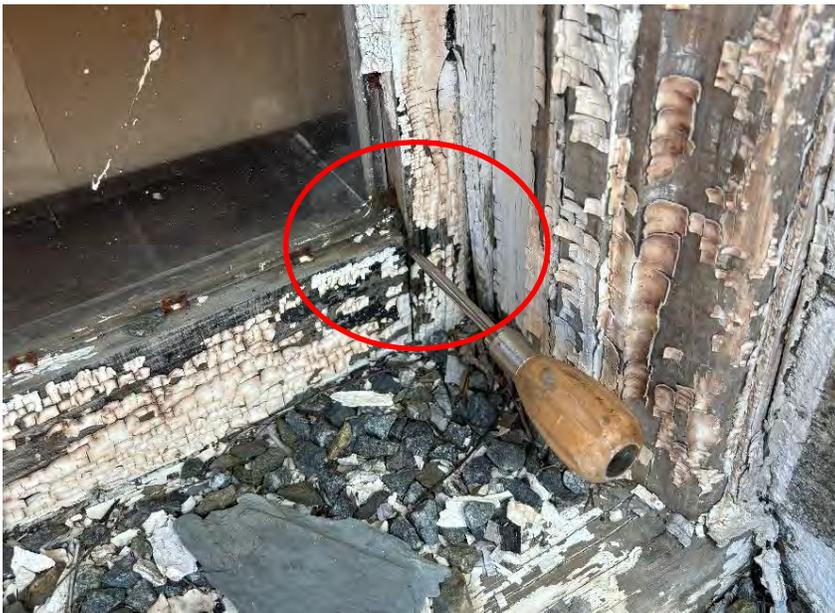
**Photo 38**

Up to 100% section loss of the wood framing (indicated in red) detected within 6 in. to 8 in. of the window sill and virtually all of the window putty is missing.

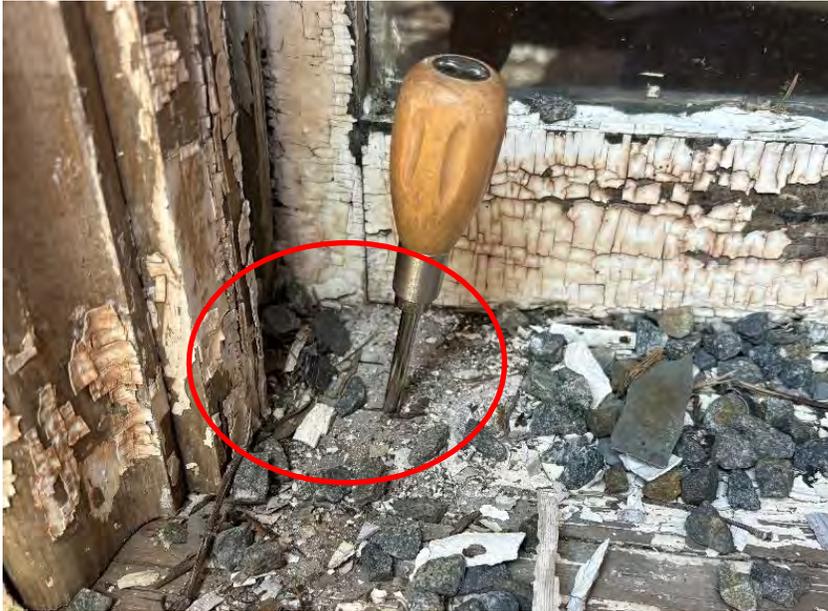
**Photo 39**

Up to 3 in. depth of softness detected at the topside of the wood sill (indicated in red) and virtually all of the window putty is missing.

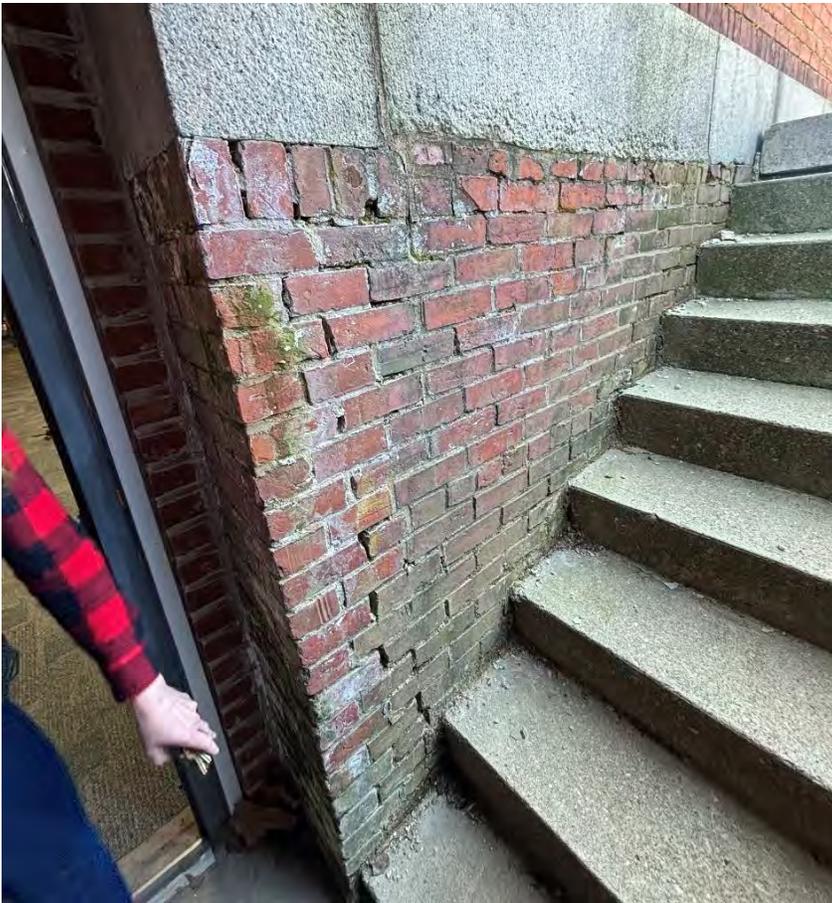
**Photo 48**

View of exterior masonry at south elevation sunken stairs, with numerous areas of mortar loss and biological growth. Note this area coincides with the finished northwest basement office that experiences reoccurring water leakage.
