# AMESBURY PUBLIC LIBRARY

## Facilities Needs Assessment Report

September 10, 2024

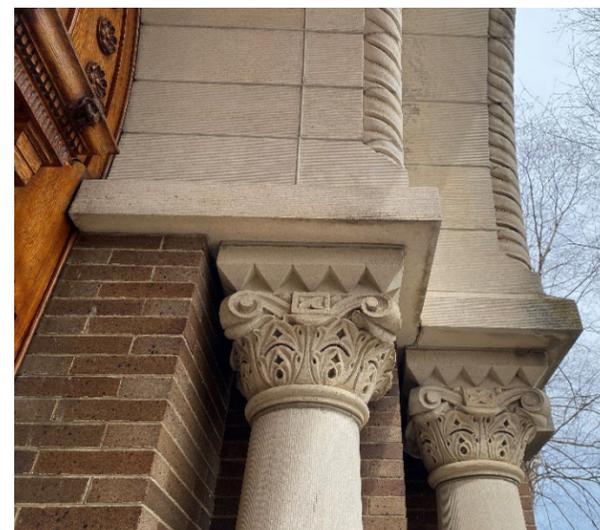
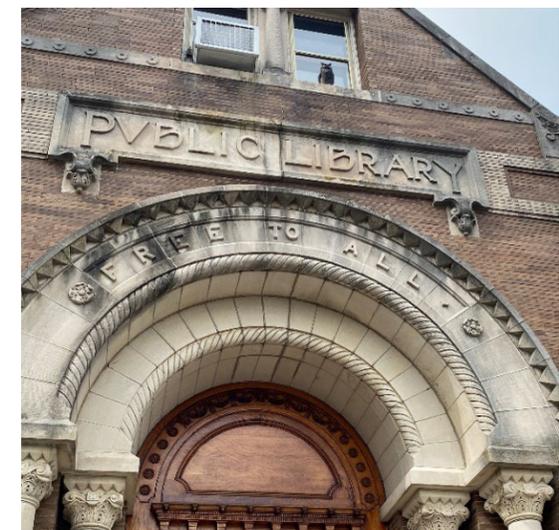
The decorative features on the exterior of the building are in good condition. There is black carbon staining on many of the stone. Stone requires cleaning and repointing many of the sky-facing joints.

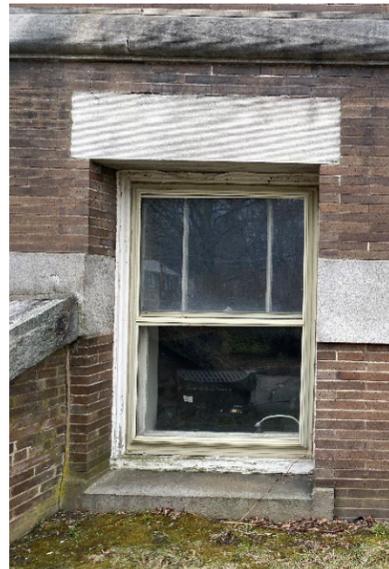
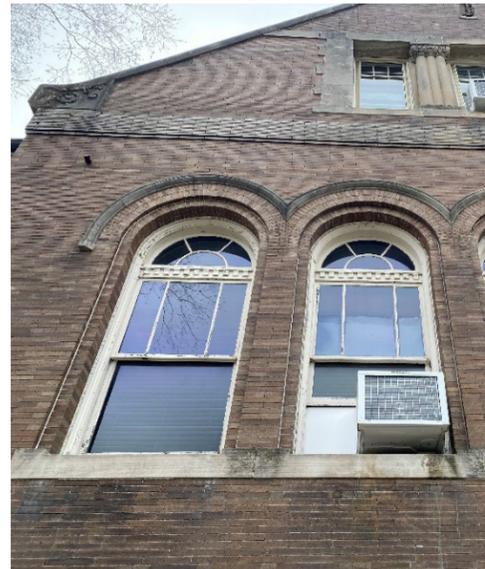
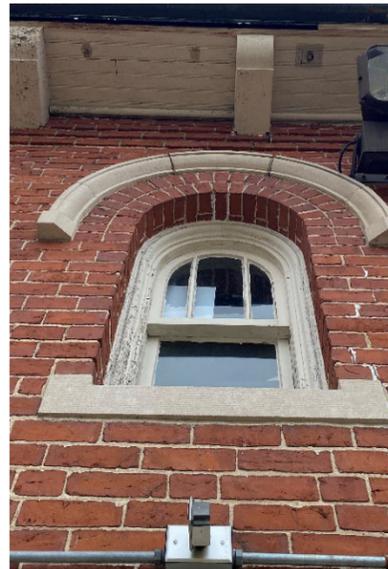
The windows are in fair condition and have peeling paint, missing glazing putty, and the sash ropes and weights are not functioning. A select few of the windows have rotted wood framing at the lower level. The lower-level windows have missing or damaged glazing putty at the window panes and the wood frame and sill is rotted on portions of the building with little to no direct sunlight (north and west sides). Limestone lintels and sills over square and arched appear to be sound, apart from minor dirt and staining. See code report for window notes. Mezzanine windows are lower than 42" along a walking path and require a guard system.

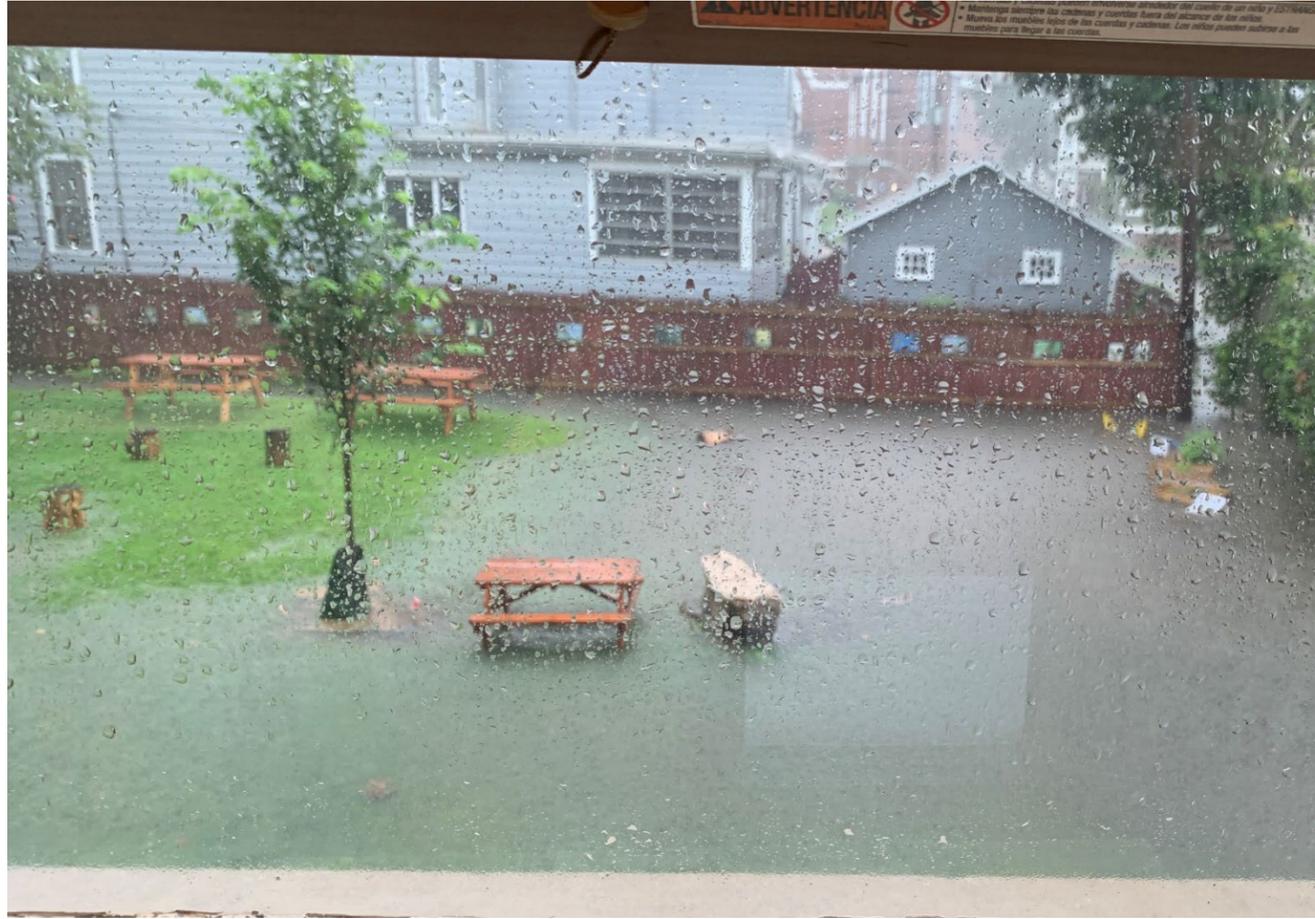
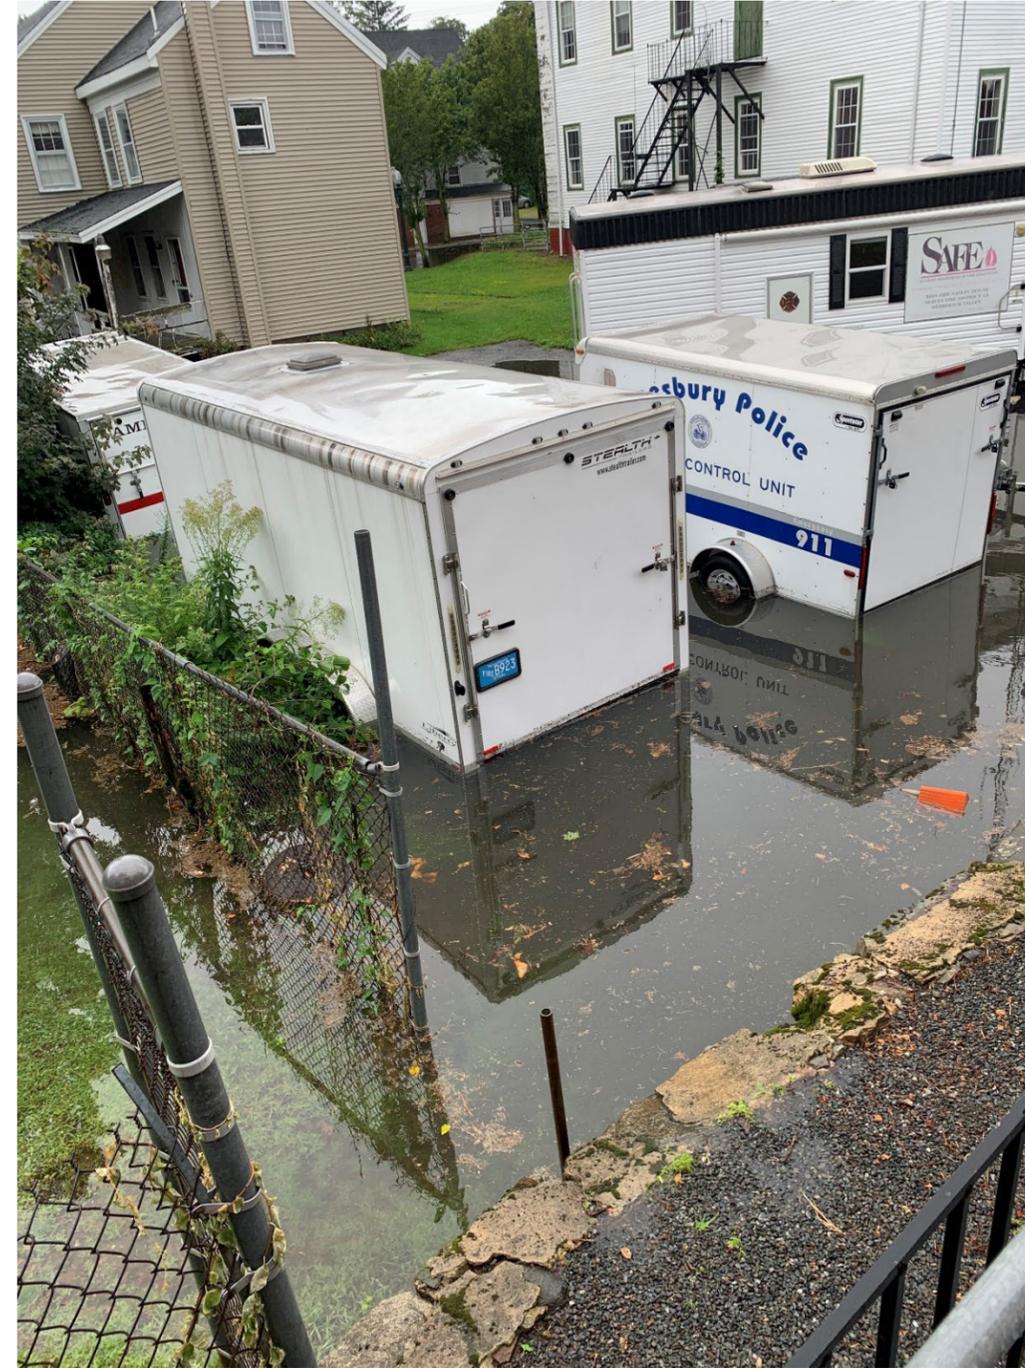
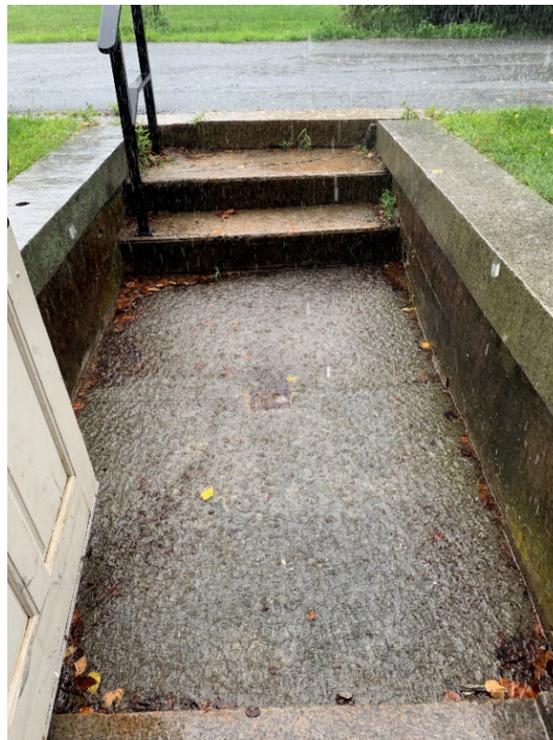
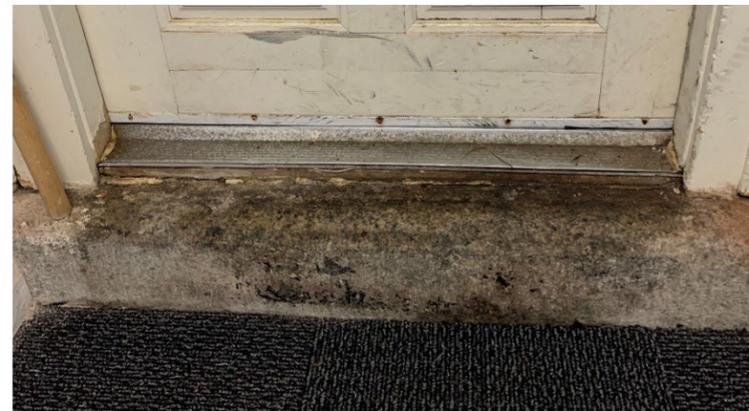
# Water Infiltration - Exterior

There are visible signs of masonry deterioration and locations that require investigation to determine how water is seeping into the walls. The southeast corner of the foundation is experiencing water infiltration. Water is actively visible during heavy rainstorms at the intersection of the basement slab and foundation wall. One possible reason is because the site walls at the exterior create a bathtub condition and the downspout does not drain away from the foundation. The second location of water infiltration is the north elevation below the dormer. Repair the dormer trim and flashing and investigate where the water is entering the building.

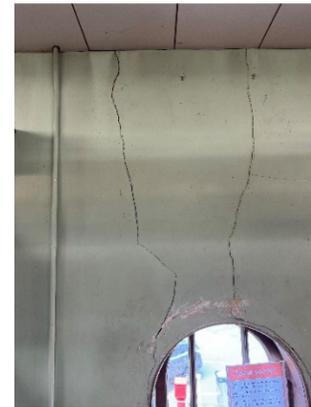
The plastered walls in the library are in fair condition and have recently been painted but have various minor cracks. The plaster walls and ceilings cracks do not translate through to the masonry structural bearing walls on the exterior, so it is believed to be superficial or cosmetic. The cracks could be part of a larger water infiltration issue- particularly at north wall stack area below the dormer. The wood wainscotting and plaster should remain intact. Adding interior insulation in the future should be analyzed to determine if the energy reduction outweighs the cost and loss of original plaster.

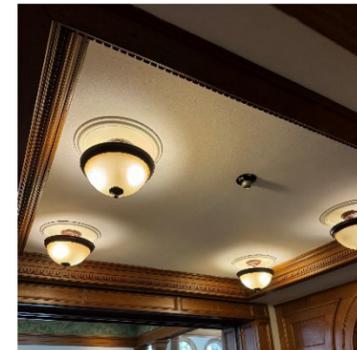
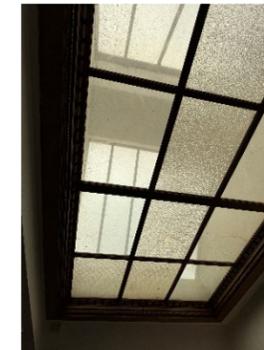
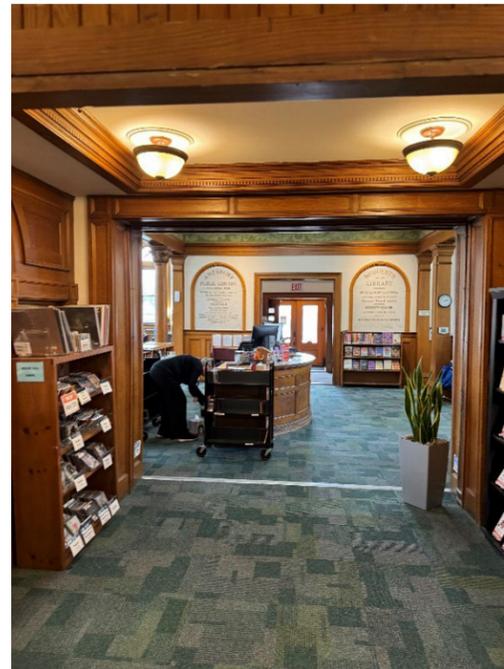
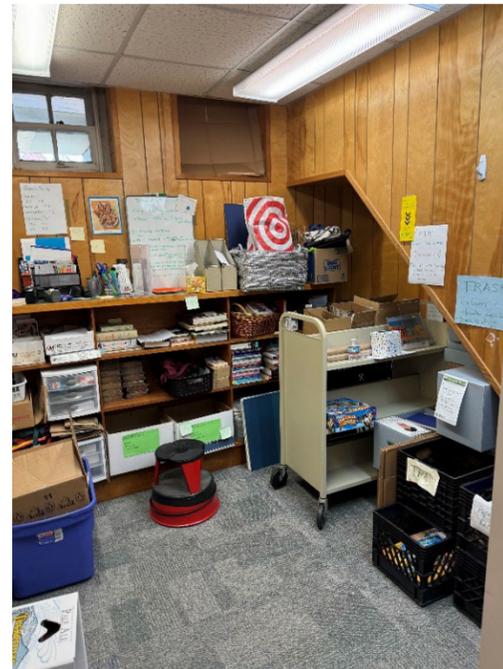
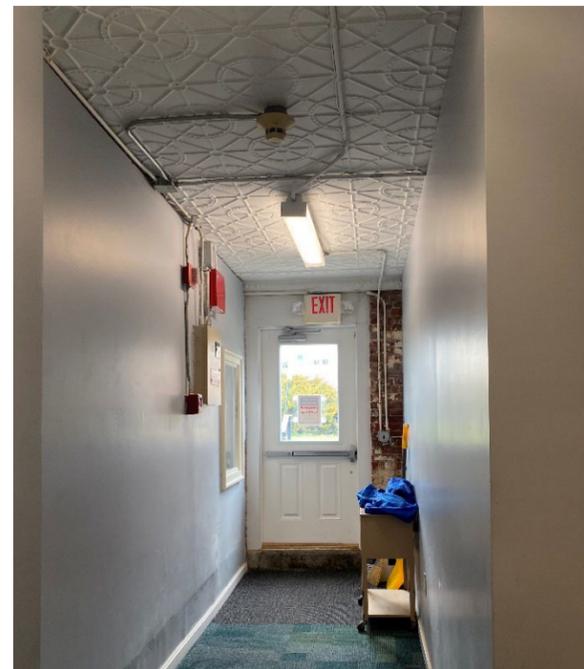
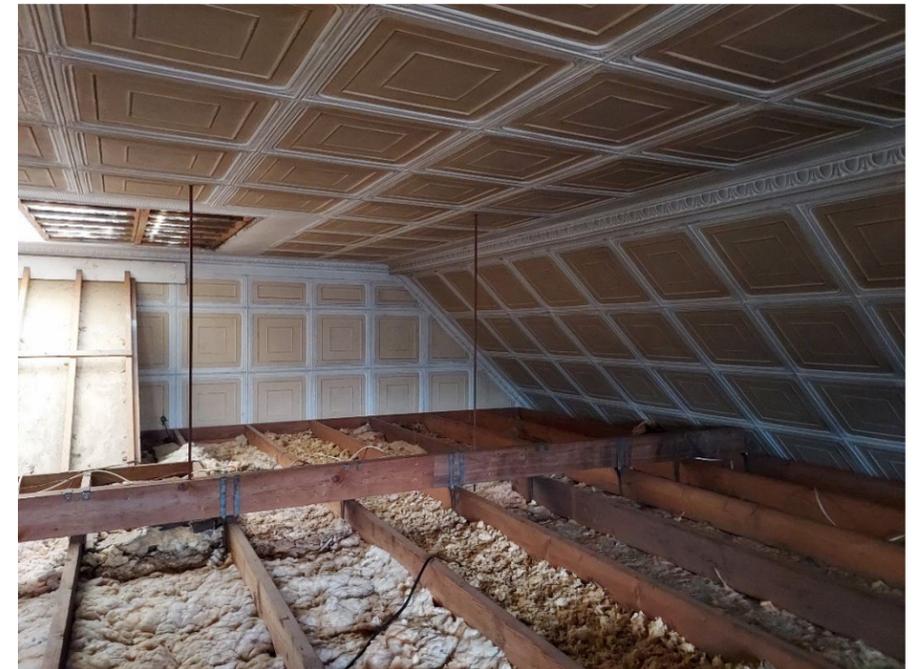
All the painted pressed metal ceilings are in good condition. The exposed pressed metal ceiling on the lower-level is painted white and has punctures for contemporary elements like smoke detectors, lighting, and associated conduits. The painted pressed metal ceilings are original to the building. The plastered vaulted ceilings are in fair condition and have minor cracks identical to the plastered walls and may require repair for aesthetic purposes.

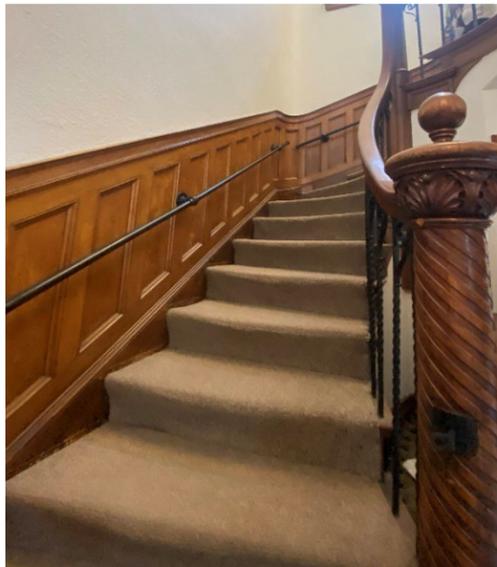
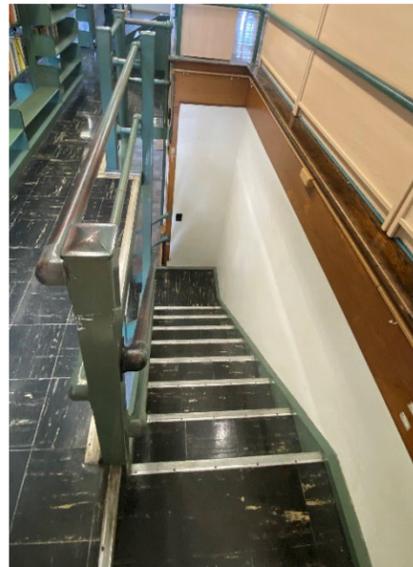
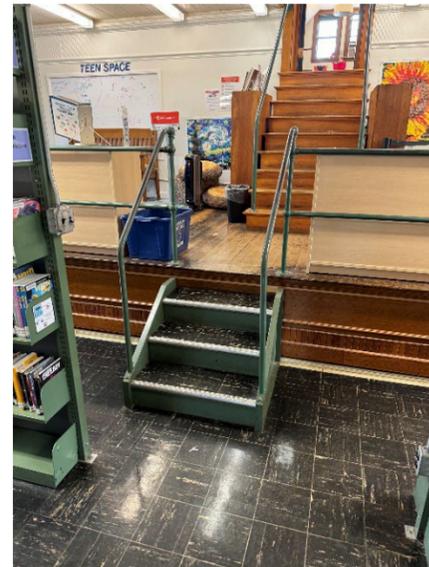
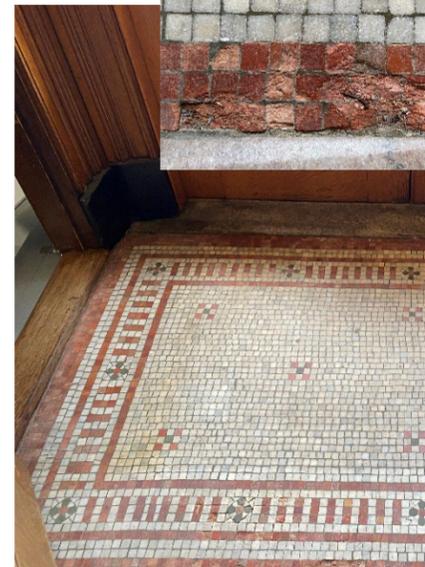
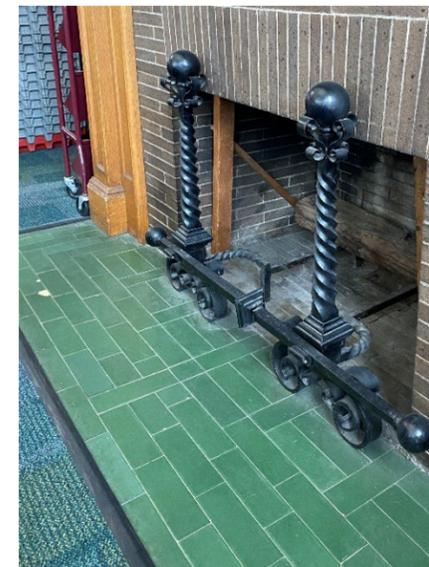
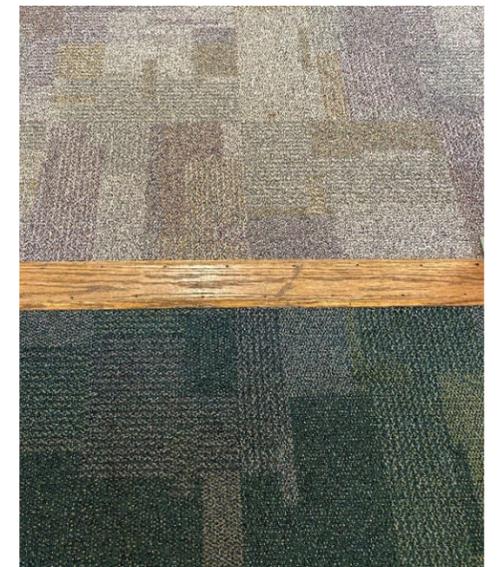
The main staircase is in good condition and should be maintained because it is original to the building. The wood handrails and wrought iron balusters are in good condition. The stair railings and guardrails are not in compliance with current code. The stacks staircase is in fair condition as is not a particularly safe stair to use. It is narrow and the guardrails are open- both cases do not meet current codes. The wood staircase to the basement is narrow with steep risers and does not meet code. Current building code does not allow three floors to be open and connected with each other. A smoke-tight enclosure of the vertical openings to the lower level may be required based on the amount of alteration of the building in a future renovation.

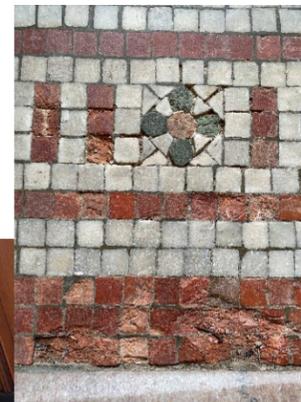
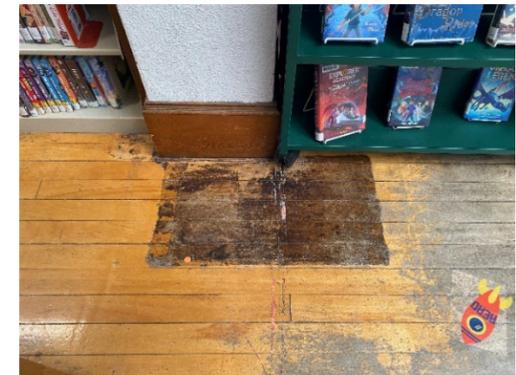
The mosaic tile floor is in fair condition with a few areas of tile spalling. The carpet flooring is in good condition and is protecting the original wood flooring. The original wood flooring on the first floor under the carpet tiles should be reviewed if there is a desire to remove the carpet and expose the original floor. Original wood floor on the second floor is in fair condition – there are ghost patterns of old wood stain and scuffs over the years of use. The asbestos-containing flooring should be encapsulated to prevent health issues. The fireplace hearth tile flooring is in fair condition with one area of spalls and cracks. A protective coating or a plexiglass covering can be installed on the tile floors to protect it from foot traffic.

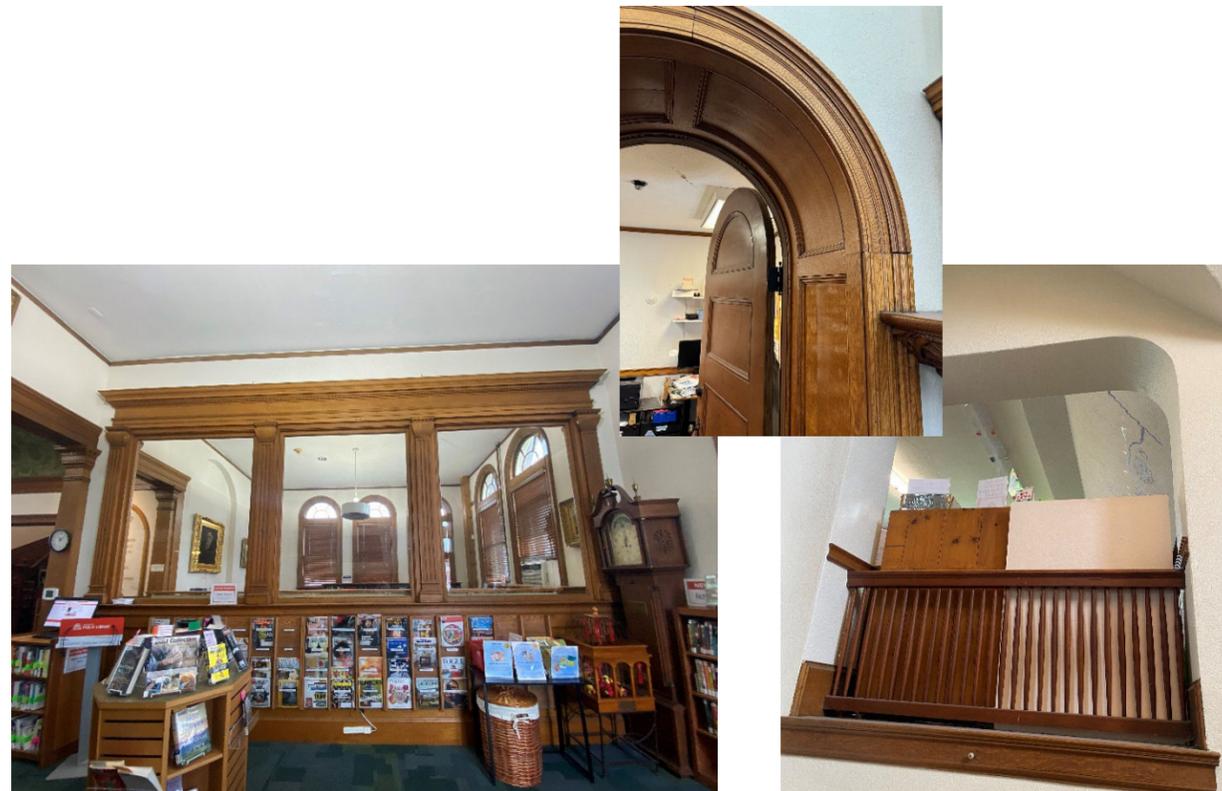
Wood trim around the door and wall openings are in good condition. The wood and glass partition wall is in good condition but if the magazine racks are removed from the wall, the wood paneling will need to be restored. The plastered openings in the Youth Services area are in similar condition as the plastered walls and should be treated the same as the walls and ceilings. The railings associated with the openings are low and do not meet code for guardrails. If the bookcases are moved away from the railings, additional guards should be installed.

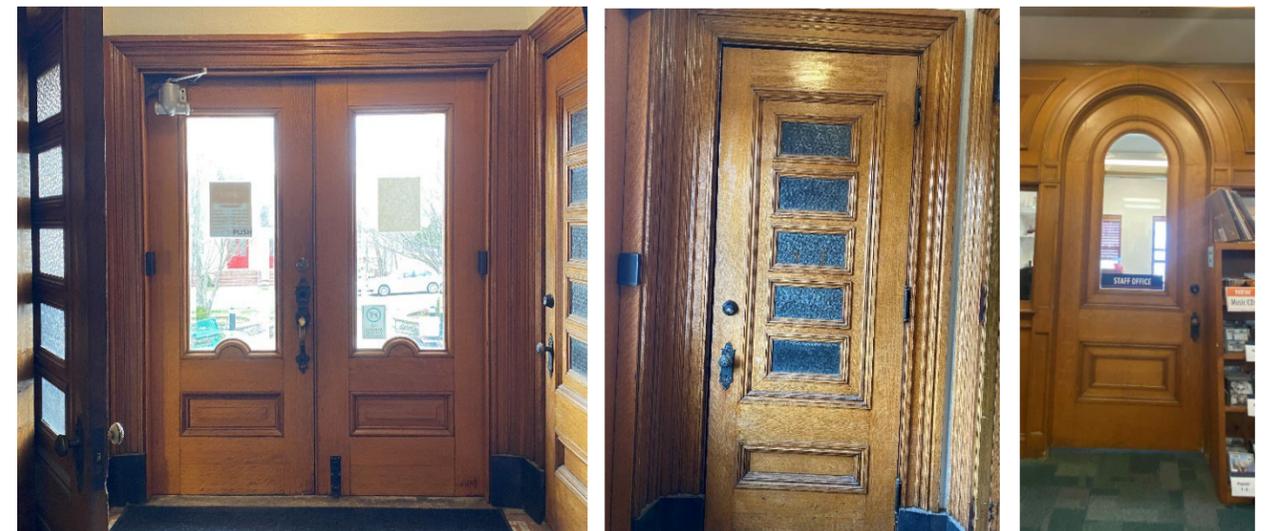
The doors are in good condition and most stained and clear-coated doors are original to the building. Painted wood doors in the lower level are not original to the building but are in good condition. The front doors were preserved in 2019-2020.

Doors serving more than 49 people per code are required to have panic hardware. See Accessibility report for door hardware compliance issues.

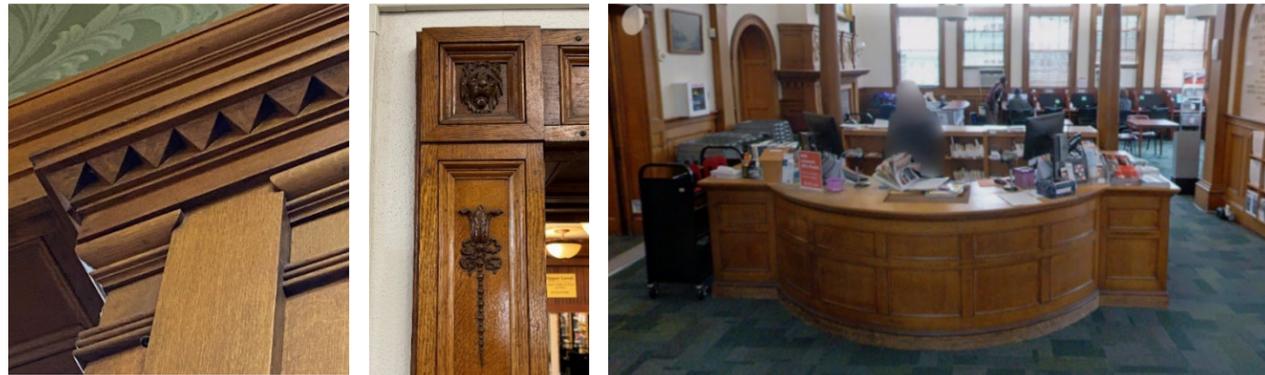
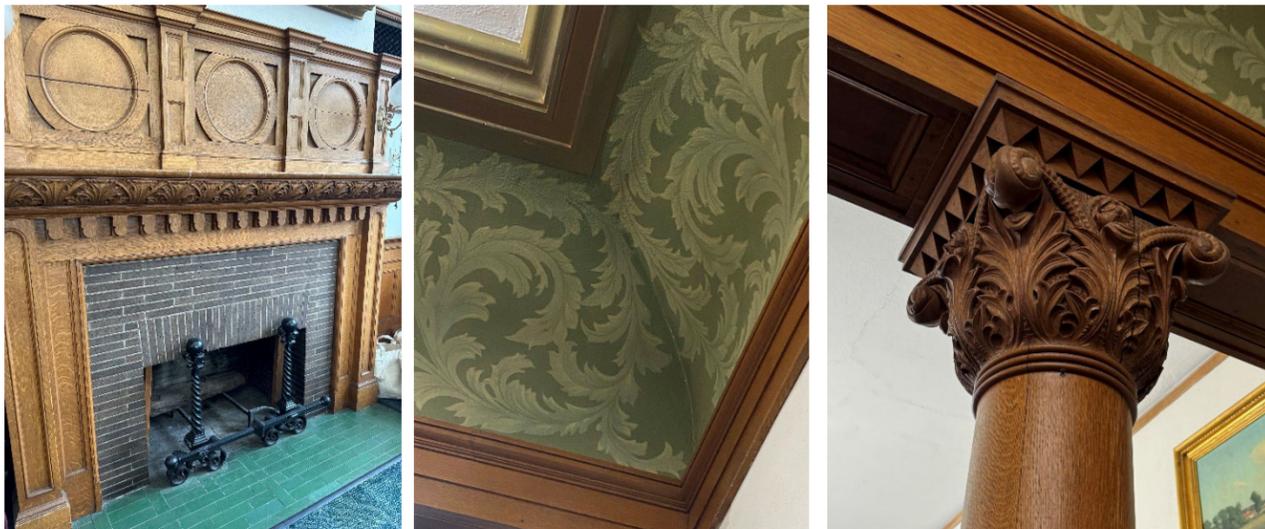
At the cove ceiling above the central portion of the main bay of the building, the painted motif is in good condition but should be assessed by a conservator. The commemorative marble plaques that flank the entry are in good condition. The circulation desk requires treatment and has been utilized to its fullest capacity after installing electrical. The oak trim, wainscot, columns and millwork are all in good condition. The oak fireplace mantle ornamentation is also in fair condition despite two large cracks in the wood paneling above the mantle in the Reference Room. The wood above the fireplaces and wood paneling throughout is in need of cleaning.

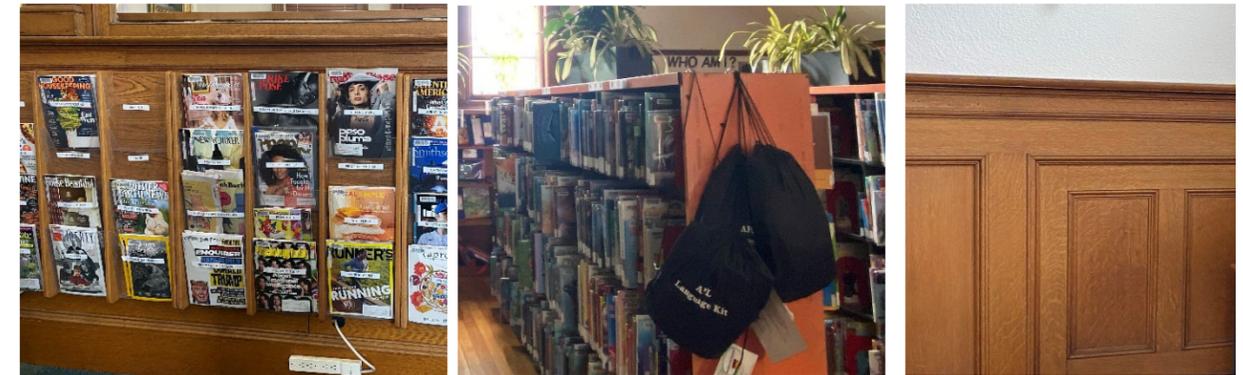
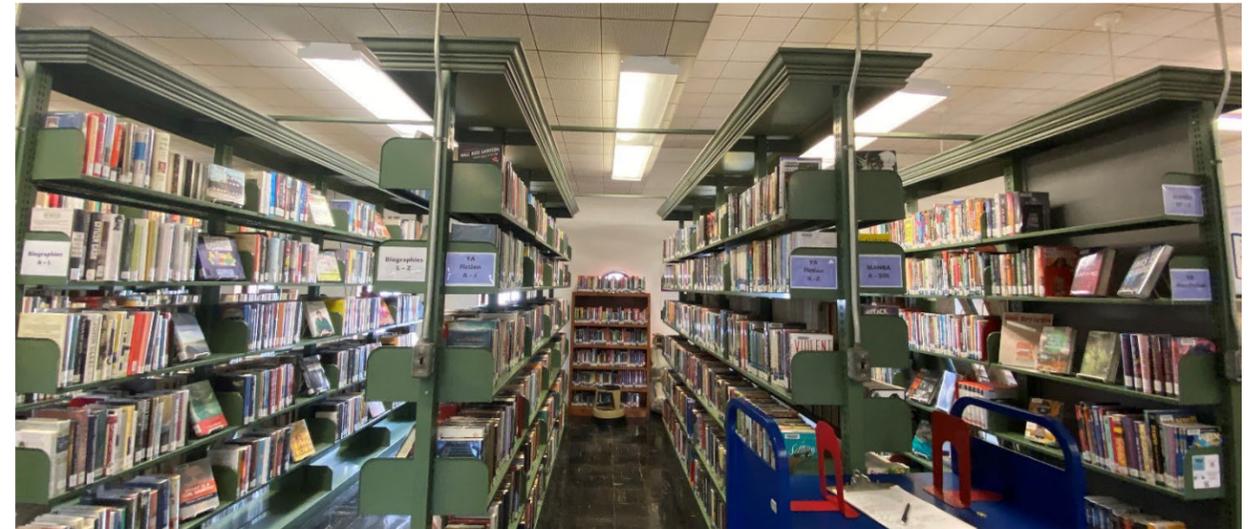
The bookcases are not historically sensitive and should be reconsidered to unify the aesthetic of the interiors. Original wood paneling should be retained and furniture and bookcase placement should be moved away from walls to allow the paneling to be more visible. Wood paneling throughout is in need of cleaning to remove oils from years of people touching it.

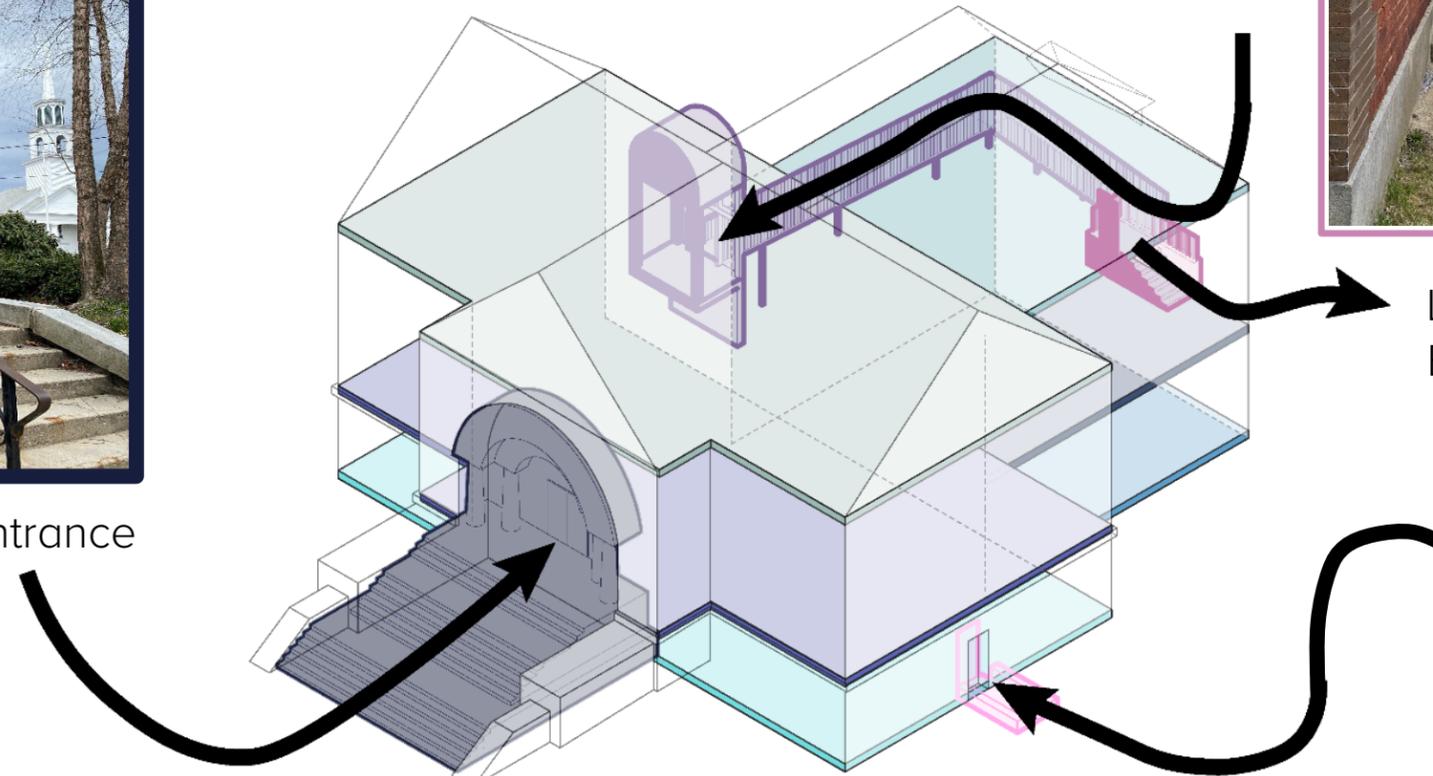
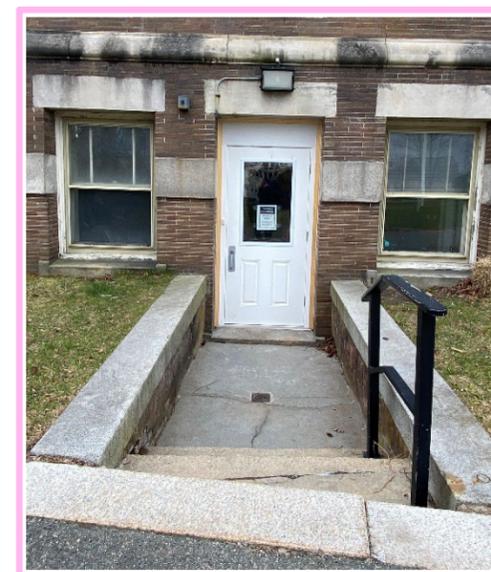
Lower level and First floor  
Emergency Exit

Delivery Entrance

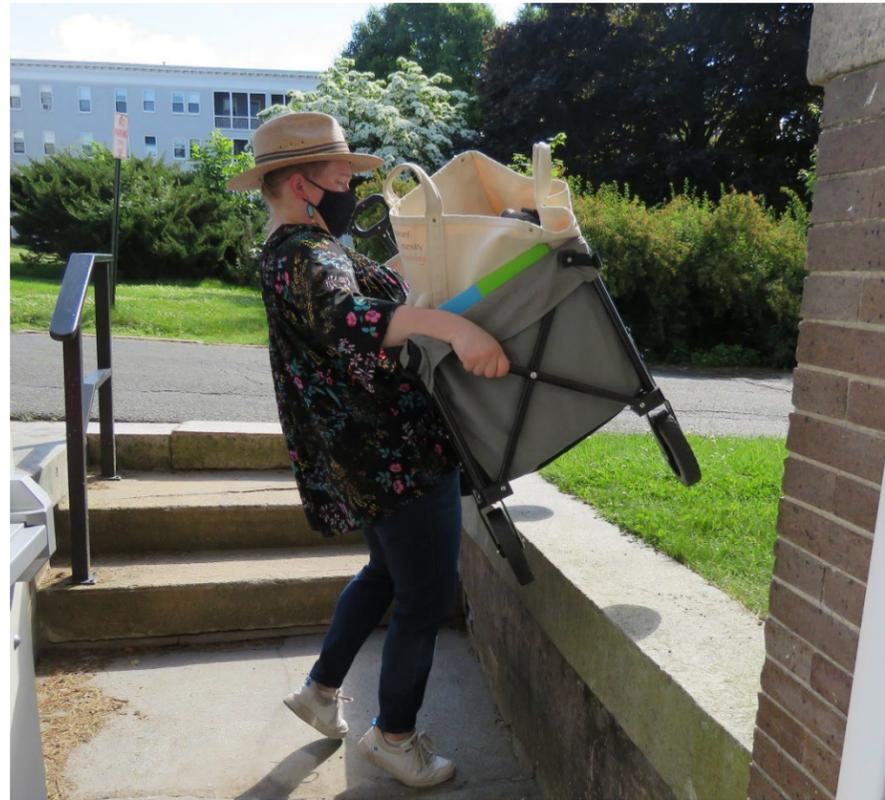
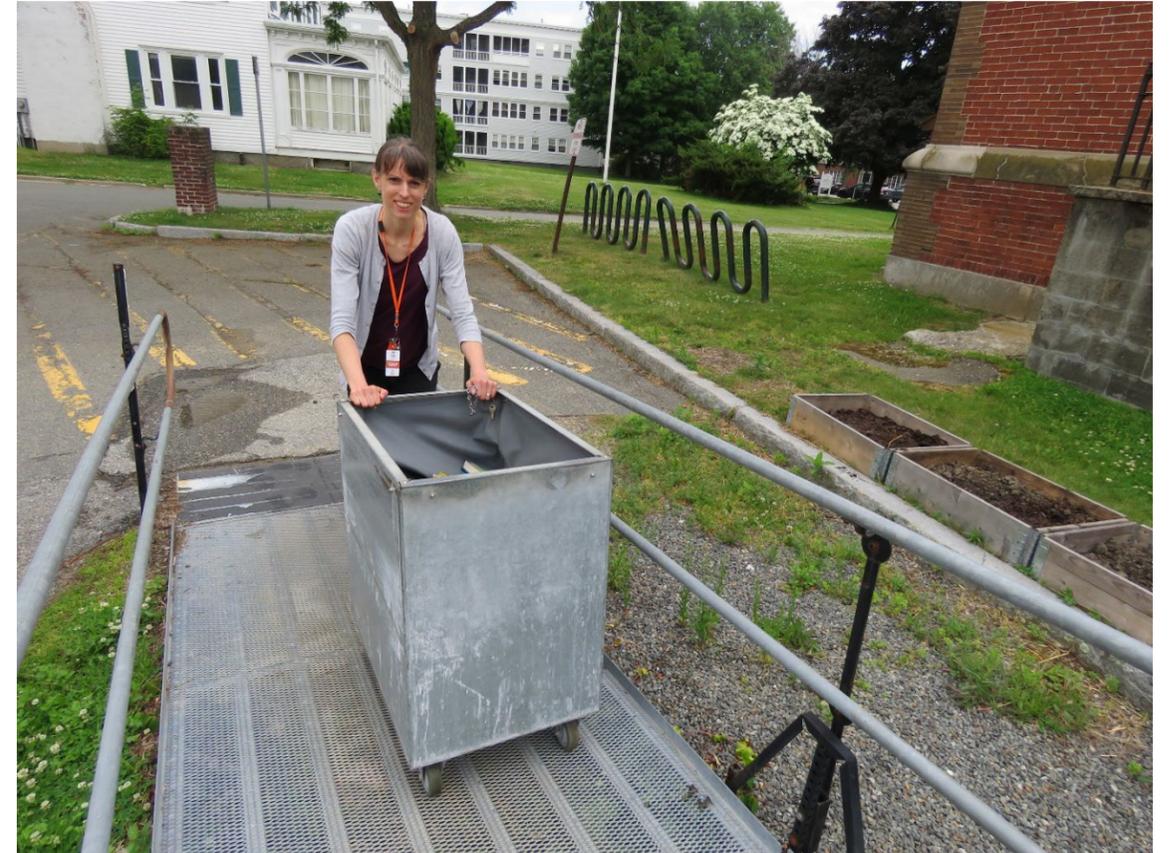
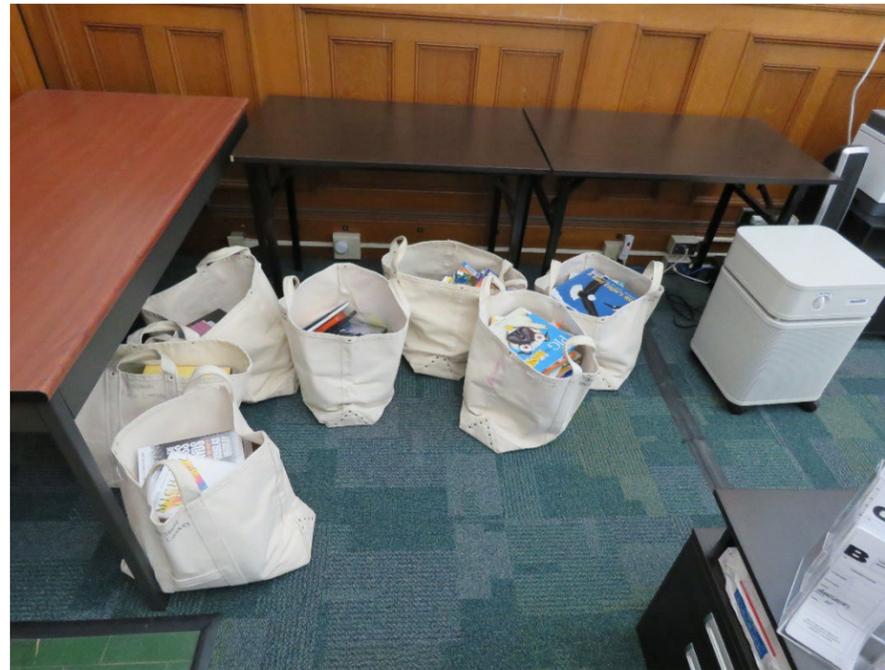
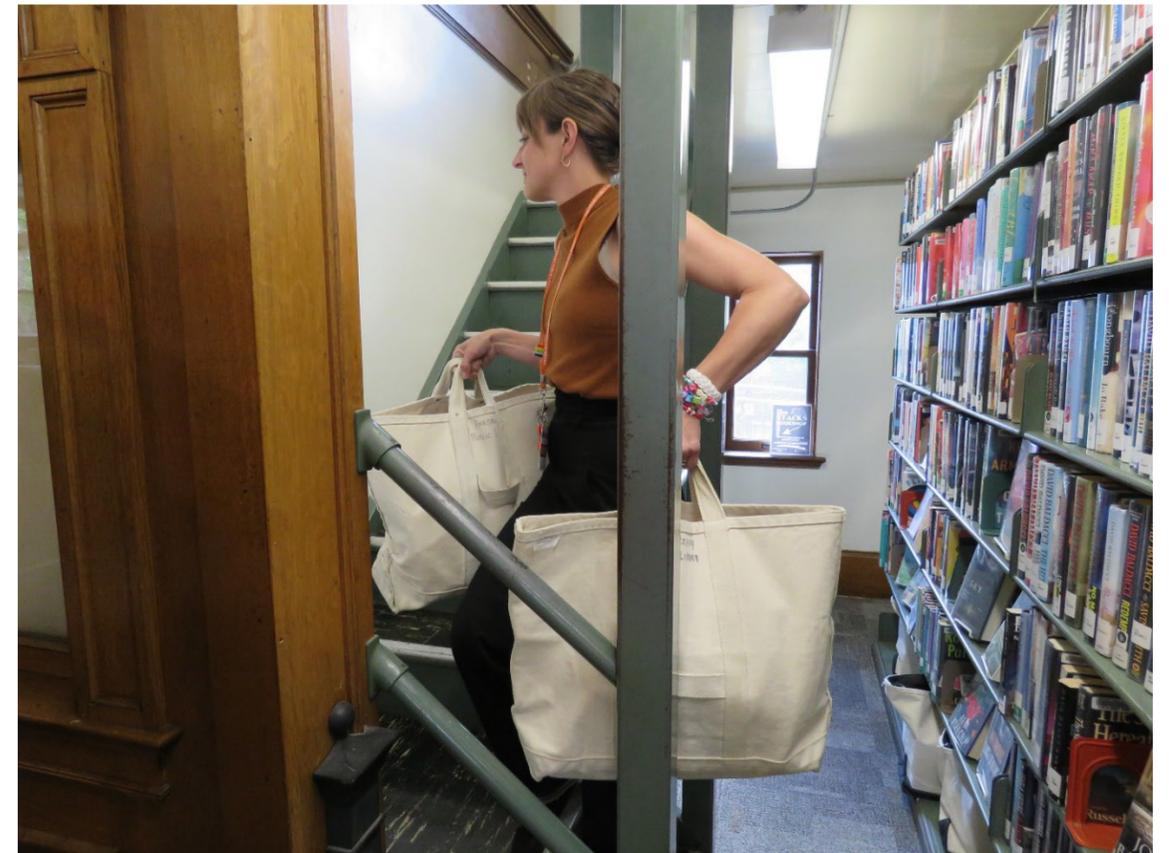
Physical barriers of the building are not only experienced by the patrons of the Library, but by the staff that work in the building every day. Staff empty the drop-off book deposit box four times a day but wheeling a cart down and up the temporary ramp. They lift heavy bags of books up and down the stairs to return them to the shelves or collect them for patrons. An accessible building will be a vast improvement to the physical labor that is currently required as part of their responsibilities.

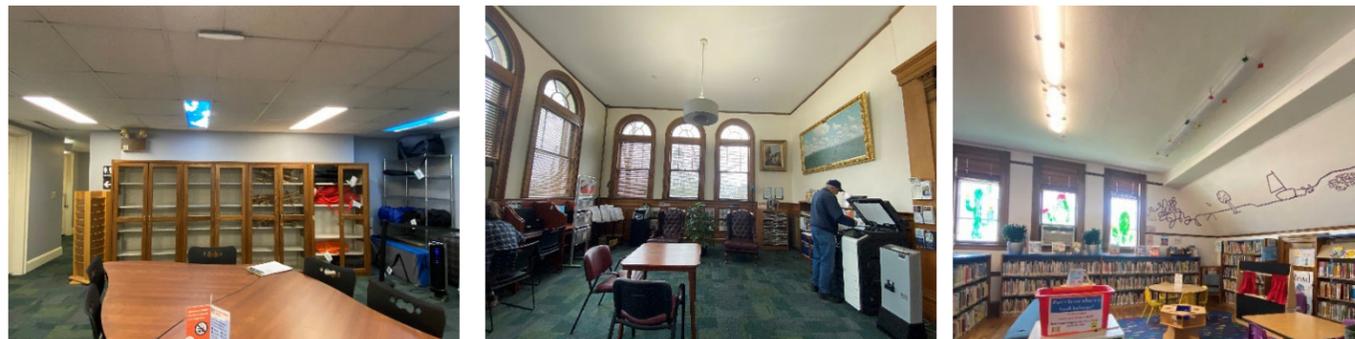
Lighting throughout has been replaced by florescent fixtures that illuminate the space but are not compatible with the interior design of the building. The facility has both fluorescent and LED type fixtures with minimal lighting controls. Many areas of the library struggled with footcandle levels and heavily relied on incoming daylight for general building lighting. Bulbs will be burned out for months without replacement. The second-floor lighting was swapped for LED lights and the staff and users comment they are too bright without any dimming capabilities. Any future renovations would recommend upgrading all existing lighting fixtures with LED that have both direct/indirect lighting distributions and provide a centralized networked lighting control system to provide both manual and scheduled controllability.

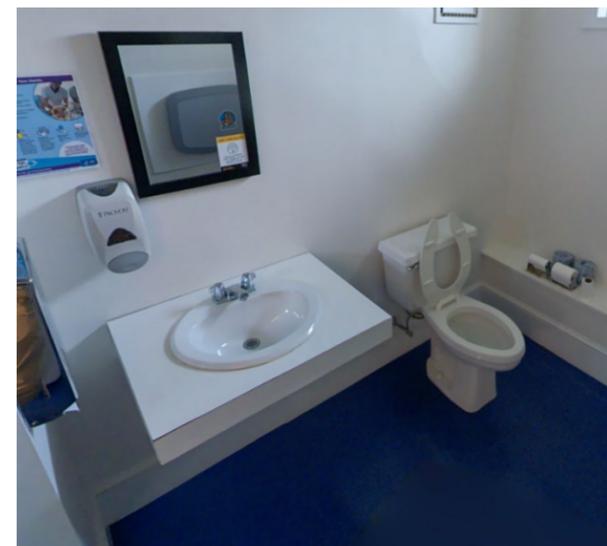
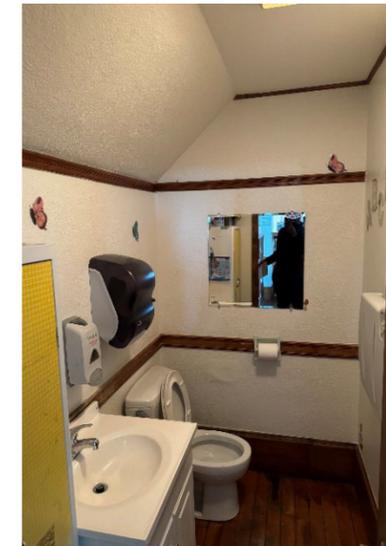
Although functioning properly, none of the restrooms are accessible per MAAB. There are two single user restrooms on the Lower Level and one single user restroom on Level 2. Based on this configuration, the maximum program load for the library is 100 occupants. The program load for libraries is based on the number of seats in the building and the maximum number of employees on duty at any given time. The program load will need to be determined by the future furniture configuration. The following table demonstrates how many single user restrooms are required based on different population thresholds (248 CMR 10.10 Table 1). Note that when four or more toilet fixtures are required, they are required to be provided in pairs on the same level (248 CMR 10.10(15)(g)(2)). If multi-stall restrooms are provided, the number of fixtures will need to be recalculated.

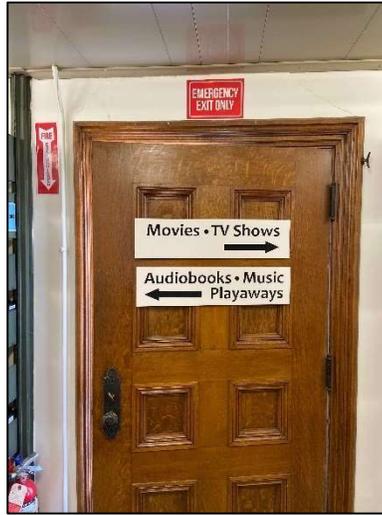
FIGURE 3: LEVEL 1 REAR EXIT

- There are excessive thresholds in many locations. Reduce/repair the thresholds to eliminate trip hazards.
- Emergency lighting appears to be lacking throughout. Confirm emergency whether the lighting fixtures serve emergency lighting function and recommend testing for lighting level coverage during emergency power. *This is an item that has been noted as a concern of the Town's Building Department on the 2023 Inspection Report.*

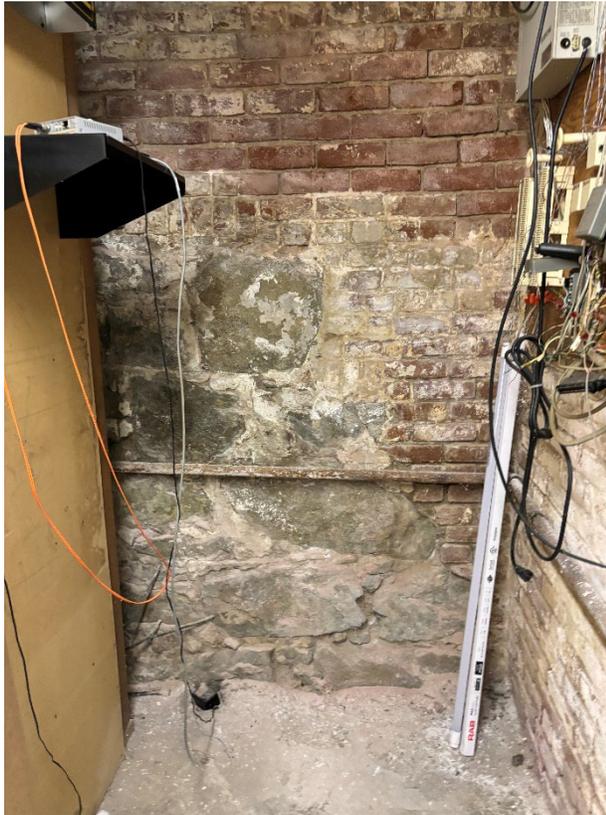
**Photo 1**

The foundation wall construction is typically mortared fieldstone and brick masonry (Photo 1). It is not typically visible from the interior spaces, but we were able to view the foundation walls at some back-of-house spaces in the basement. At the utilities closet along the south exterior wall, the finishes are removed, exposing a 2x4 stud wall with a plaster wall behind it, and the fieldstone foundation wall, which appears in good condition (Photo 2 and 3).

- A portion of the slab-on-grade is removed in the utilities closet between the bathrooms, with below-grade plumbing exposed (Photo 4). The slab-on-grade is approximately 2 in. thick at this location (Photo 5).
- A portion of the slab-on-grade is removed and sawcut along the north wall in the Utilities/Storage room, with below-grade plumbing exposed. There is apparent differential settlement of the slab at the sawcut portion (Photo 6).
- There is efflorescence on the interior face of the east wall of the North Wing (Photo 1).

Fieldstone and brick foundation wall at east wall of North Wing, with some efflorescence on the brick and fieldstone.

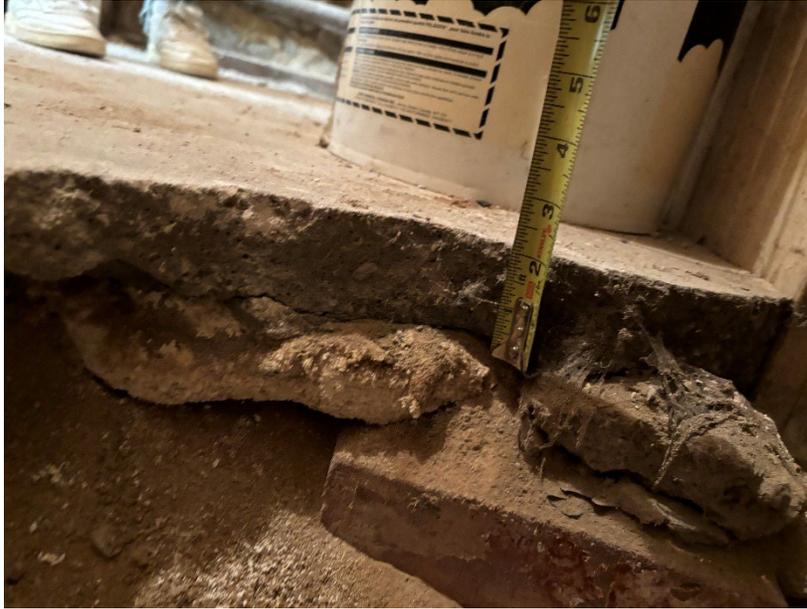
**Photo 5**

The slab-on-grade in the Utilities Closet between the basement bathrooms is approximately 2 in. thick.

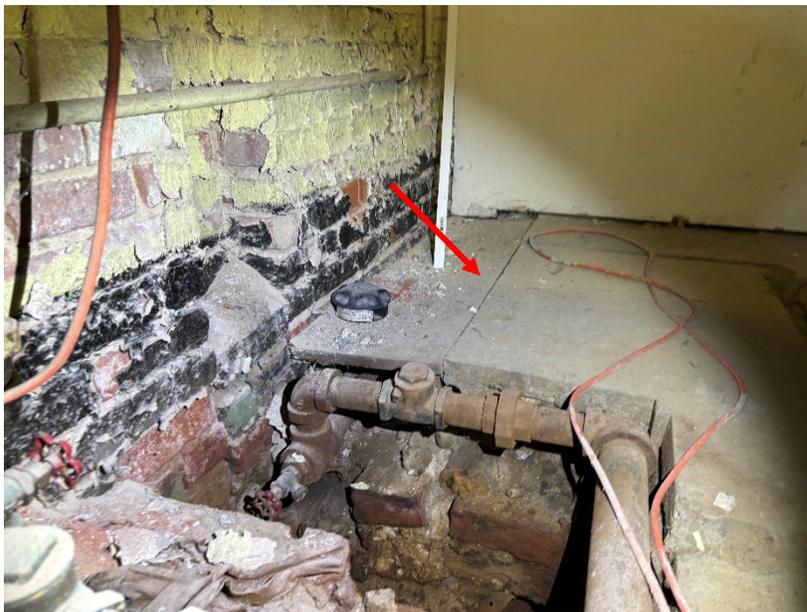
**Photo 6**

Sawcut and partially demolished slab-on-grade at Utilities/Storage Room with differential settlement.
