# AMESBURY PUBLIC LIBRARY

## Facilities Needs Assessment Report

September 10, 2024

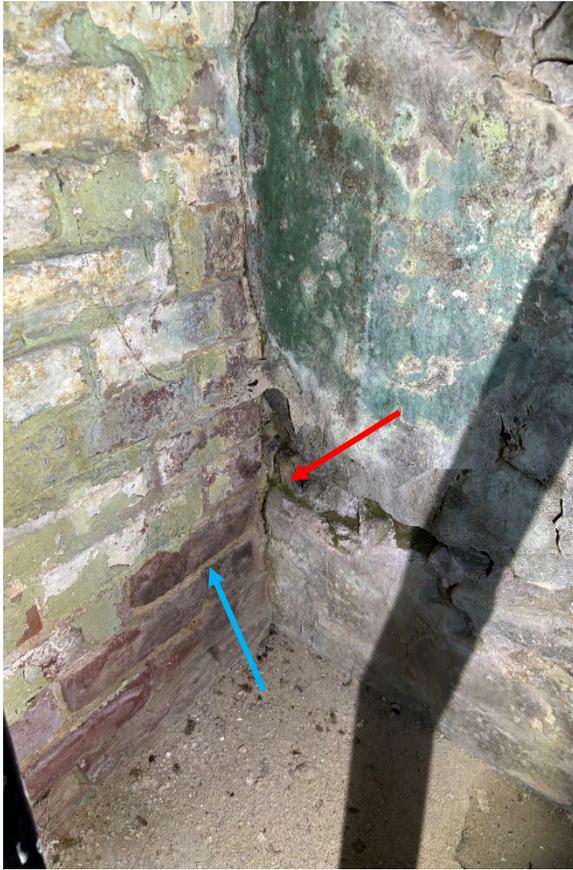
**Photo 7**

- Mortar is missing and deteriorated at the north fieldstone wall at the basement storage area in the Printer/Copier Room (Photo 7).

Deteriorated mortar at the north wall of the basement Storage Room (red arrow). The blue arrow indicates a nonstructural interior partition wall.

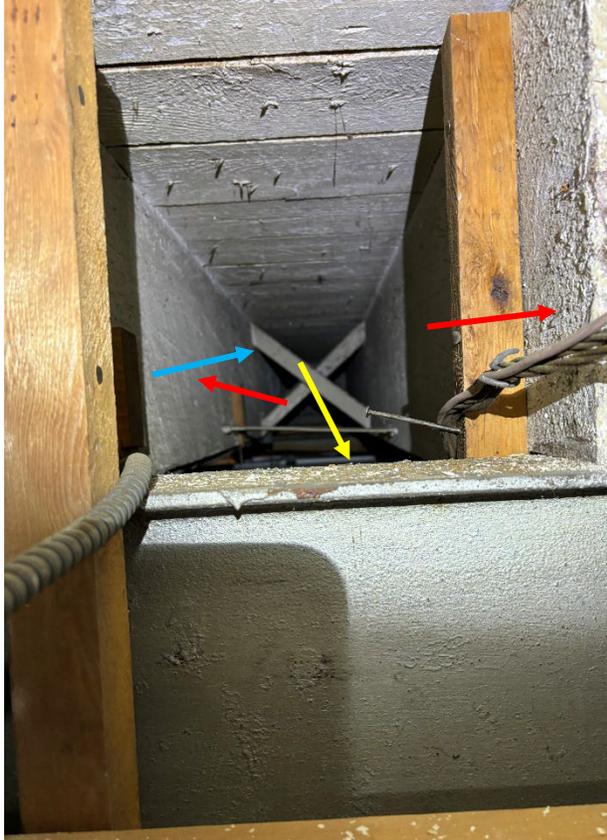
**Photo 8**

First Floor framing in North Wing, looking east.

Yellow arrow indicates steel beam.

Blue arrow indicates wood X-shaped bridging.

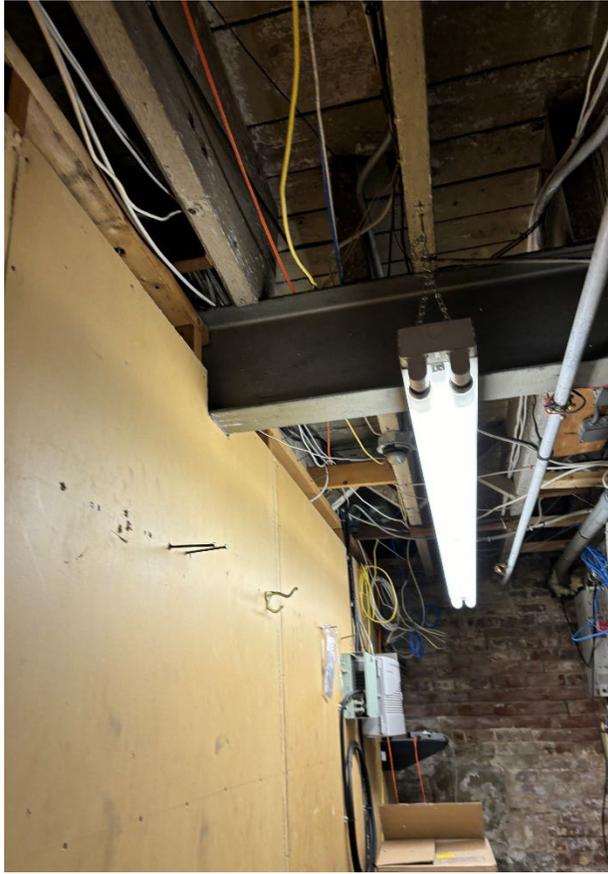
**Photo 9**

First Floor framing in north wing, looking east.

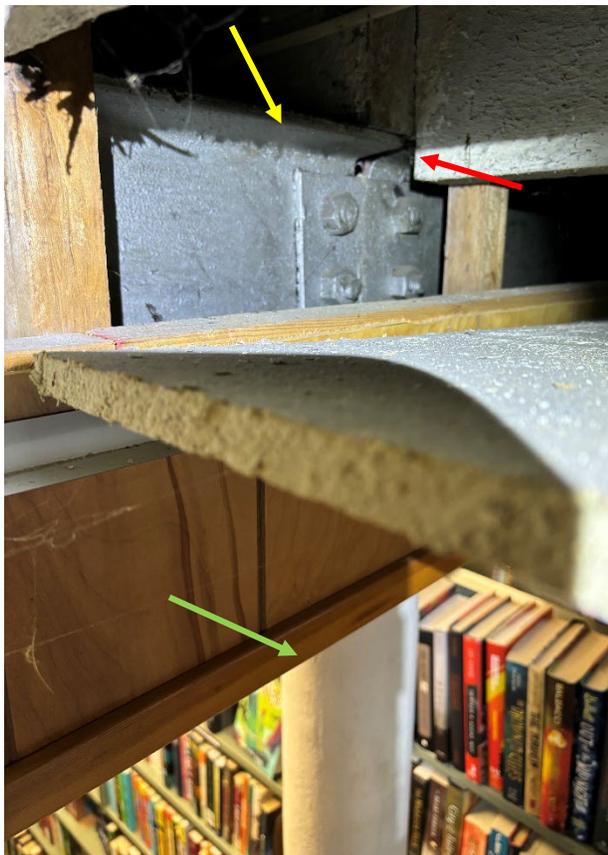
**Photo 10**

First Floor framing in North Wing, looking southeast.

Yellow arrow indicates steel beams, both bearing on the column cap plate.

Green arrow indicates steel post.

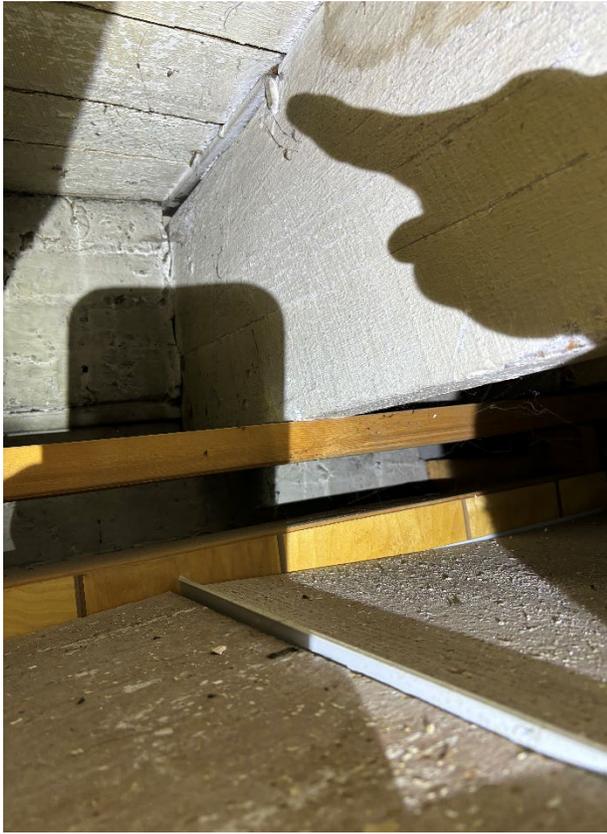
**Photo 11**

The North Wing divides into three bays by 10 in. deep steel beams spanning north-south at the approximate third point of the wing. Wood joists, approximately 2 in. wide by 13-3/4 in. deep, span east-west between the steel beams and foundation walls at approximately 16 in. on center. The wood joists bear on top of the steel beams, with an approximate 1 in. notch, making the depth of joist above the beam approximately 12-3/4 in. deep. X-shaped wood bridging braces the joists at their approximate mid-span (Photos 8, 9, and 10). The steel beams bear on round steel posts (Photo 10). At some, but not all, joist pockets, steel straps mount to the top of the joists and extend into the exterior masonry walls (Photo 11). The joist spans range from 10 ft 10 in. to 12 ft 8 in.

Steel strap mounted to the top of the first-floor joist, extending in to the masonry wall.

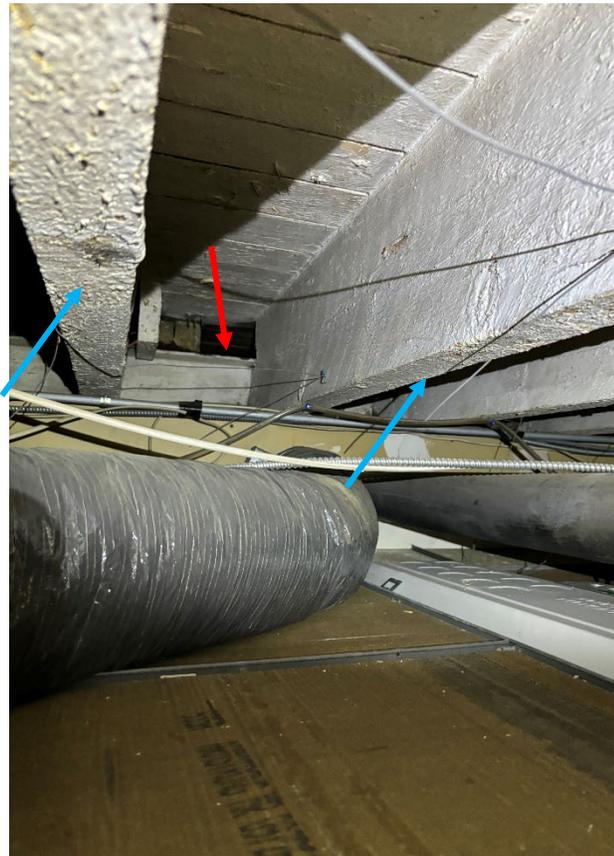
**Photo 12**

The South Wing divides into three bays by steel beams spanning north-south at the approximate third points (Photo 12). Where we were able to observe a steel beam up close along the wall between the Utilities/Storage Room and Workshare Space; the beam appeared to be an 8-1/2 in. deep beam, with a horizontal steel stiffener running longitudinally approximately 4 in. above the bottom flange (Photo 13). In the center bay, wood joists, approximately 2-1/2 in. wide by 12 in. deep, span east-west between the steel beams at approximately 16 in. o.c. The joists bear on the horizontal steel stiffener. At the east bay, wood joists, approximately 2 in. by 5-1/2 in. deep span between joist pockets in the exterior wall and the steel beam. They bear on top of the steel beam, with an approximately 1 in. notch.

First floor framing above the Workshare Space in the South Wing, looking west.

Red arrow indicates steel beam.

Blue arrows indicate wood joists.

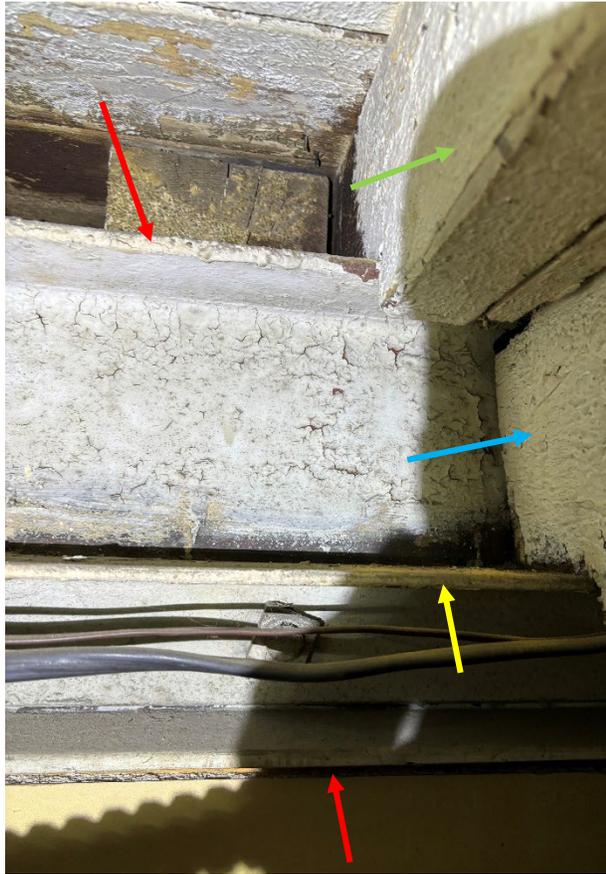
**Photo 13**

First floor joists bearing on steel beam between Workshare Space and Utilities Space (from Workshare Space side).

Blue arrow indicates notched wood joist.

Green arrow indicates atypical blocking next to notched joist.

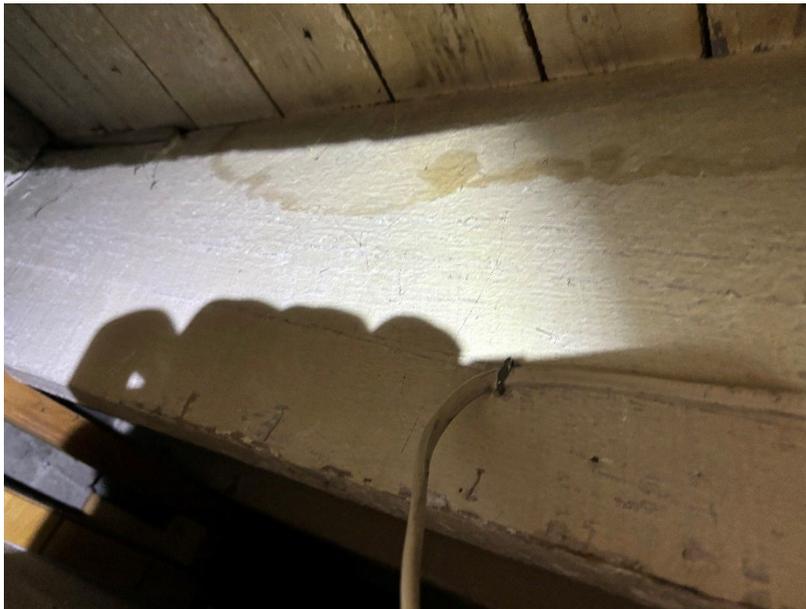
**Photo 14**

- We observed some localized staining consistent with water infiltration on a floor joist in the North Wing but did not observe any deterioration associated with staining (Photo 14).
- Just south of the rear (north) entrance, there is a 44 in. x 44 in. floor infill framed with 2 x 4s and plywood sheathing. Sheet metal extends along the face of the surrounding typical floor framing that makes the perimeter of the infilled opening (Photos 15 and 16).
- The hard ceiling in the basement storage area within the Printer/Copier Room has staining and cracking consistent with water infiltration. Additionally, the paint on the interior face of the east exterior brick wall is peeling, particularly at the mortar joints (Photo 17).

Staining on First Floor joist with no associated deterioration.

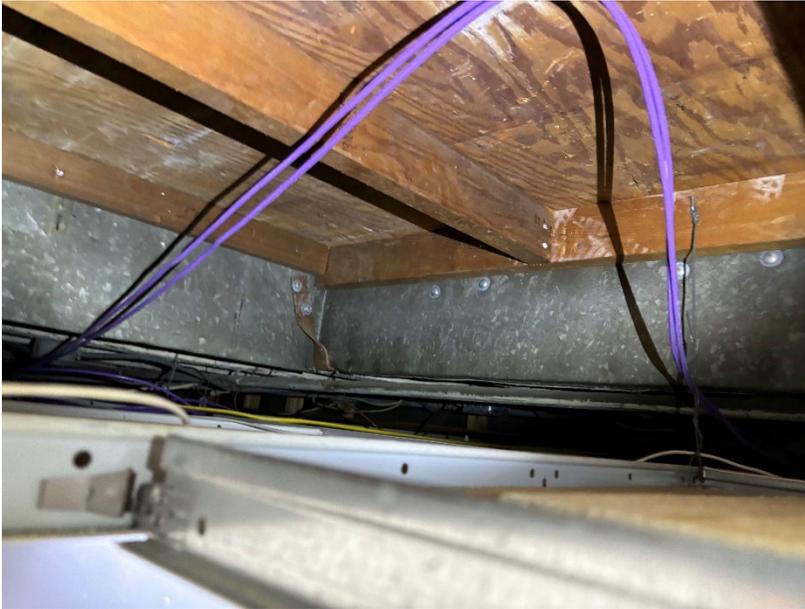
**Photo 15**

2x4 infill in the First Floor framing just south of the north entrance.

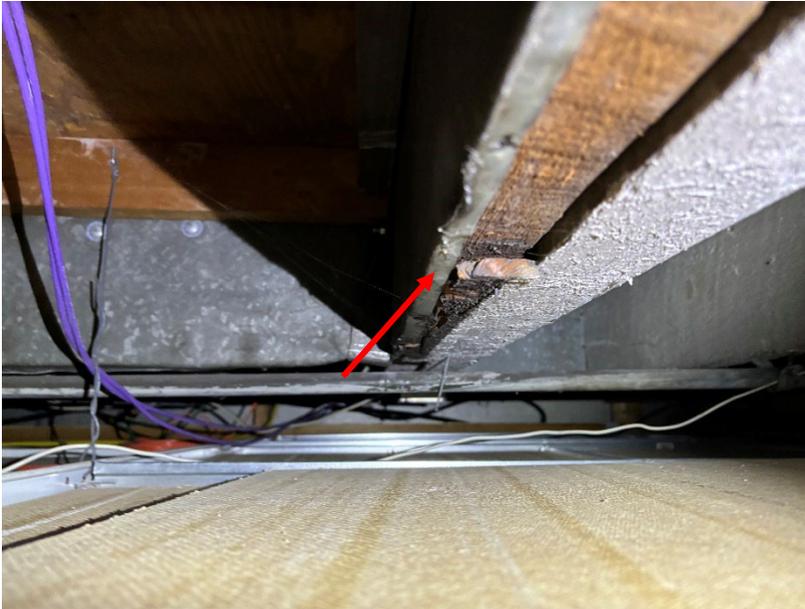
**Photo 16**

Sheet metal around 2x4 infill in the First floor framing just south of the north entrance.

Red arrow indicates bottom lip of metal flashing on the perimeter framing.

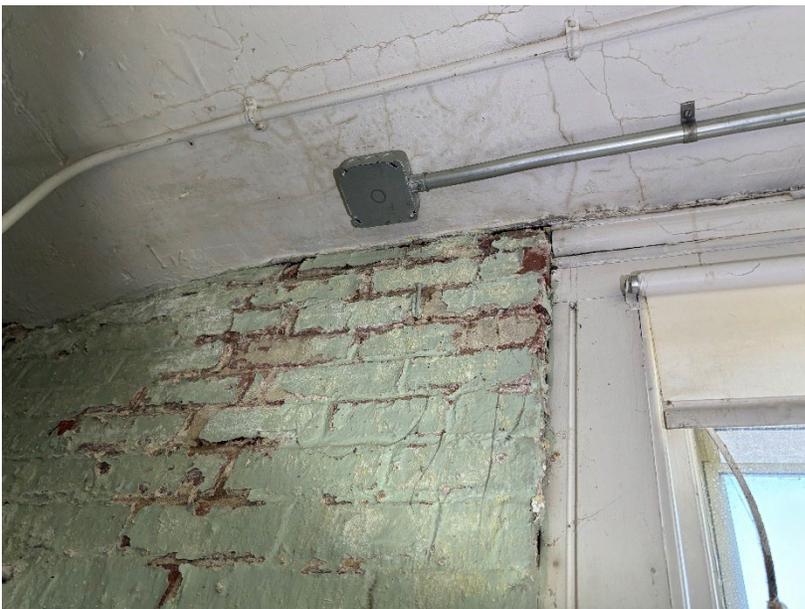
**Photo 17**

Cracks and staining on ceiling of Storage Room and peeling paint on interior face of exterior masonry wall.

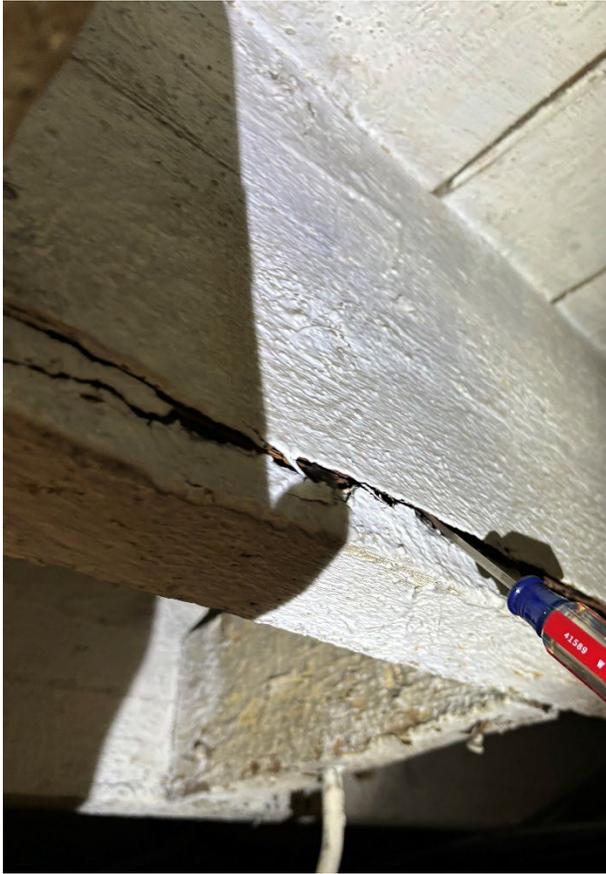
**Photo 18**

- We observed a longitudinal crack/check along a first-floor joist above the Workshare Space in the South Wing (Photo 18).
- Above a portion of the Staff Breakroom, there is 2 x 8 sub-framing below the existing First floor framing (Photo 19).
- There are two steel posts in the Utilities/Storage Room that are not part of the original building structure. Both bear on the lower-level slab-on-grade with no apparent foundation and they support blocking that is tight to the ceiling (Photos 20 and 21).
- There is missing brick masonry at both sides of the arch that forms the opening in the wall separating the North Wing from the South Wing (Photo 22).

Longitudinal crack/check in  
First Floor joist above  
workshare space.

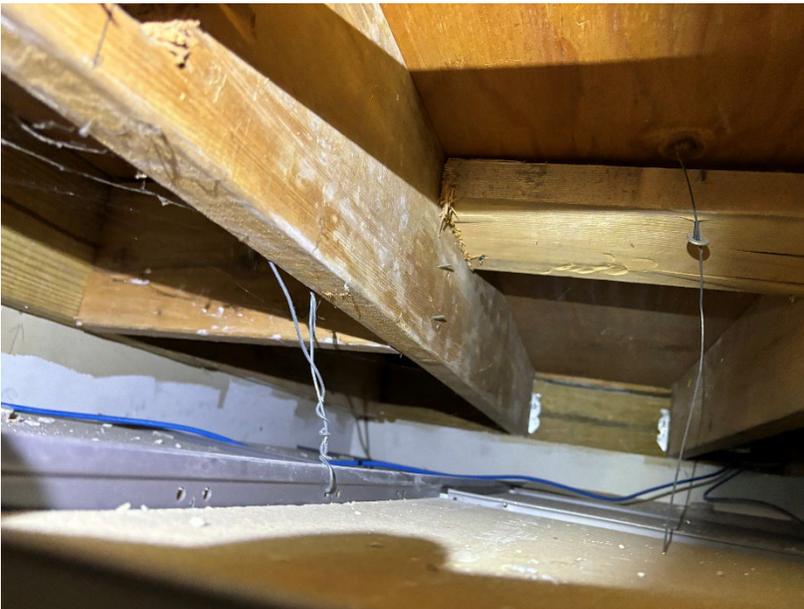
**Photo 19**

Wood 2x8 sub-framing  
below the existing first floor  
framing above the Staff  
Breakroom.

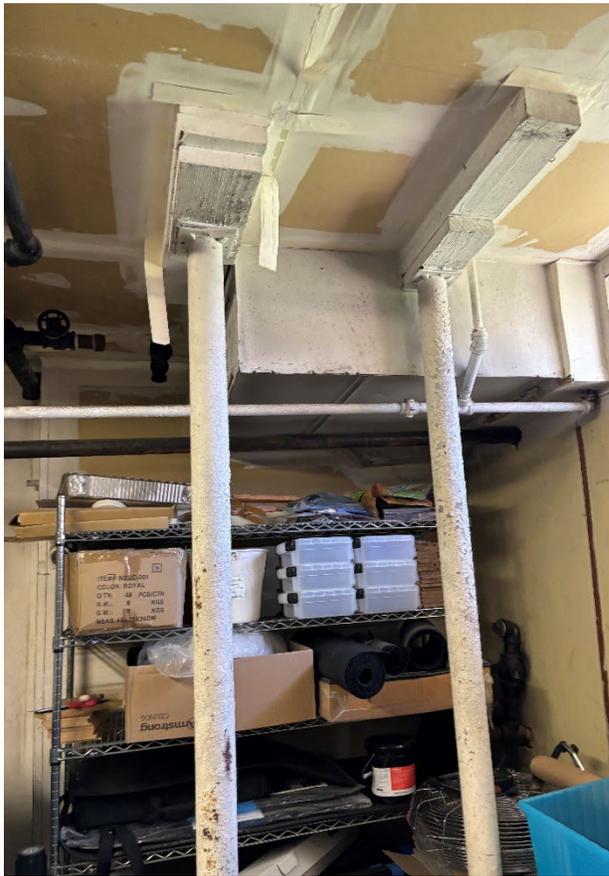
**Photo 20**

Steel posts in Utility Room with blocking to bottom of the ceiling.

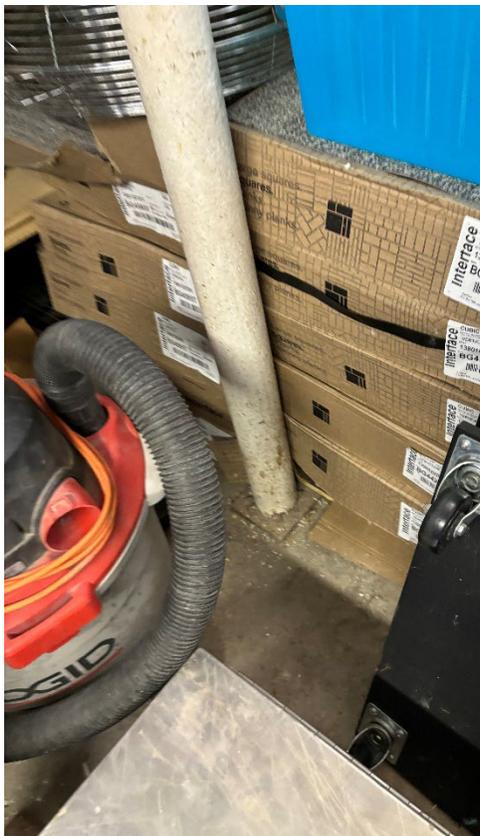
**Photo 21**

Steel post in basement Utility Room with base plate bearing on slab-on-grade.

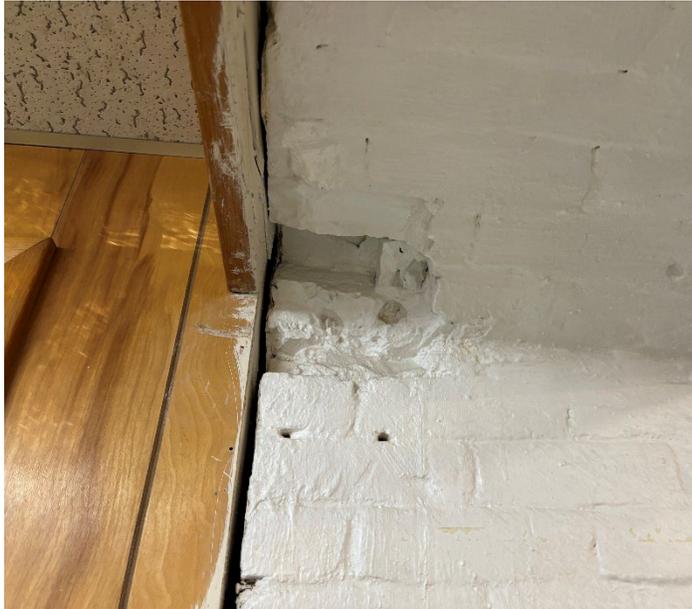
**Photo 22**

Damaged brick at the arch between the north and south wings in the basement.

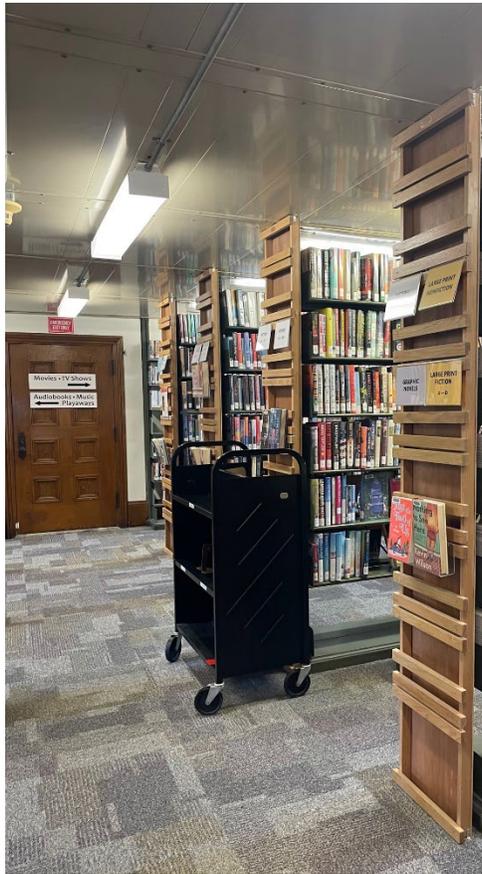
**Photo 23**

From the background documentation, we understand that the Library removed their original stacks in the North Wing and installed the self-supporting two-story stack structure in its place (Photos 23 and 24) in 1955.

Overall view of first floor stacks.

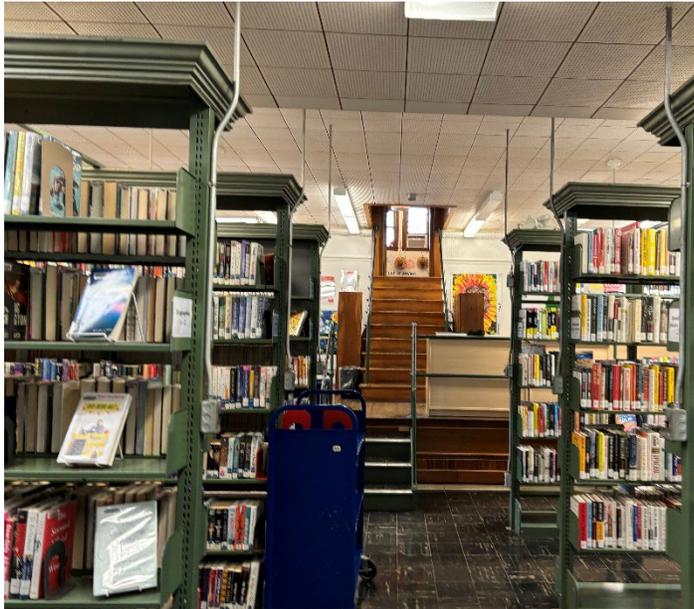
**Photo 24**

Overall view of second floor stacks.

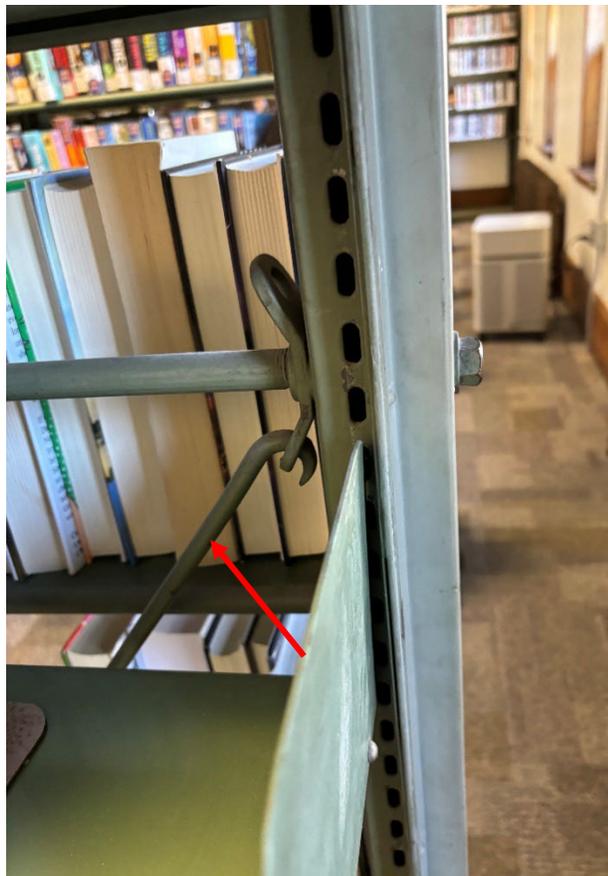
**Photo 25**

First floor stack posts constructed of two hat-shaped steel member with a steel plate sandwiched between.

Lateral bracing attaches to the posts (red arrow).

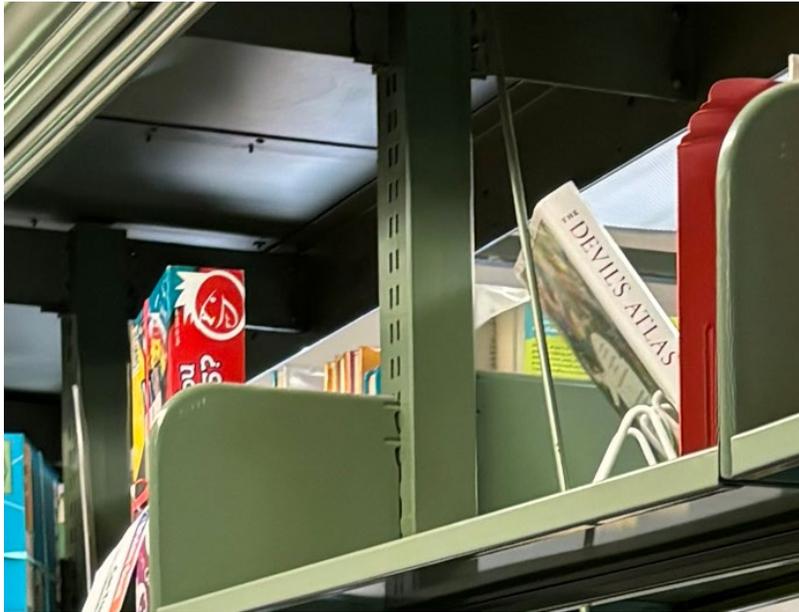
**Photo 26**

Rectangular posts at the  
Second-floor stack structure.

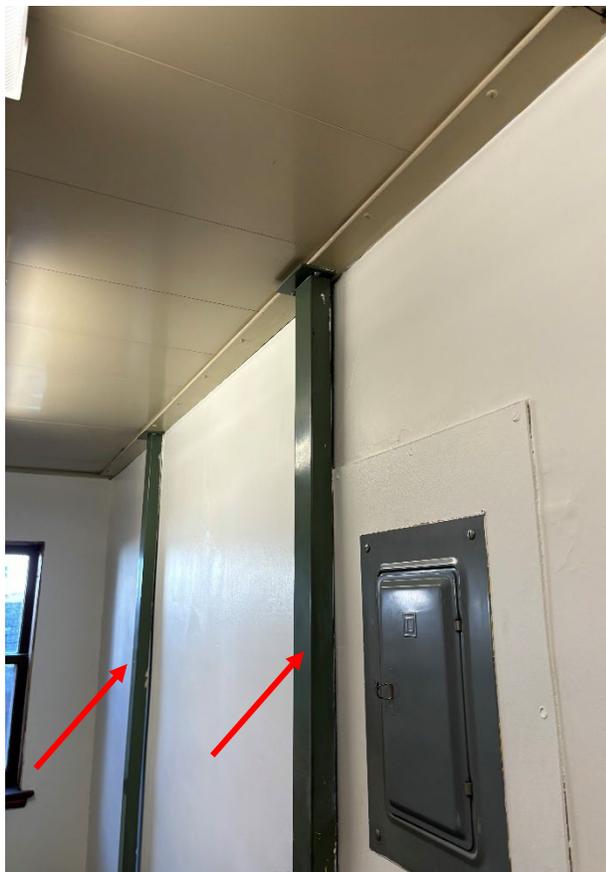
**Photo 27**

Steel posts at the south wall  
of the stack space at the First  
Floor.

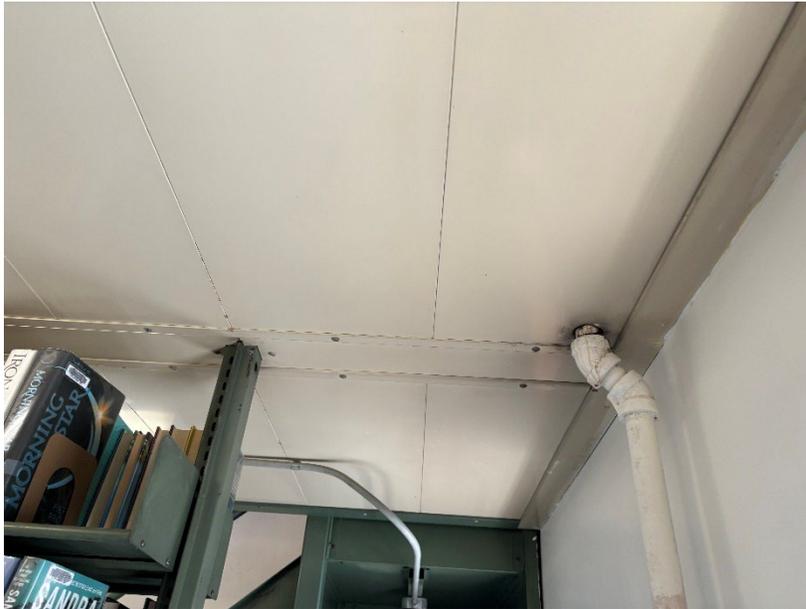
**Photo 28**

The walking surface of the second-floor stack structure extends to the east and west exterior walls, but it is unclear if there is a gravity support at the exterior walls or if the stack floor structure cantilevers (Photo 28). The 1955 drawings show an angle along the exterior wall, but it is not clear if the angle connects to the masonry. The second-floor stack structure is 3-1/2 in. thick at the stair opening (Photo 29).

Second floor of the stack structure (looking south along the west exterior wall) as viewed from below. It is unclear if the floor structure is supported by the exterior wall or if it cantilevers from the posts.

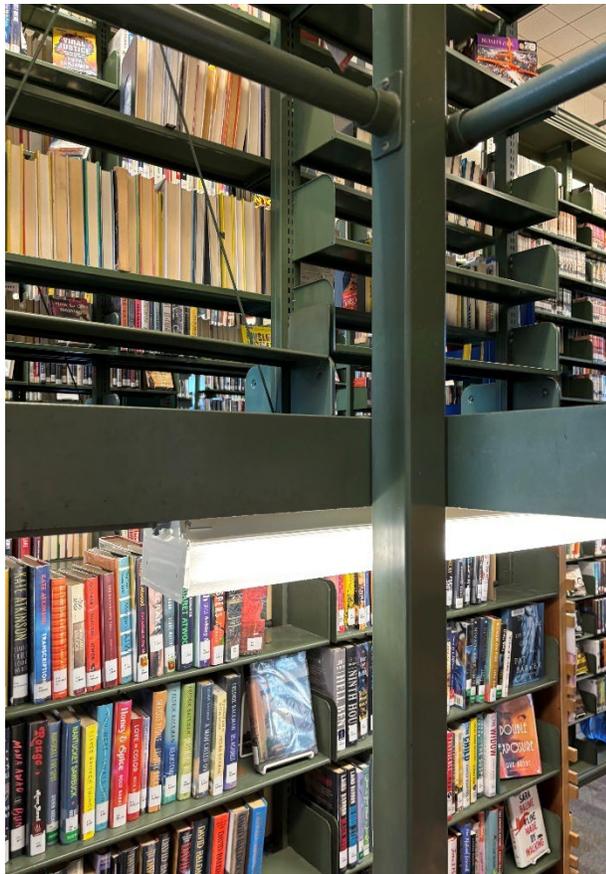
**Photo 29**

View of the second-floor structure from the stair opening.

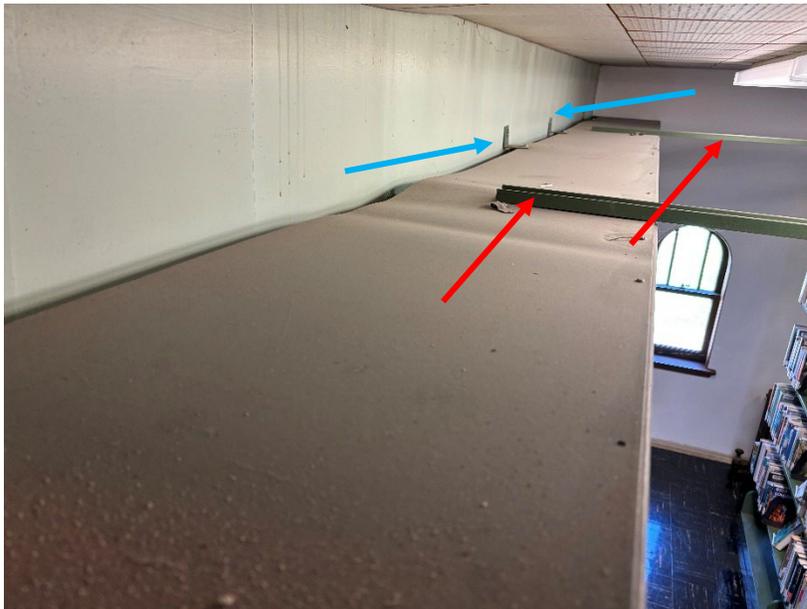
**Photo 30**

The tops of the second-floor stack shelves are braced by two lines of small continuous channels that run north-south. The shelves along the north elevation clip to the north exterior wall. (Photo 30).

Continuous channel bracing at tops of Second Floor stack shelves (red arrows).

Clips to north wall (blue arrows).

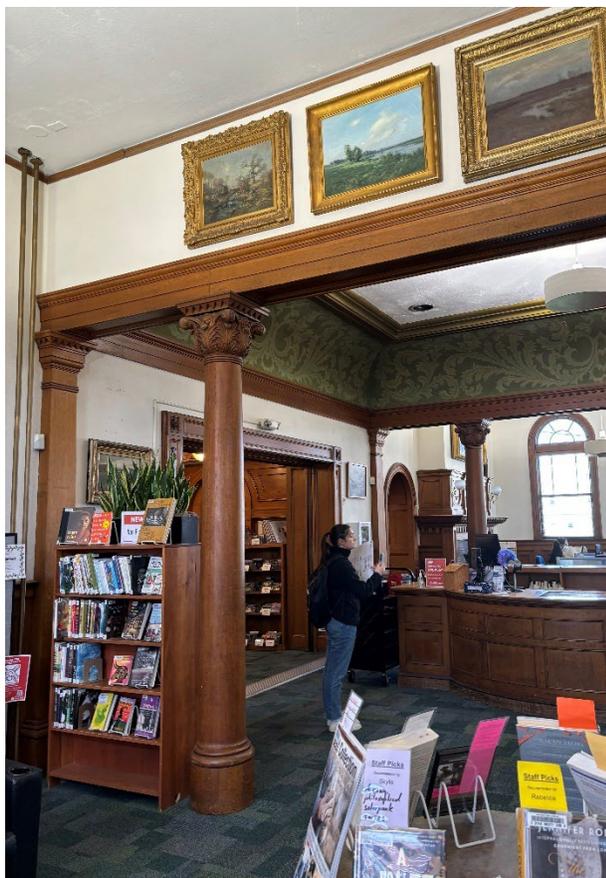
**Photo 31**

The first floor of the South Wing has hard ceilings throughout (Photo 31), so we were not able to observe the second-floor framing condition and configuration at the South Wing. Most of the ceilings appear to be original plaster, but the ceiling in the Reference Room appears newer (Photo 32).

South Wing of First Floor with finished ceilings.

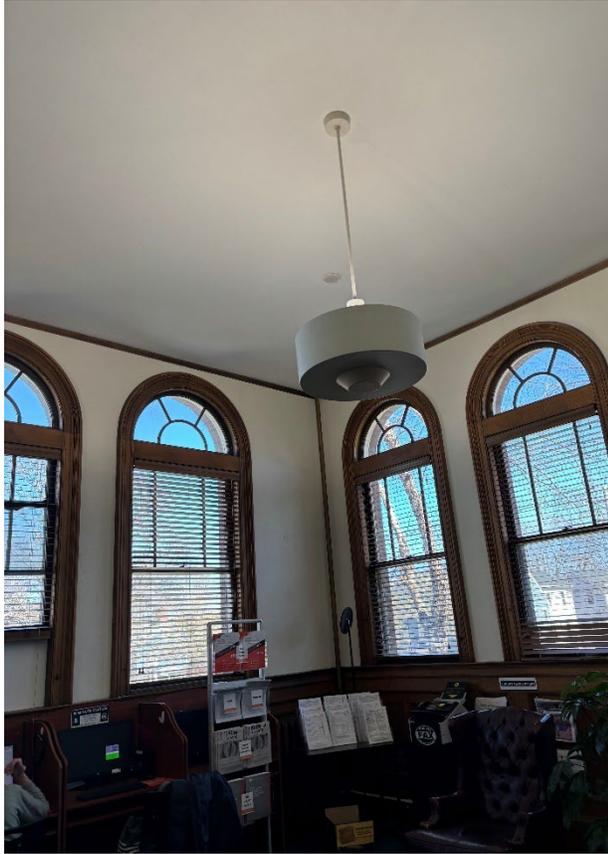
**Photo 32**

Newer ceiling in the Reference Room.

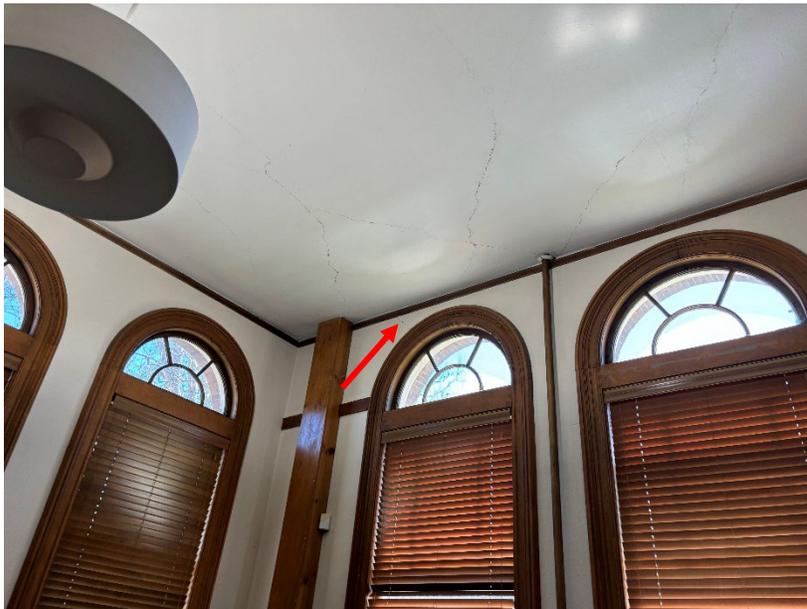
**Photo 33**

Extensive cracks in the first floor ceiling and additional crack above a window (red arrow) in the Amesbury Room.

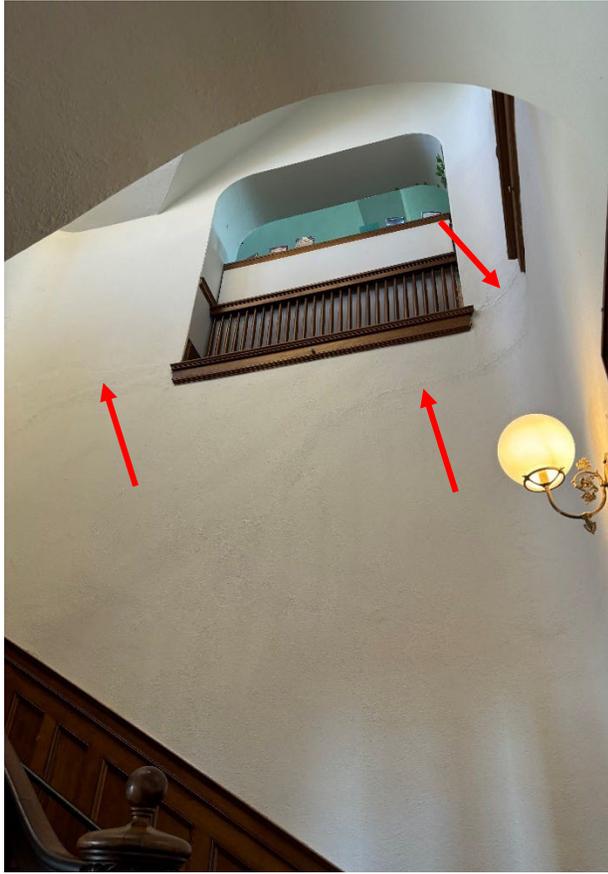
**Photo 34**

Cracking in the Main Stair wall finishes near the Second-Floor elevation.

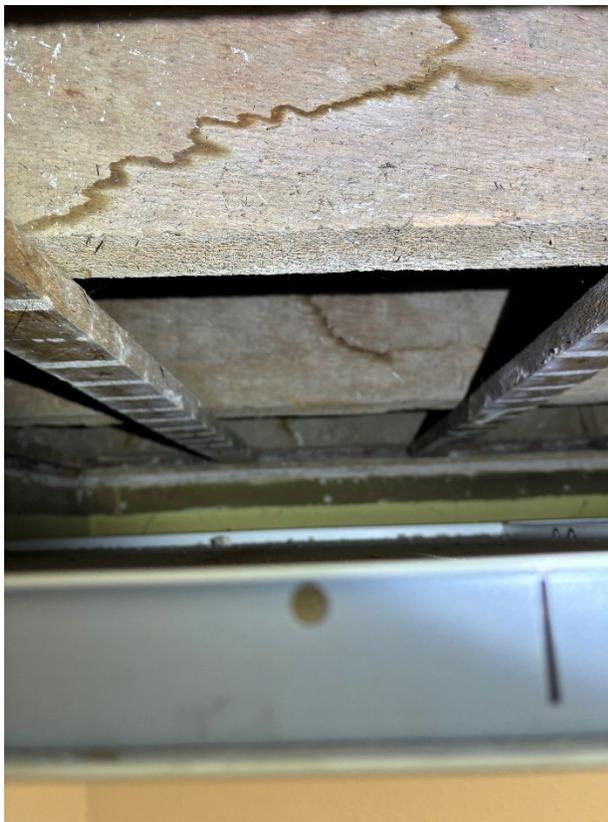
**Photo 35**

Staining on the floor joists above the Director's Office.

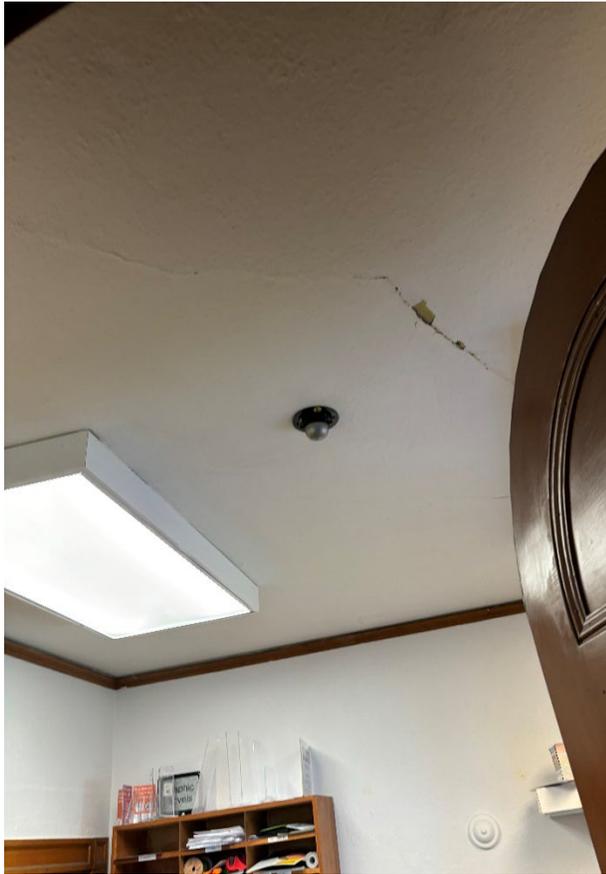
**Photo 36**

Cracked plaster ceiling in the Assistant Director's office.

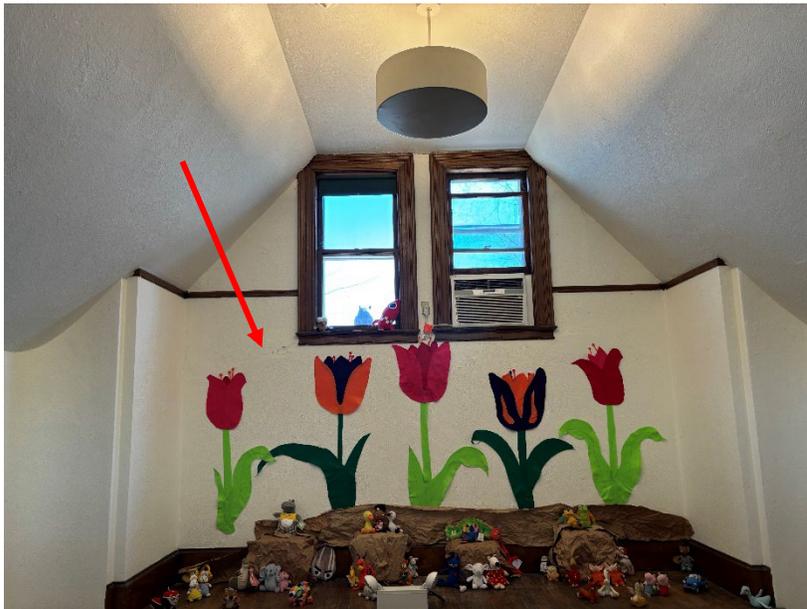
**Photo 37**

Cracked wall plaster at the south gable.

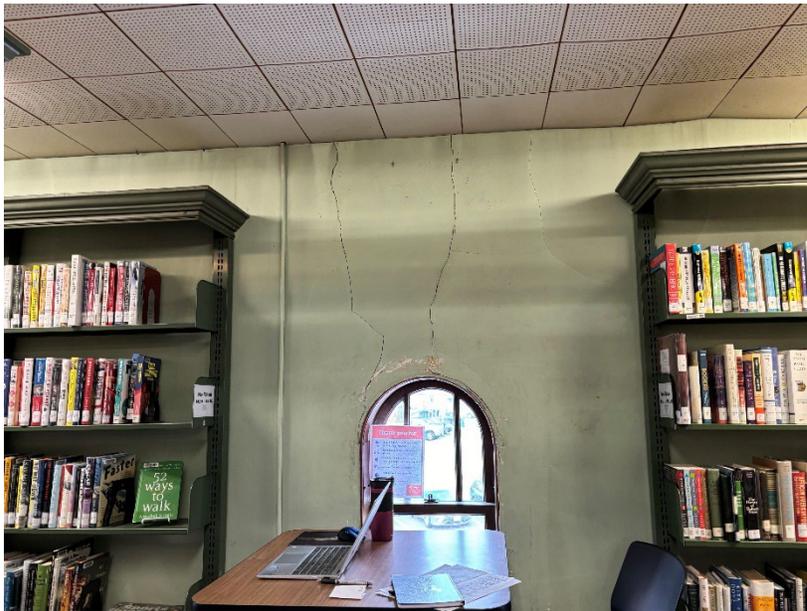
**Photo 38**

Large plaster cracks in the center of north wall.

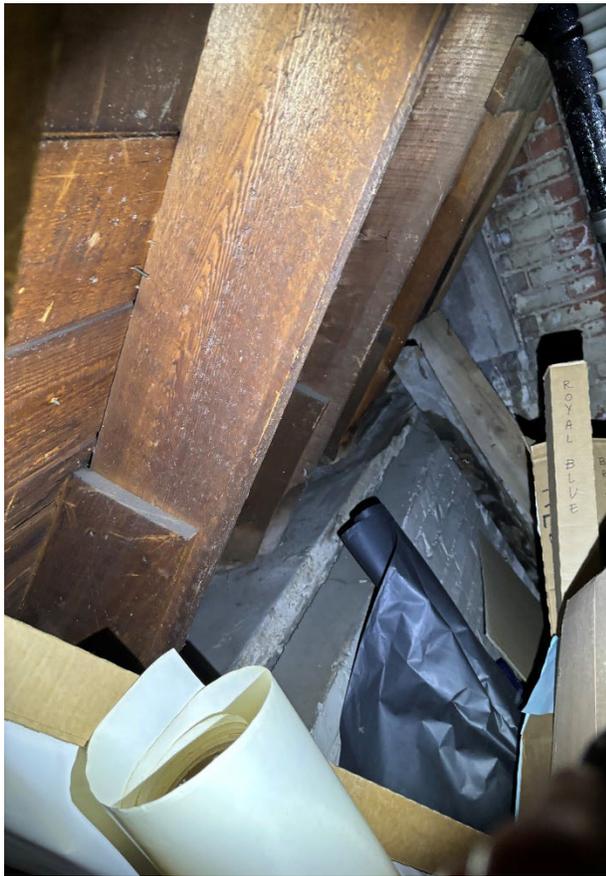
**Photo 40**

Rafters bearing on wood sill over the south wall of South wing.

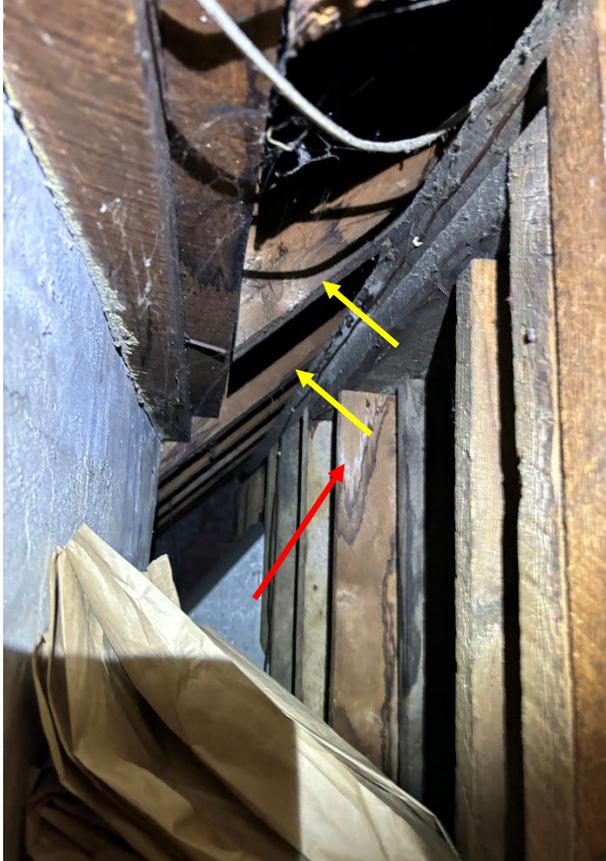
**Photo 41**

2 in x 7-1/2 in. rafters (yellow arrow) spanning to the north exterior wall of the north wing.

Wood wall making the front side of the closet (red arrow) that may also support the rafters.

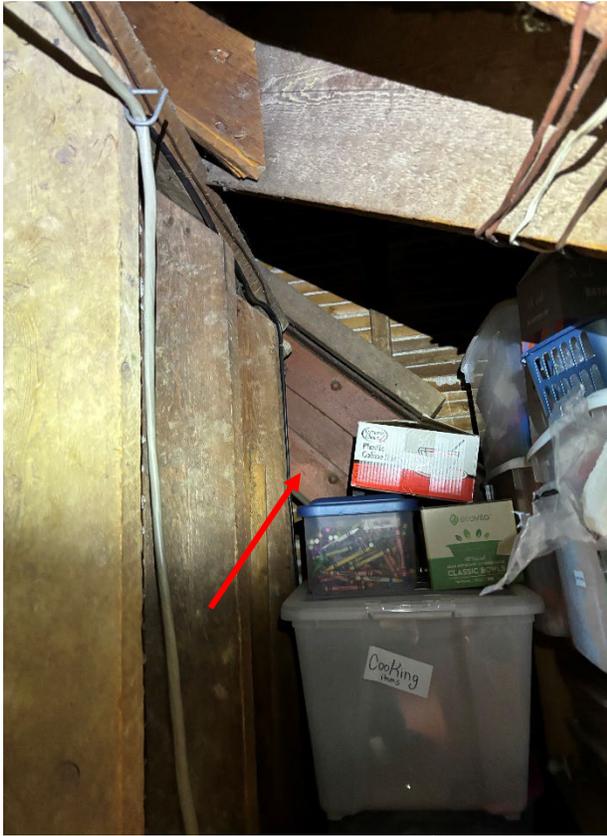
**Photo 42**

Built-up steel beam at the approximate third point of the South Wing roof.

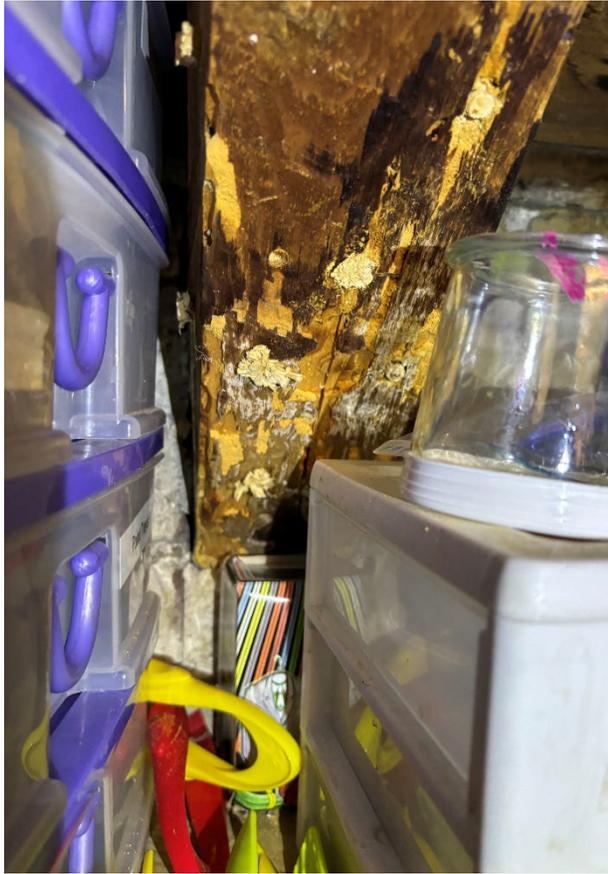
**Photo 44**

Large rafter with apparent insect damage and insect mitigation repairs.

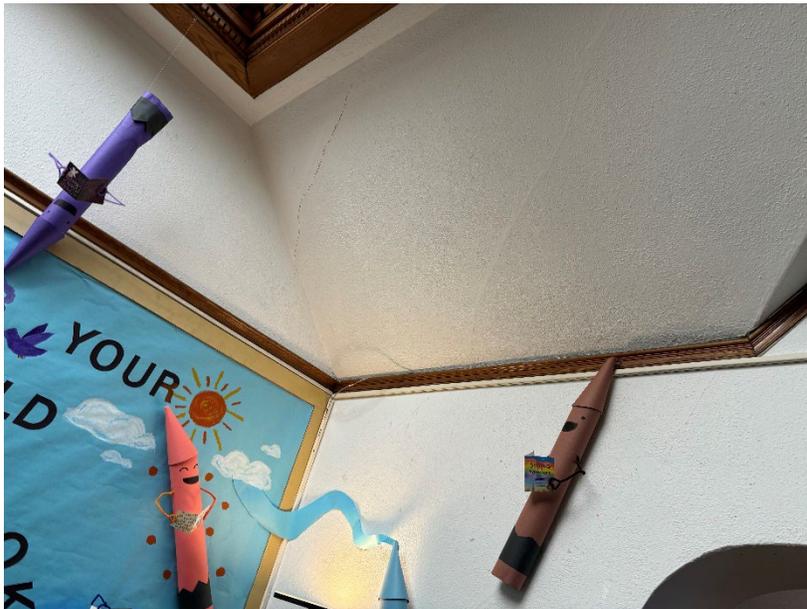
**Photo 45**

Cracked plaster at the east side of the central skylight.

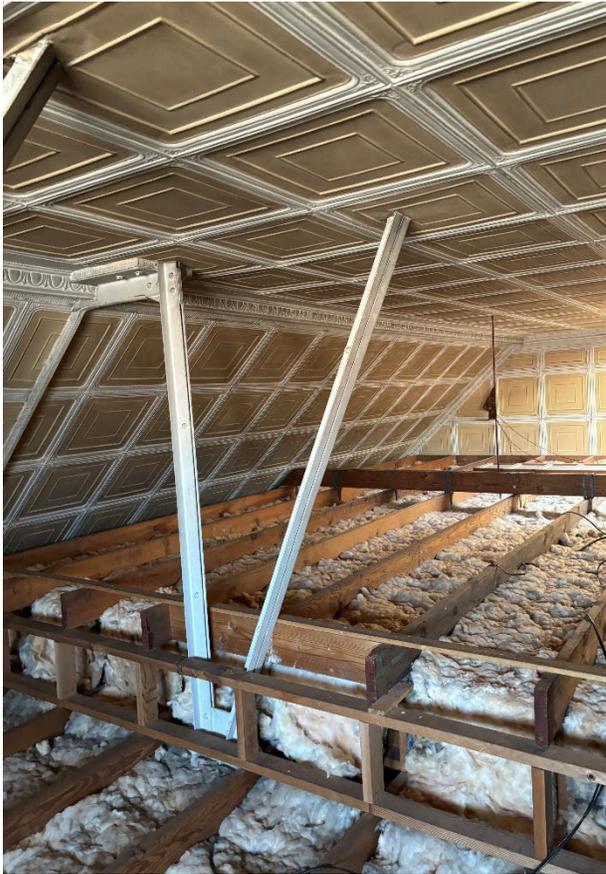
**Photo 46**

Attic space, with the original ceiling in place. Exposed steel roof trusses are in good condition.

Mid 1900s wood ceiling forms "floor" of attic.

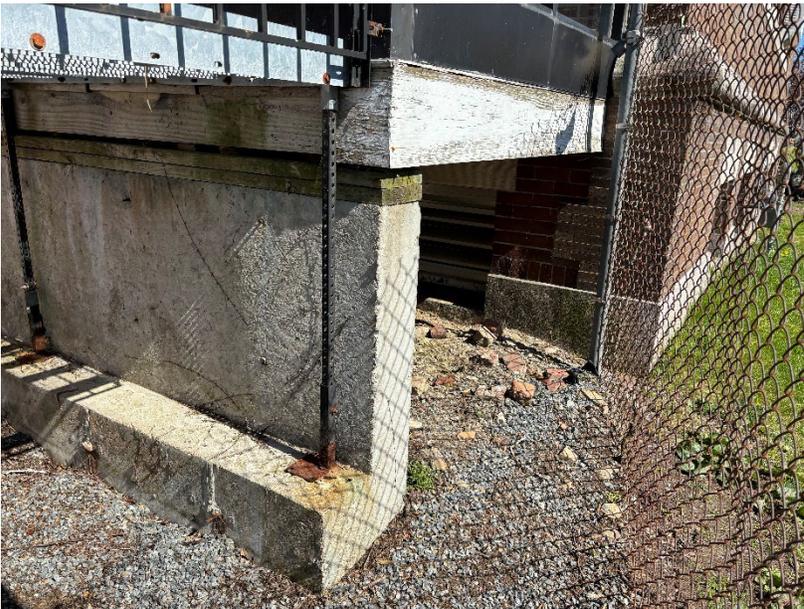
**Photo 47**

North foundation wall of the glass vestibule.

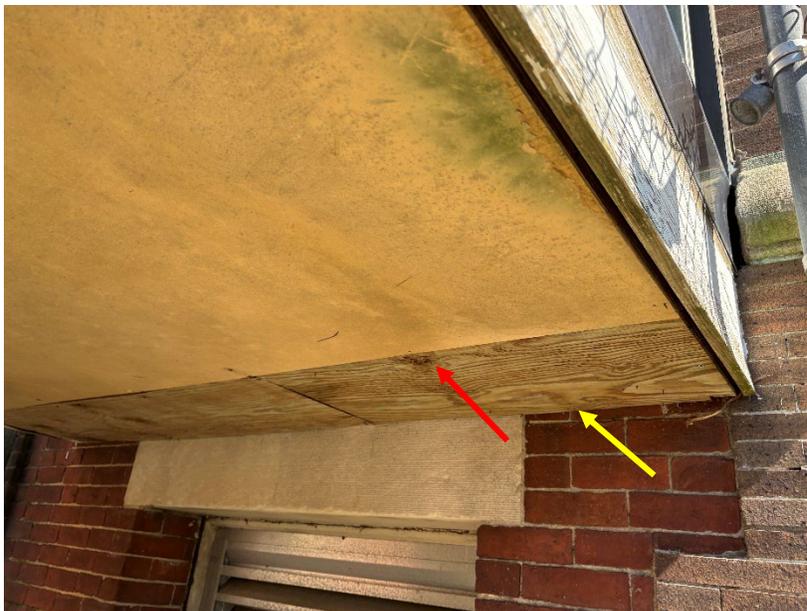
**Photo 48**

The underside of a glass vestibule floor with finishes obscuring the floor attachment to the base building structure.
