# AMESBURY PUBLIC LIBRARY

## Facilities Needs Assessment Report

September 10, 2024

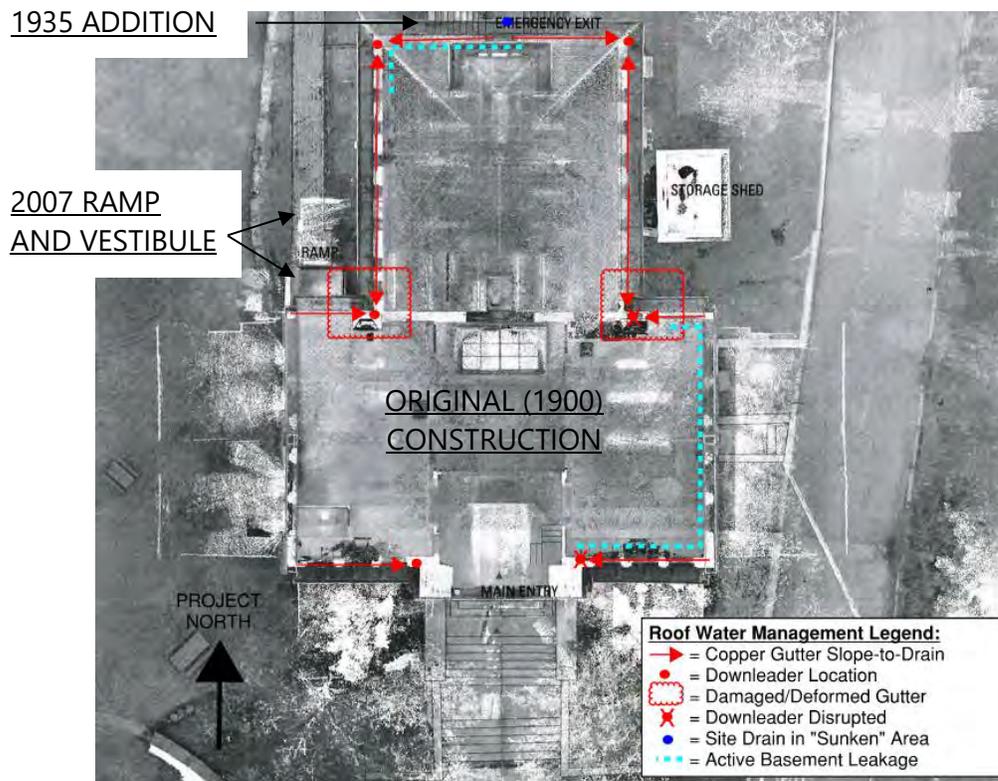
**Figure 1 – APL aerial view, with roofing drainage and reported basement leakage overlaid.**

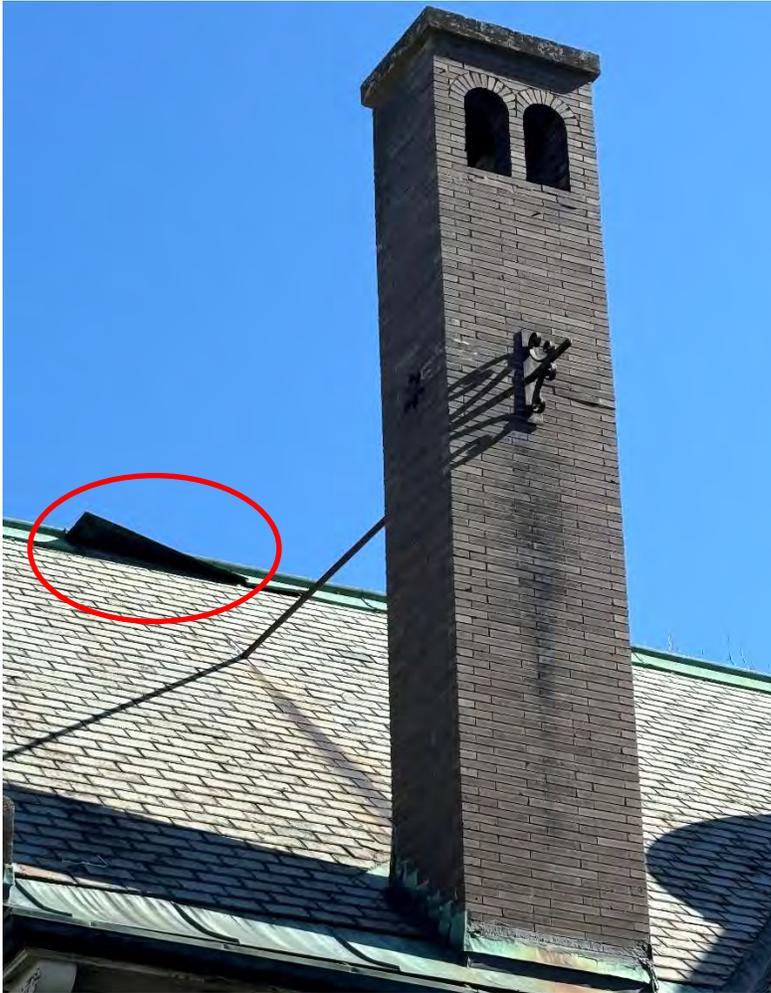
**Photo 5**

Some of the copper ridge flashing is not uniformly secured (indicated in red, Photo 5). We informed the project team of this location while on-site and followed-up via email on 26 April 2024, recommending the area be secured as soon as practical.

Example of exposed copper ridge, eave and chimney stepped base flashing at the existing slate roofing system, with green patina. Note a portion of the ridge cap copper flashing is not continuously secured (indicated in red, refer to Appendix A for location).

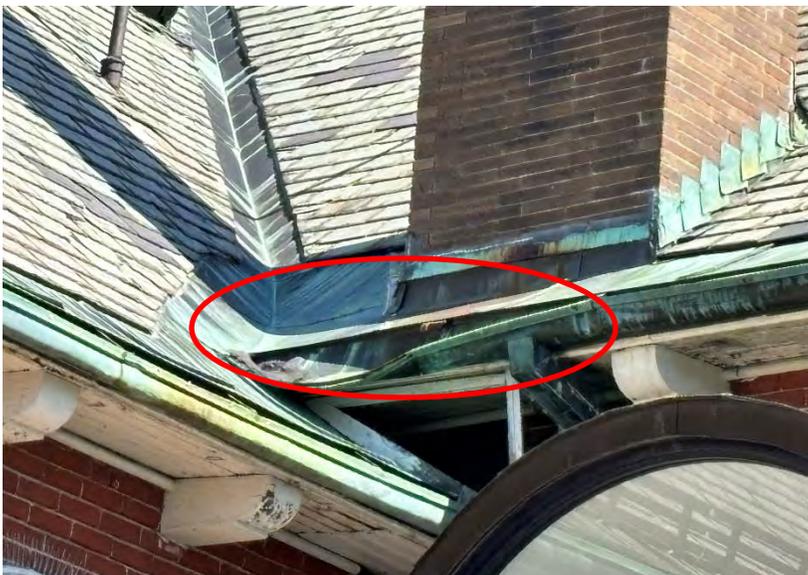
**Photo 6**

Example of exposed copper valleys, eave and chimney stepped base flashing at the existing slate roofing system, with green patina. Note a portion of the copper gutter is deformed downward and missing brackets/straps (indicated in red).

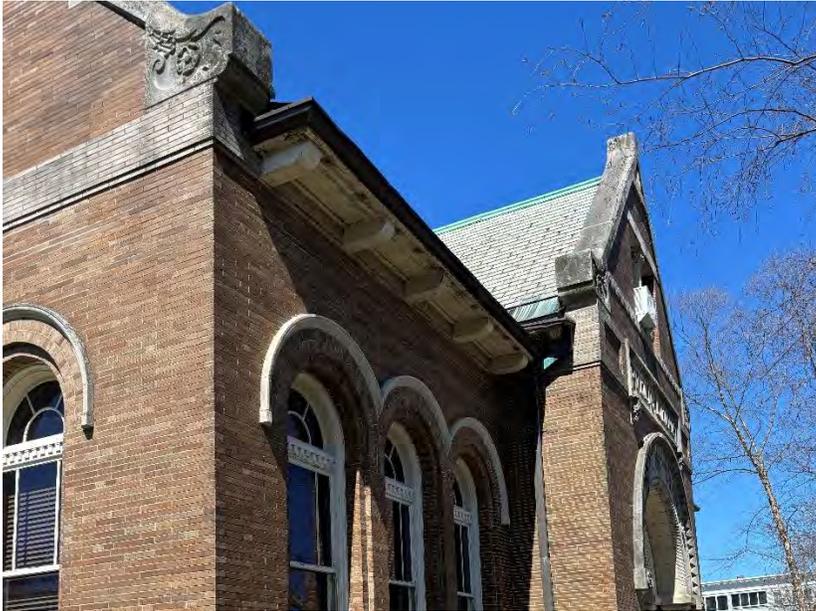
**Photo 7**

Exterior view of the relatively new copper gutter and downleader at the south elevation, which is still red (compared to the green patina visible elsewhere).

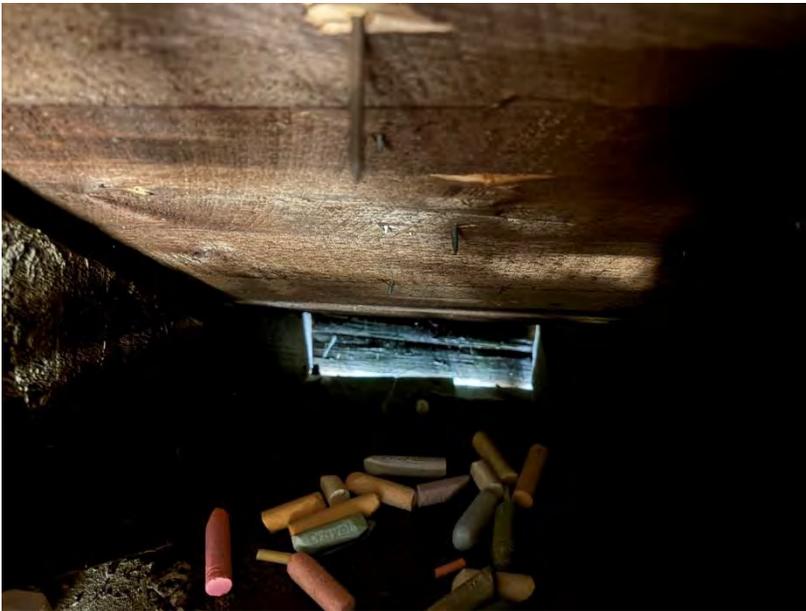
**Photo 10**

The underside of the wood roof deck is not insulated in areas we observed, and daylight is visible at the eave in several locations (i.e., where the roof slope extends beyond the outer vertical plane of the exterior wall) (Photo 10). Many of the areas with daylight correspond to locations where there is an approximately 3 ft-deep exterior wood soffit (Photo 11). We observed localized areas where the wood soffit is damaged, displaced or otherwise deteriorated (Photo 12). We observed a hatch at the second-floor ceiling that may provide additional views of

Example of an area where daylight is visible at the interior of the eave (i.e. where the roof slope extends beyond the outer plane of the exterior wall). Photo taken looking "down-slope" between purlins.

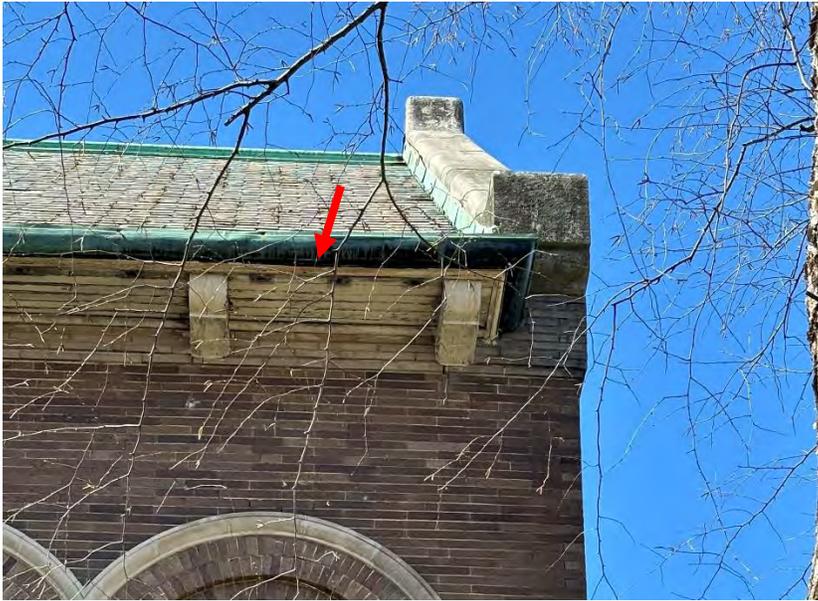
**Photo 11**

Exterior view of wood soffit conditions in areas where daylight is visible at the eave from the interior. Note loose/deformed soffit board (red arrow).

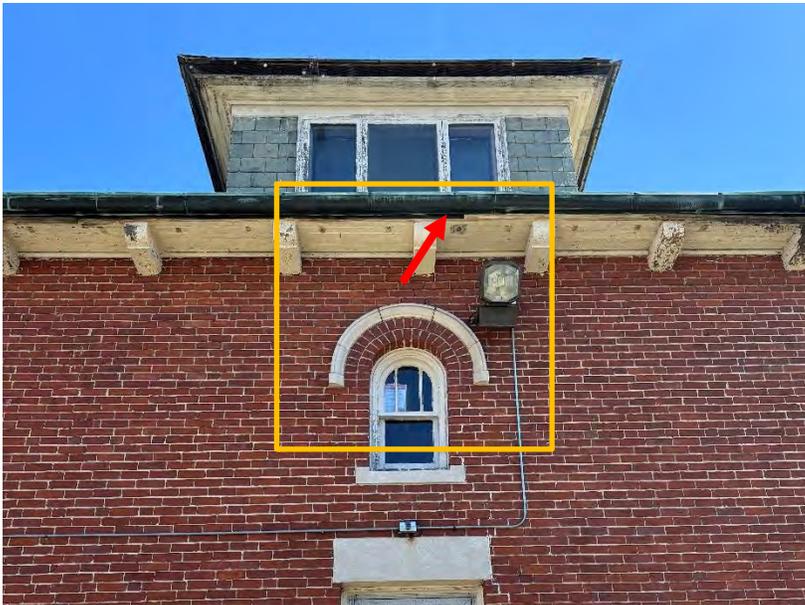
**Photo 12**

We observed several areas where the wood boards at soffits are rotted, displaced, missing, or otherwise deteriorated (Photos 12 and 18). The wood soffit boards are oriented parallel to the roof eave and located above cantilevered rafter tails. It is not clear, without additional

Example of an area where portions of the wood soffit are missing (red arrow).

Refer to Photo 30 for interior view of through-wall masonry cracking in the area indicated in yellow.

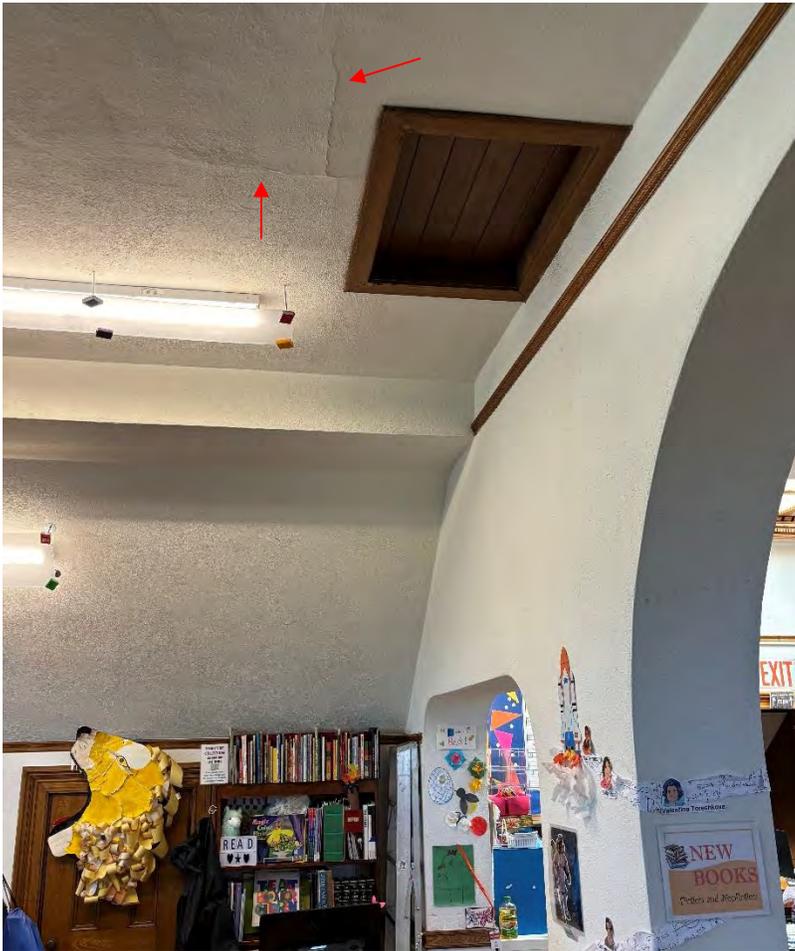
**Photo 13**

Ceiling hatch at second floor of library requires ladder to access and review the underside of the slate roofing above the plaster ceiling.

Note cracks in the adjacent plaster ceiling (red arrows).

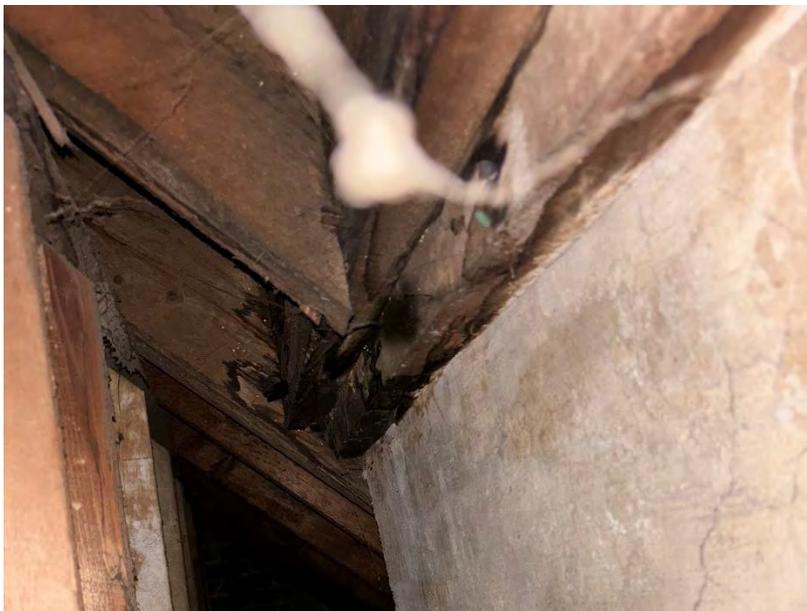
**Photo 14**

We observed dark staining at the interior plaster finishes and/or wood framing in several locations, particularly where the roofing decking is in contact with the chimney rising walls and intersect with masonry gable end walls (Photos 14 and 15, respectively). While an approximately 3 ft-wide space between the finished interior walls at the second floor and the exterior masonry walls potentially provides close-up access to these roofing areas (Photo 16), we were unable to enter this space safely due to excess storage materials present at the time of our review. APL indicated that storage materials could be potentially moved with sufficient notice and if/when the library is closed to the public.

Example of dark staining at the underside of the wood plank roof deck and framing where it abuts the chimney walls at the northern side of the west elevation.

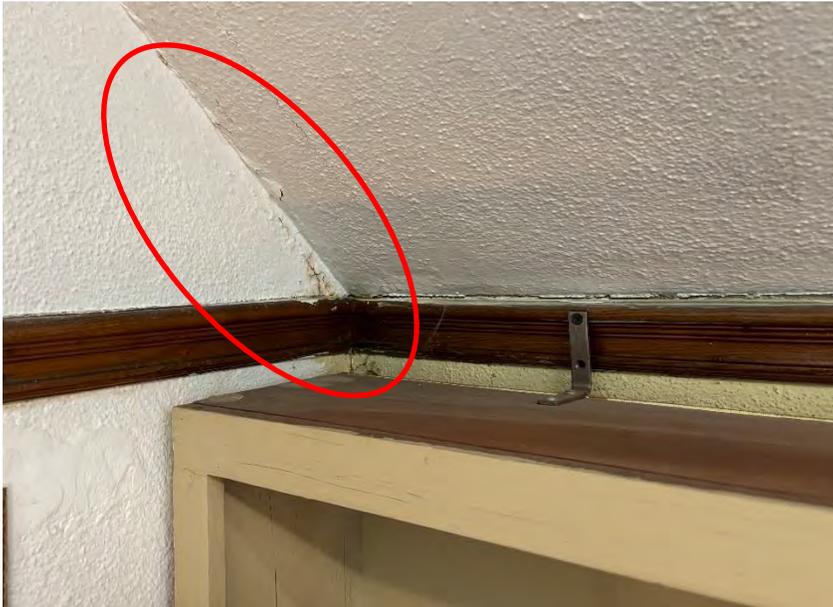
**Photo 15**

Example of dark staining (circled) at interior surface of plaster finishes below roofing intersection with gable end wall.

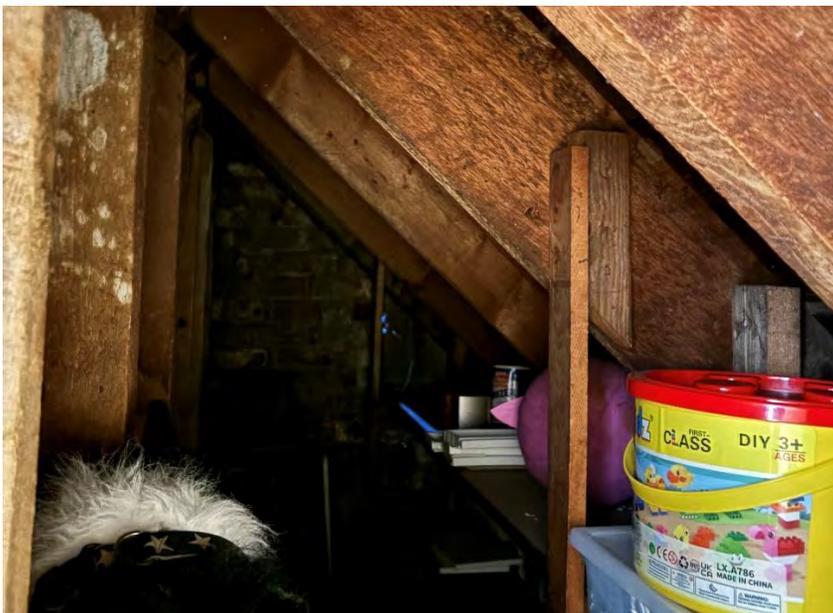
**Photo 16**

Interior view of the interstitial space between the finished areas at the second floor (left) and the exterior masonry walls (lower right), blocked by storage materials.

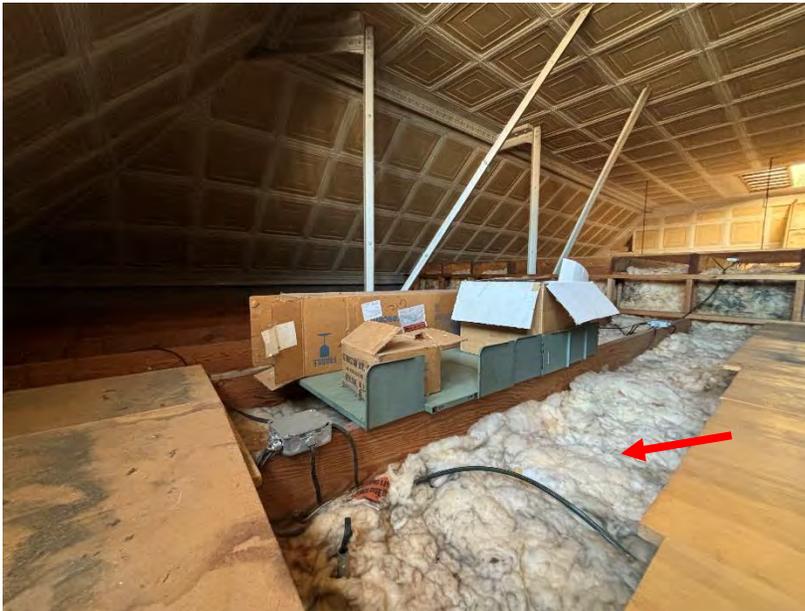
**Photo 17**

A tin roof located above the stack mezzanine area at the northern portion of the building conceals the existing conditions at the underside of the slate roofing assembly (Photo 17). We observed little to no staining at the tin roof. Approximately 3 in.-thick of batt insulation is present at the attic floor below the tin roof (red arrow, Photo 17).

Interior view of the tin ceiling above the northern portion of the building, with little to no visible staining or deterioration.

Note about 3 in. of batt insulation is installed (red arrow) along the attic flooring in this area.

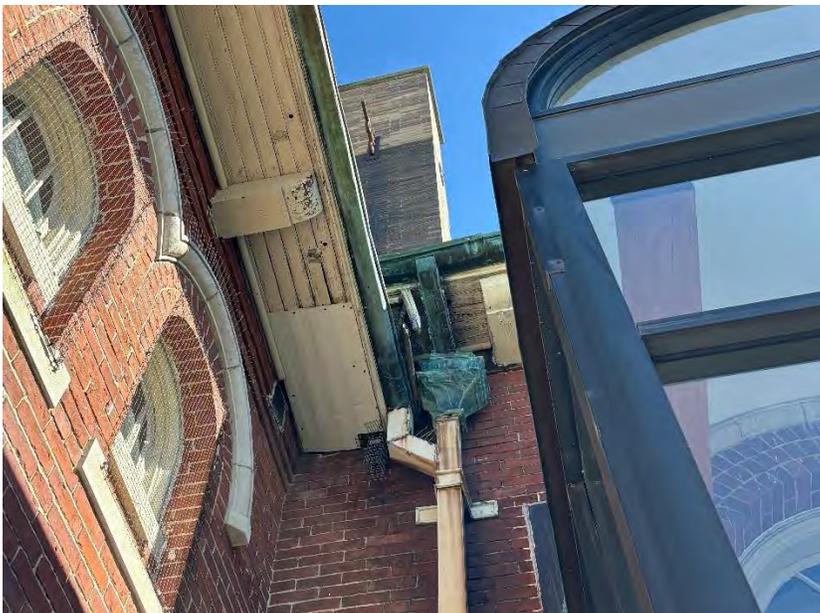
**Photo 18**

Copper gutters at the roof eave appear to be sloped to drain towards exterior-mounted downleaders, as depicted by red arrows in Figure 1. Except for a localized portion of the copper gutter at the western side of the south elevation (Photo 7), the gutters typically exhibit green patina. Where two or more roofing slopes intersect, we observed the copper gutter is typically deformed or otherwise damaged (indicated in red, Photo 6 and Figure 1). Several twisted gutter brackets and soffit boards are missing at damaged gutter areas, and collection boxes are dented (Photo 18).

Exterior view of the underside of the damaged copper gutter area indicated in red in Photo 6. Note a cover board in place at the soffit and damaged collector head, with multiple gutter pipes intersecting into a single downleader. A portion of the downleader is painted white metal.

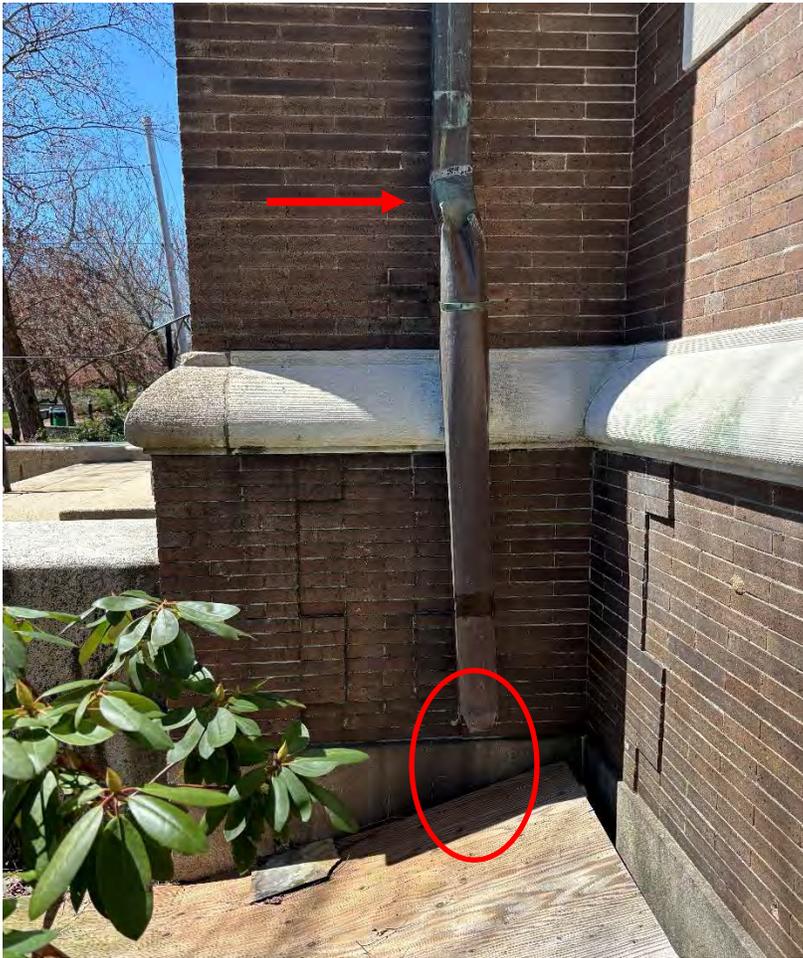
**Photo 19**

Example of damaged (dented, red arrow) and disrupted (circled) downleader that discharges water directly at the building foundation. Note the make-shift plywood diverter and that this area coincides with a below-grade space where reoccurring leakage is reported.

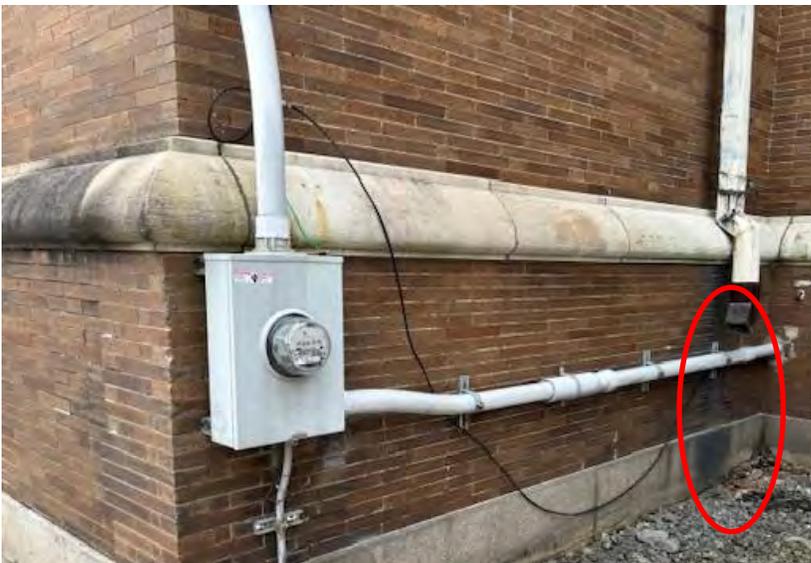
**Photo 20**

Example of disrupted (circled) downleader that discharges water directly at the building foundation.

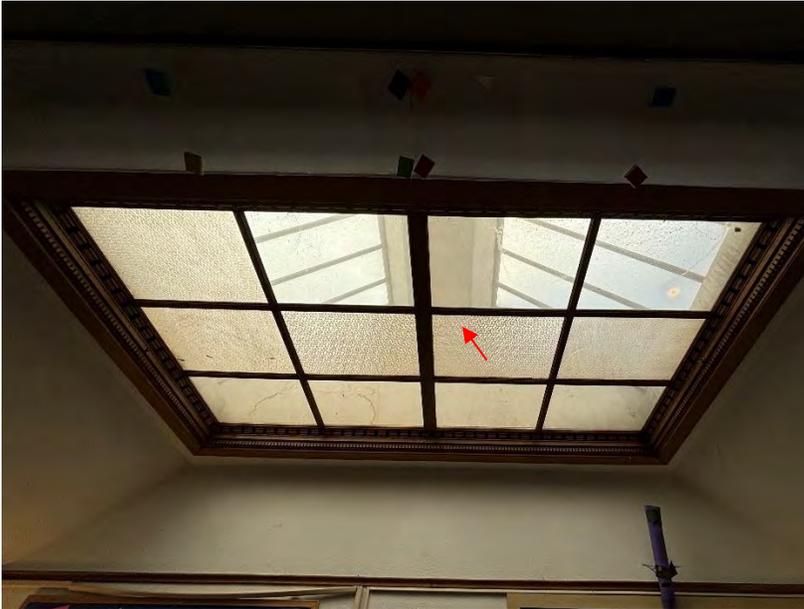
**Photo 21**

The slate roofing area includes three skylights with laylights. We did not review the skylights and laylights up-close due to limited interior and exterior access; however, we observed at least one pane of glass in a laylight is cracked (Photo 21).

Cracked light (red arrow) at laylight below sloped skylight.

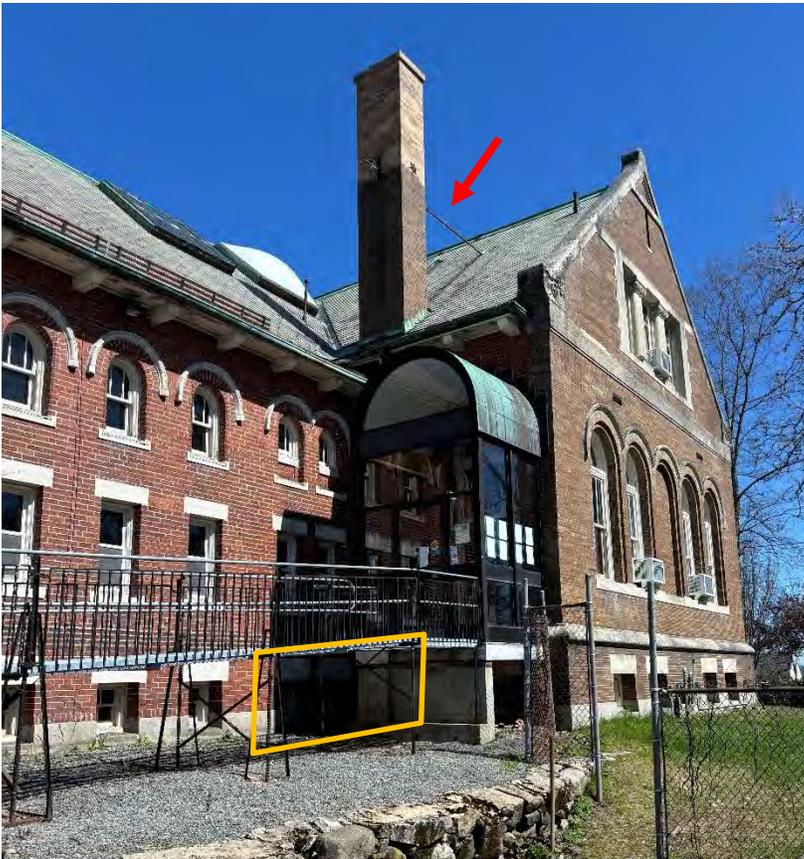
**Photo 22**

Each chimney is tied back to the roofing with a metal (presumably wrought iron) tie rod (red arrow, Photo 22). The brick above the tie back rod insert at the west elevation chimney is visibly lighter than the brick below, suggesting the chimney was rebuilt (or substantially repaired) at some time after original construction. The chimney at the east elevation is a more consistent color and includes two arched openings at the northern face of the chimney. It is unclear from our ground observations whether either chimney is capped.

View of the chimney at the west elevation, with wrought iron tieback to the roof deck and mismatch brick above (red arrow).

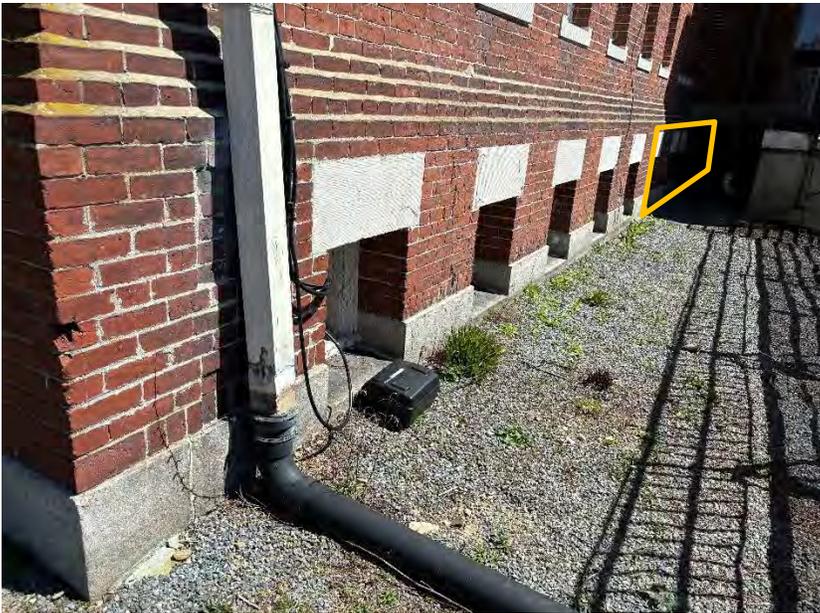
**Photo 26**

View of red brick masonry at the northern (rear) portion of the building. Note stepped band course with mortar wash at the sky-facing surface of each setback.

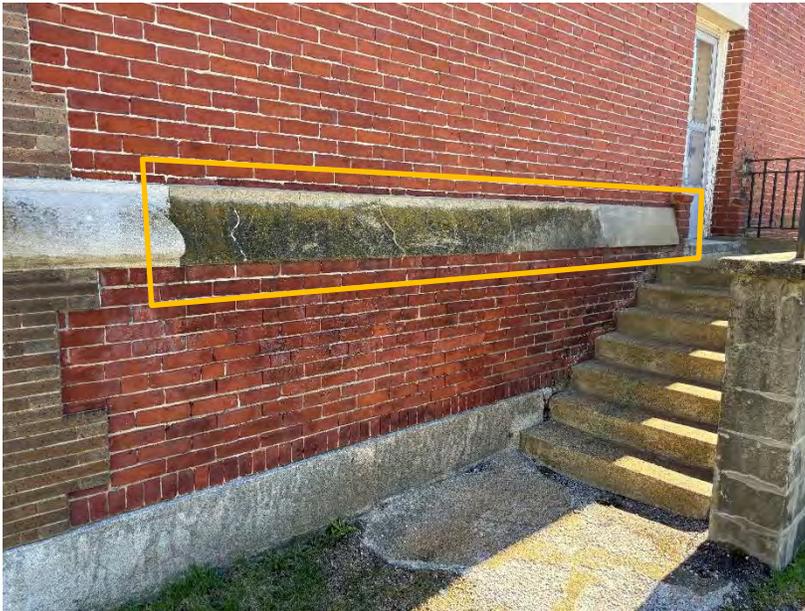
**Photo 27**

Overview of mortar wash installed at the entire brick stepped back band course (indicated in yellow), which sounds debonded (hollow) when tapped with a hammer. Note vertical cracking every few feet.

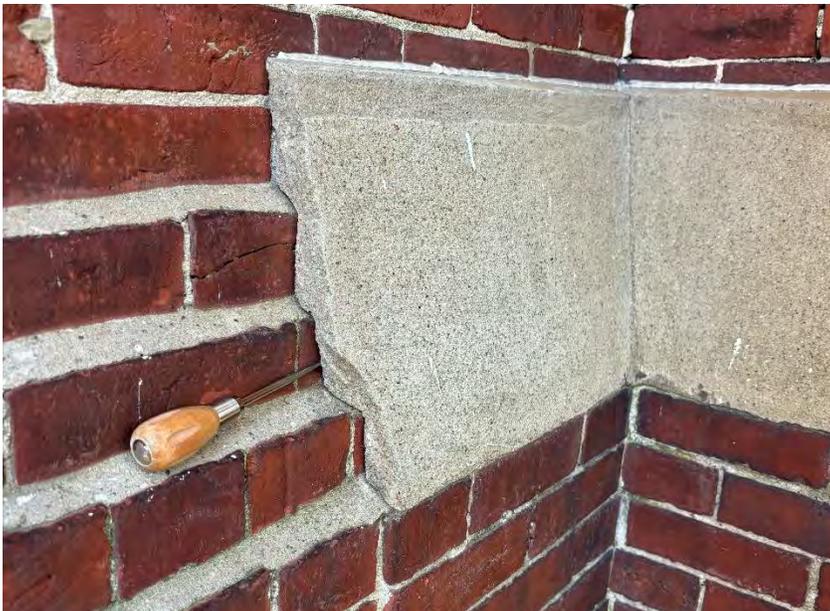
**Photo 28**

Spalled edge of the mortar wash installed at the brick stepped back band course, which is visibly separated from the brick surface.

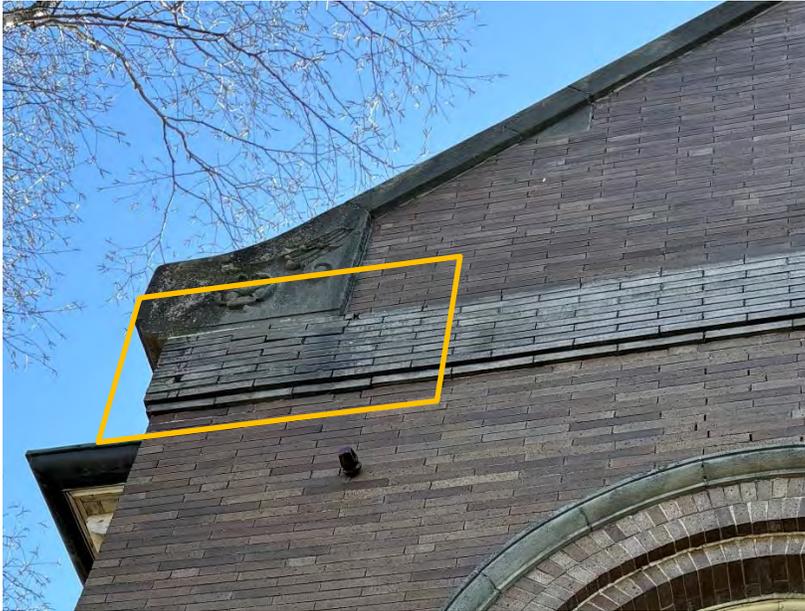
**Photo 29**

Example of brick that appears to be out-of-plane (area indicated in yellow) relative to the surrounding conditions.

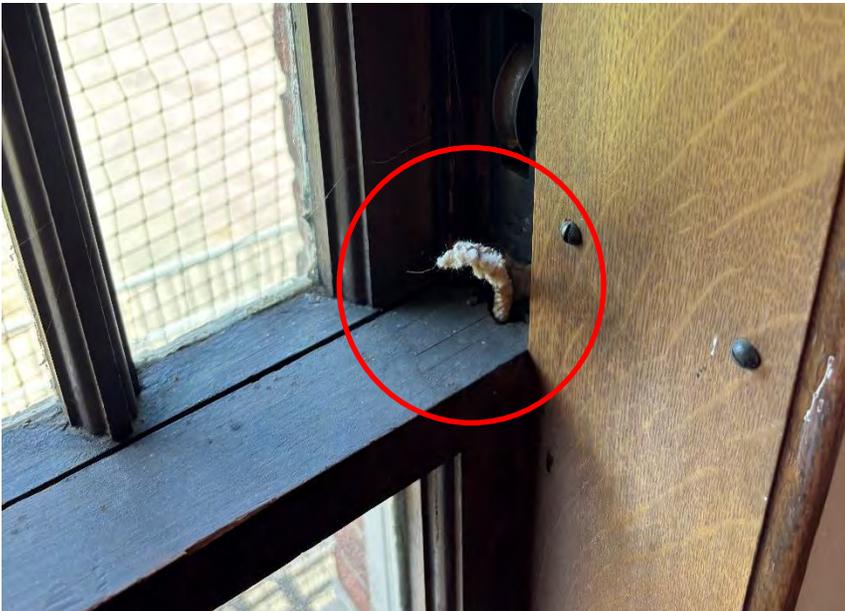
**Photo 32**

Example of broken rope/pulley system at operable window (indicated in red).

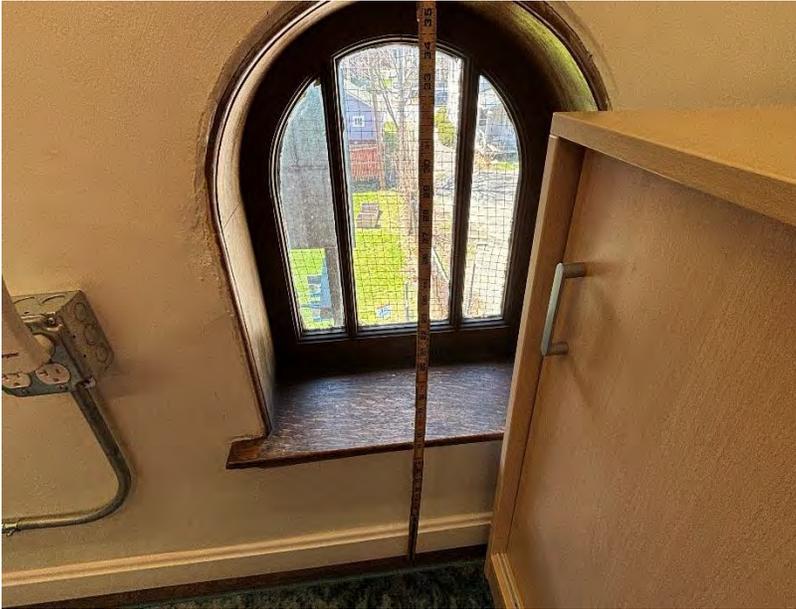
Several of the single-pane windowpanes are cracked (Photo 31) and some windows are difficult to operate due to damaged/missing interior rope/pulleys (Photo 32). We observed several locations where the single-pane (presumably annealed glass) windowpanes are located within 18 in. of a walking surface, which does not meet current glazing safety standards (Photo 33).

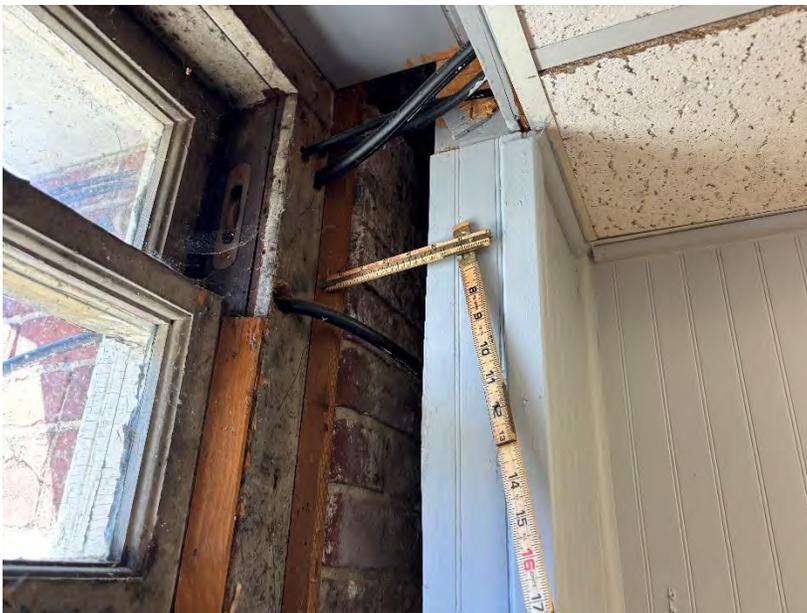
**Photo 45**

At the north elevation office (Photo 45), we estimate an approximately 2 in. to 4 in. uninsulated "build-out" is present based on gaps between the finishes and the wood-framed windows (Photo 46). Signs of water leakage at the interior face of the exterior below-grade walls in this office are not evident due to installed finishes; however, library staff report leakage primarily occurs within the vicinity of the sunken stairs at the north elevation (Photos 46 and 47). We observed numerous areas where the mortar is cracked, eroded, missing or otherwise deteriorated at the exterior wall at the sunken stairs (Photos 47 and 48).

View of interior office at the northwest corner of the building, which experiences reoccurring water leakage at the exterior walls and/or slab-on-grade. See Photo 46 for closeup of area indicated in red.

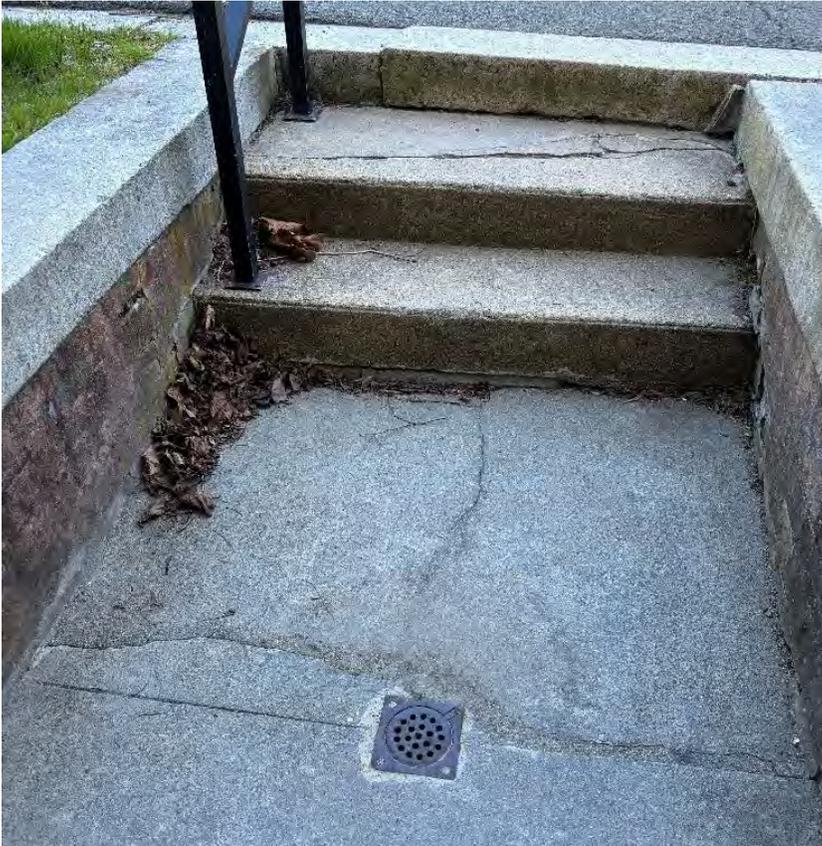
**Photo 48**

View of exterior masonry at south elevation sunken stairs, with numerous areas of mortar loss and biological growth. Note this area coincides with the finished northwest basement office that experiences reoccurring water leakage.

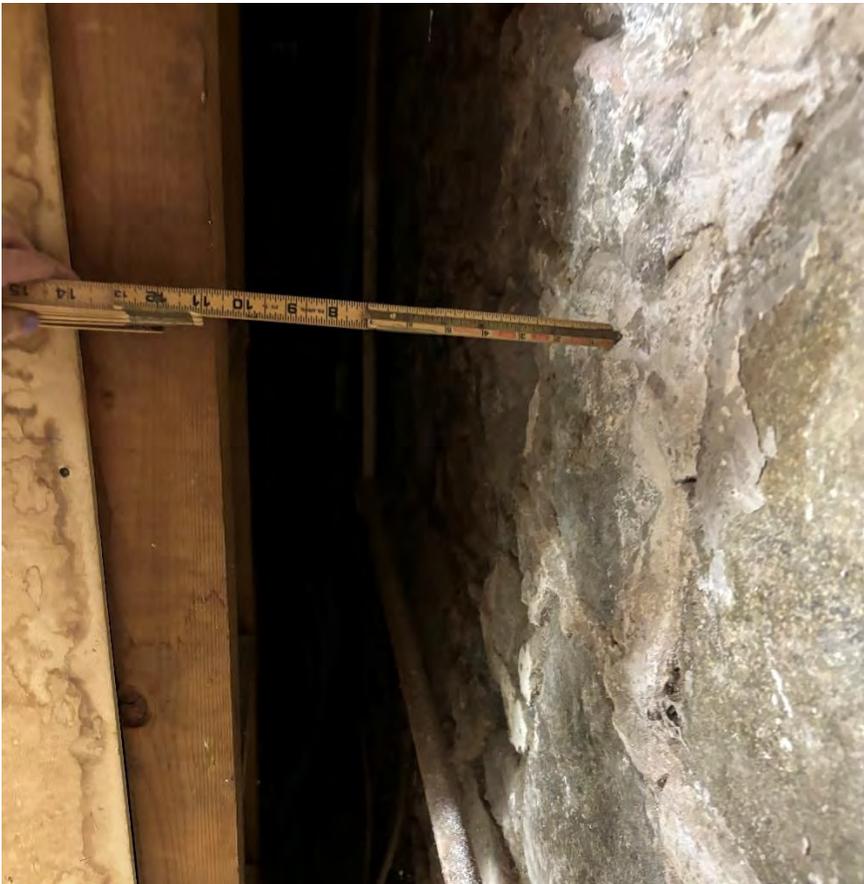
**Photo 51**

We observed some areas in the basement where leakage is not reported by APL that similarly exhibit signs of reoccurring exposure to moisture (Photo 51). Because interior finishes are built away from the inner face of the exterior wall about 12 in. in these areas (Photo 52), it is possible some water leakage occurs and is not detected. It is important to evaluate below-grade water leakage issues holistically (i.e., in areas where leakage does and does not reportedly occur), within the context of the building site drainage and geotechnical characteristics (ground water elevation).

Interior view of painted masonry conditions along the east elevation below-grade wall (at the northern portion of the building at the east elevation). Note the wood-framed stud wall and interior finishes are built about 12 in. away from the interior face of the exterior masonry wall, and several pipes/conduits extend through this space.

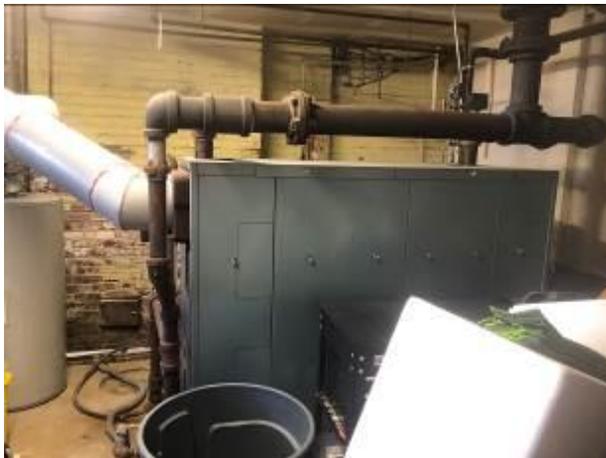
The boiler vents to a masonry chimney via round single wall uninsulated steel breeching. The condition of the inside of the chimney is unknown. Combustion air is provided from 2 sources. The main source of combustion air is from a single 16x16 wall opening covered with expanded metal. The wall opening ties into a 42x12 duct that terminates 12" above the floor. The second source of combustion air is from a 24x24 transfer grille on the boiler room door, pulling air from the occupied basement area. Neither method of combustion air is code compliant, as a high and low opening connected to the exterior is required.

*Gas-Fired Steam Boiler*

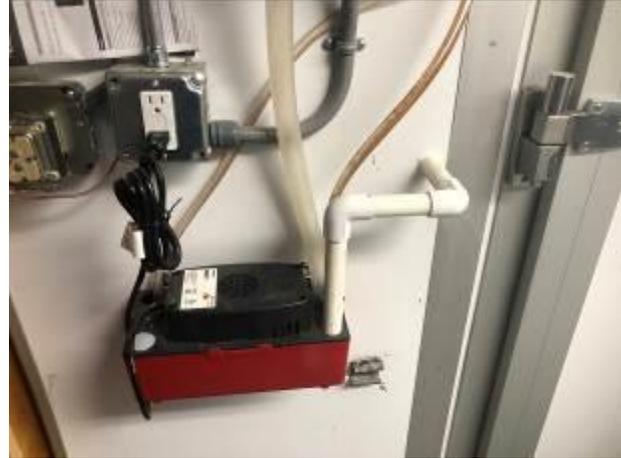
The vault archive has both humidification and dehumidification equipment that was installed in May 2023. The vault is cooled and dehumidified by a Mitsubishi Model PUZ-HA24NHA1 2 ton split system heat pump. This 2 ton heat pump serves a ceiling mounted exposed air conditioner. The vault is further dehumidified by a small Santa Fe dehumidifier on a shelf that free blows into the space. The vault is humidified in the winter by an AprilAire Model 865 electric steam humidifier with a distribution fanpack located in the vault. This humidifier can supply 34.6 gallons/day. The bleed from the humidifier drains to a condensate pump that is then pumped to drain through PVC piping. This bleed happens when the humidifier is running to remove sediment from the humidification cannister. The plastic condensate pump and PVC piping is not the appropriate material for hot condensate. The condensate pump and discharge piping should be replaced with materials that can withstand high temperatures.

*Humidifier Bleed Condensate Pump*

- Replace the vault humidifier condensate pump and discharge piping with a high temperature condensate pump and copper discharge piping.
- The heat output of the steam radiators are controlled by manual handwheels. Verify the handwheels on the more problematic radiators are fully open. The handwheels may be stuck in a partially closed position which could be reducing the output to the radiator. If they cannot be adjusted, replace the handwheel.

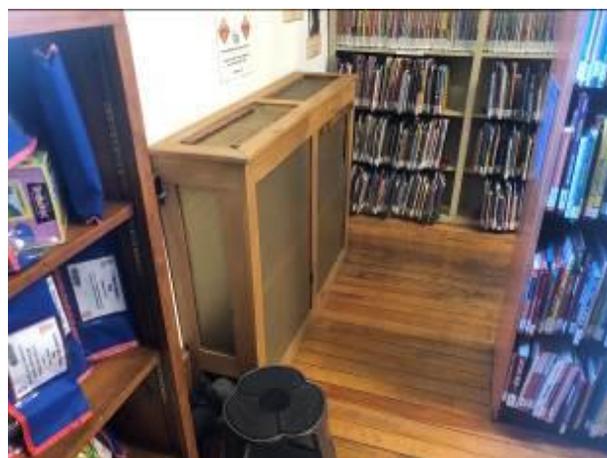
Space heating is handled by cast iron sectional vertical steam radiators located along exterior walls. Originally these steam radiators had manual handwheels to adjust steam flow and output, but the wheel adjustment is now missing, so the radiator is set to a constant throttled setting. The radiators in the children's area are covered by a protective enclosure. The workshare space at archives is heated by a hot water wall heater. A Taco 007 cartridge circulator pulls hot water off the base of the steam boiler to circulate hot water to the wall heater. The reference room is heated by vertical steam radiators. It was once also heated by natural convection from a steam radiator in a box, located in the basement storage room below. Air would move through a floor grille then through this box with the radiator inside ductwork, where the heated air would then naturally rise up to a large wall grille located midway up the reference room wall. This natural convection radiator/wall grille is no longer operative.

*Radiator in Enclosure*

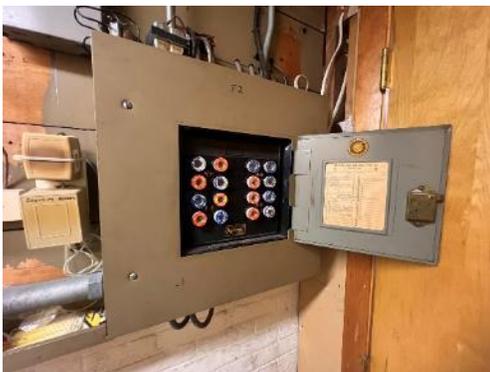
Existing lighting and power panels are located within the Main Electric Room and throughout the building. The new Eaton panel that has been installed is in good condition. Other panelboards are original to the building and are of fuse type and should be replaced. All panelboards have combined lighting, power, computer and mechanical loads. As a whole the existing electrical distribution equipment should be upgraded and located in dedicated electrical room spaces.

*Fuse Type Panelboard*

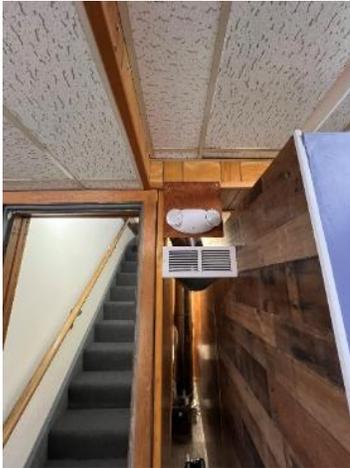
The emergency lighting system consists of wall mounted emergency battery units. The exit signs are not illuminated and are a code violation. Overall emergency lighting is minimal and does not look like it would properly light the path of egress in most spaces.

*Wall Mounted Battery Unit*

- Emergency lighting throughout the building is lacking and does not look like it would provide the code required 1 foot candle along the egress pathways. A majority of exit signs throughout the building are not illuminated and are a code violation to today's standards. We would recommend installing a centralized inverter system to provide the proper emergency exit lighting throughout the building.

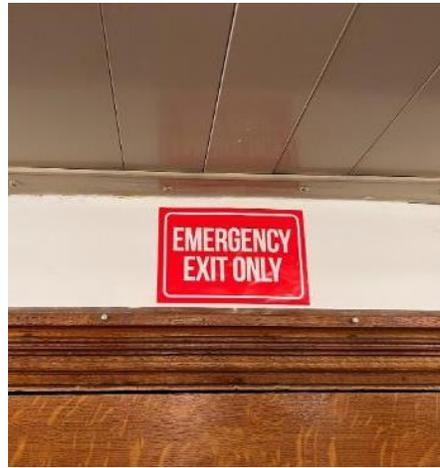
*Non-Illuminated Exit Sign*

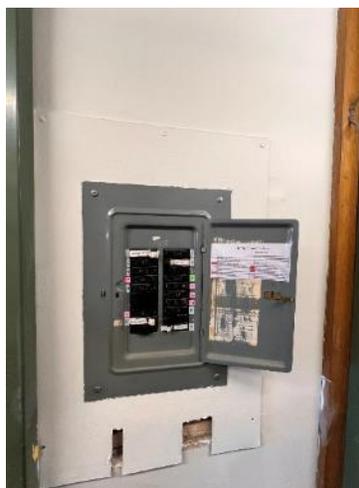
Building lighting is controlled via local wall switches in all spaces. Since there is no central lighting control system or time clock in place, building lighting is controlled at the start and end of each day from a recessed mounted panelboard on the first floor.

*Building Lighting Panelboard*

- The existing interior lighting system is in fair condition. Many spaces lack the appropriate foot candle levels for its space type and full building lighting control is obsolete. We would recommend a full lighting system redesign that utilizes energy efficient LED fixtures with 0-10V dimming capability in order to provide proper foot candle levels. We would also recommend a distributed lighting control system to provide the building with basic controllability that would include occupancy control, daylight harvesting, dimming control and time scheduling.
- All upgrades above should be part of 3-5 year upgrade project.

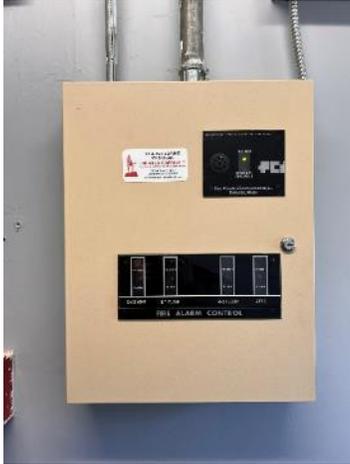
*Fire Alarm Control Panel*

- The existing conventional fire alarm control panel is obsolete and should be replaced with a new addressable system. The existing system appears to be ADA compliant.
- All upgrades above should be part of 1-2 year upgrade project.

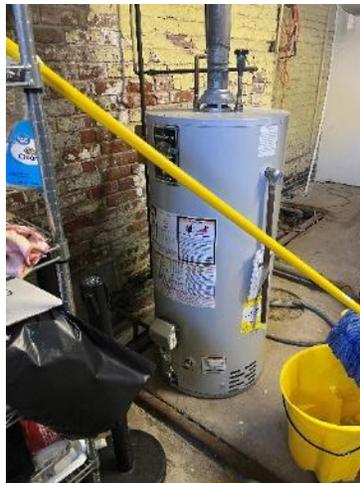
Domestic hot water in for the plumbing fixtures is generated through a natural gas fired tank type water heater. The water heater is standard efficiency, with a natural gas input of 40,000 BTUH, and 40 gallons of storage. The hot water systems are not recirculated. There is no thermostatic mixing valve on the system to prevent scalding. The water heater appears to be in good condition.

*Domestic water heater*

- Domestic hot water shall be stored at 140-degrees to prevent bacteria growth. Install thermostatic mixing valve set to deliver 120-degrees to plumbing fixtures requiring hot water. Provide a recirculation loop with pump at existing water heater to decrease hot water delivery time at remote plumbing fixtures. This is a short-term recommendation (3-5 years) as a Code requirement and operational/maintenance upgrade.

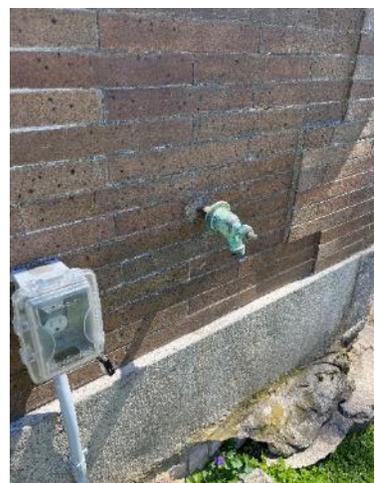
Piping, where exposed, appears to be copper tubing with sweat joints. The majority of piping is 3/4-inch in size and smaller. The piping is not insulated. Exterior wall hydrants are not non-freeze type and are not equipped with vacuum breakers.

*Exterior wall hydrant*

- Replace existing exterior wall hydrants with non-freeze hydrant with integral vacuum breakers. This is a short-term recommendation (3-5 years) as a Code requirement upgrade.

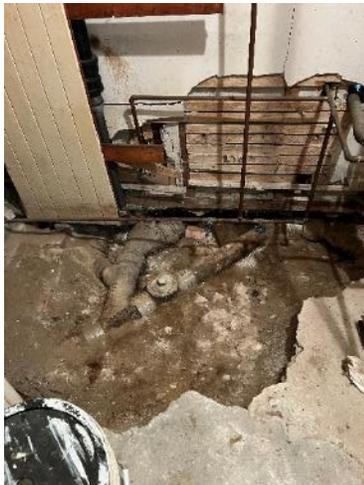
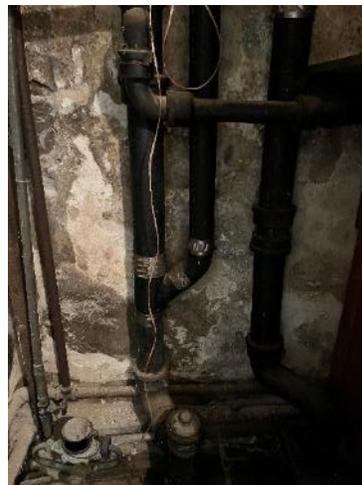
Cast iron is used for sanitary drainage. Where visible, the cast iron pipe appears to be in fair condition. Smaller pipe sizes appear to be copper.

*Typical cast iron drainage piping*

In general, the cast iron drainage piping can be reused even in a major renovation where adequately sized for the intended new use.

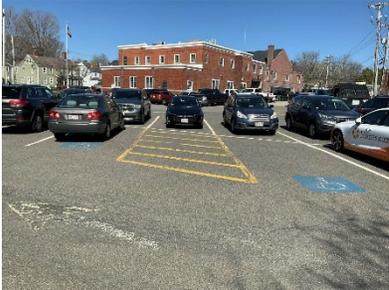
#	Barrier	Photo
1.	<p><b>Parking Lot</b></p> <p>The accessible parking spaces and its associated access aisle have slopes &gt;2%, @ up to 2.4%.</p> <p>The accessible parking spaces lack the required signage.</p>

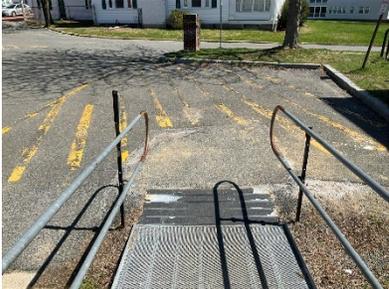
2.	<p><b>Route from Parking to Accessible Entrance</b></p> <p>The route from parking to the ramp leading to the accessible entrance has uneven ground surfaces, and excessive cross slopes, @ up to 2.6%, that create abrupt changes of level.</p>

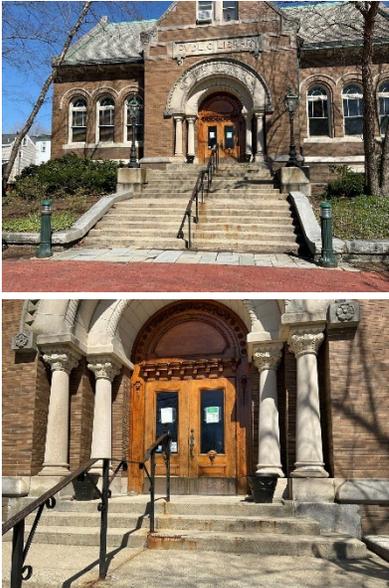
3.	<p><b>Main Entrance</b></p> <p>Directional signage is not provided at the non-accessible entrance.</p> <p>Stair treads have abrupt changes of levels due to areas of deterioration/material settlement.</p> <p>The stairs lack the required handrails on both sides (only the center handrail is provided).</p> <p>The handrail lacks the required extensions at the top and bottom.</p> <p>The handrail cross section is not rounded.</p> <p>The door lacks a level landing, @ 2.9%.</p> <p>The threshold is &gt; 1/2" high, @ 3/4".</p> <p><i>Note: The door also functions as a means of egress.</i></p>
