# AMESBURY PUBLIC LIBRARY

## Facilities Needs Assessment Report

September 10, 2024

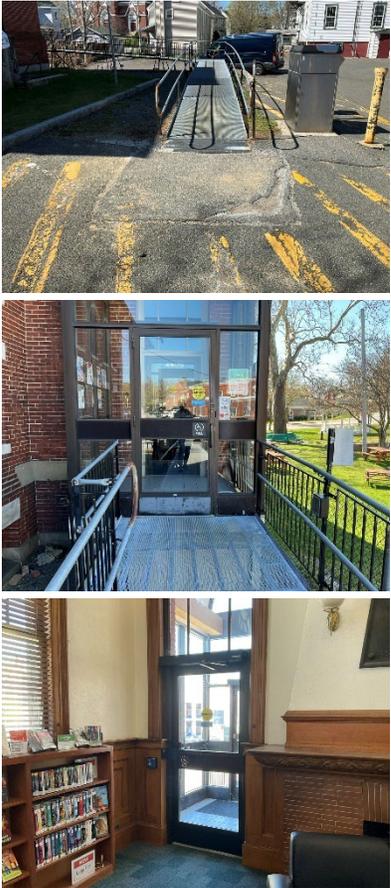
<p>4.</p>	<p><b>Accessible Entrance/ Egress</b></p> <p>The transition from the ramp to the parking lot is not flush and has abrupt changes in level.</p> <p>The running slope of the ramp is &gt;8.3%, @ up to 9.5%.</p> <p>The ramp lacks bottom, middle and top level landings, @ up to 2.3%.</p> <p>The ramp lacks the required bottom handrail extensions.</p> <p>The ramp lacks the required drop-off edge along the entire ramp on both sides.</p> <p>The door lacks a level landing, @ 2.2%.</p> <p>The door opener lacks an adjacent level clear floor space.</p> <p>The door lacks an illuminated exit sign identified by the International Symbol of Accessibility inside the vestibule.</p> <p><i>Note: The door also functions as a means of egress.</i></p>

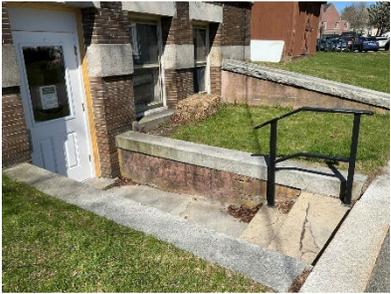
<p>5.</p>	<p><b>Staff Entrance</b></p> <p>Directional signage is not provided at the non-accessible entrance.</p> <p>The entrance on the East side of the building is not accessible due to the stairs.</p> <p>The stairs lack the required handrails on one side.</p> <p>The handrail lacks the required extensions at the top and bottom.</p> <p>The handrail cross section is not rounded.</p> <p>The door lacks a level landing, @ 2.3%.</p> <p>The threshold is &gt; 1/2" high, @ 3/4".</p> <p><i>Note: The door also functions as a means of egress.</i></p>

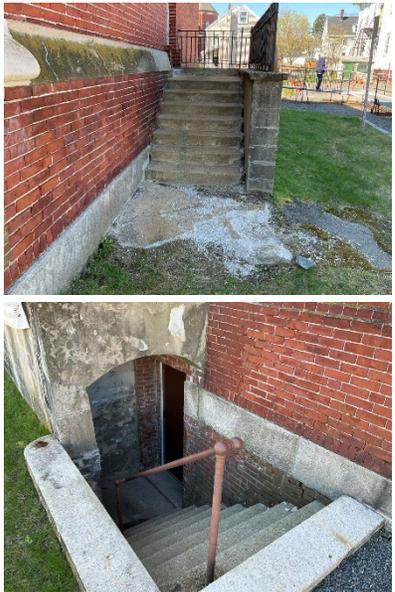
<p>6.</p>	<p><b>Means of Egress</b></p> <p>The egress doors on the North side of the building are not accessible due to the stairs.</p> <p>The egress doors have thresholds that are <math>&gt; \frac{1}{2}</math>" high.</p> <p>The stairs lack the required handrails on one or both sides.</p> <p>The handrail at one of the stairs lacks the required extensions at the top and bottom.</p> <p>One of the door hardware requires tight grasping, pinching, or twisting of the wrist to operate.</p> <p>The egress doors lack a level landing.</p>

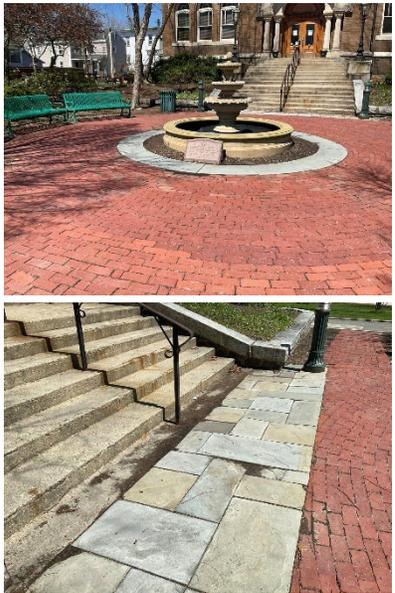
<p>The top photograph shows a set of concrete stairs leading up to a doorway in a brick wall. The stairs are narrow and lack handrails. The bottom photograph shows a close-up of the doorway, highlighting a high concrete threshold and a simple metal handrail.</p>
<p>7.</p>	<p><b>Walkways Around the Building</b></p> <p>The walkways have uneven ground surfaces, and excessive cross slopes, @ up to 3.1%, due to areas of deterioration/material settlement.</p>

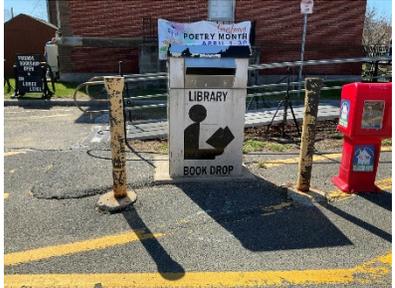
<p>8.</p>	<p><b>Book Drop</b></p> <p>There is not a 30" x 48" clear floor space adjacent to the book drop off, @ 8.7%.</p>

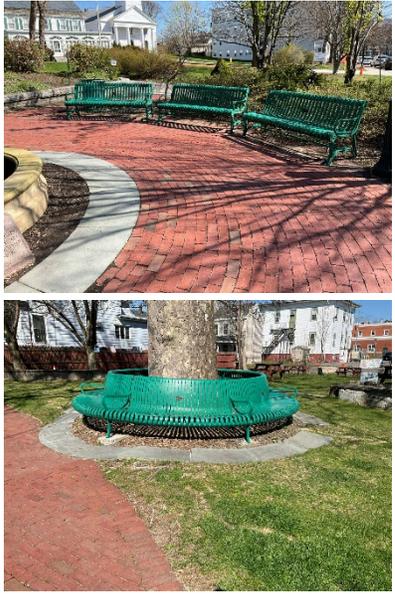
<p>9.</p>	<p><b>Benches</b></p> <p>There is not a 30" x 48" clear floor space adjacent to the bench.</p> <p>Some benches are not located on an accessible route due to the grass surface.</p>

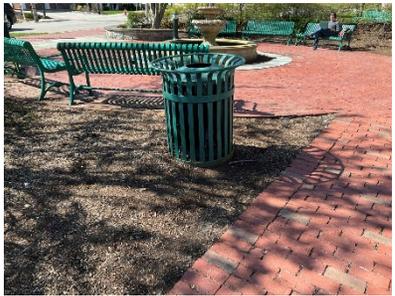
<p>10.</p>	<p><b>Trash Bin</b></p> <p>There is not a 30" x 48" clear floor space adjacent to the trash bin.</p>

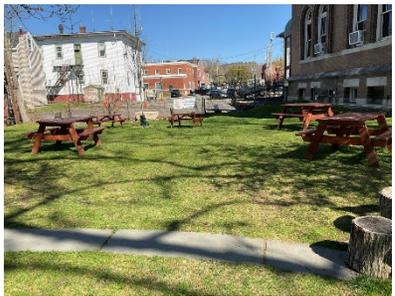
<p>11.</p>	<p><b>Picnic Tables</b></p> <p>5% of the picnic tables are not located on an accessible route due to the grass surface.</p> <p>5% of the picnic tables lack the required knee and toe clearance for a forward approach.</p>

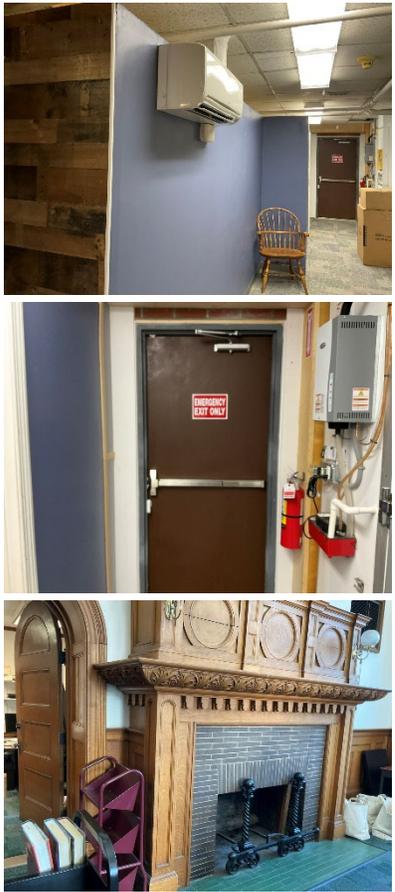
<p>13.</p>	<p><b>Protruding Objects - Typical</b></p> <p>The air conditioning, fireplace mantel shelves, shelves, and fire and electrical boxes protrude &gt;4” into the circulation area, @ up to 11”.</p> <p><i>Observed in Basement and 1<sup>st</sup> Floors corridors, and Staff office.</i></p>

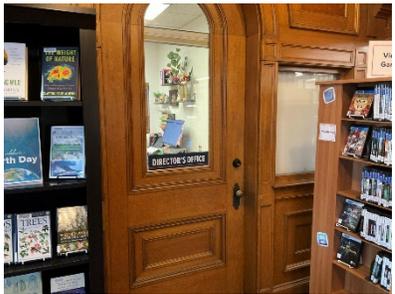
<p>14.</p>	<p><b>Interior Signage - Typical</b></p> <p>There is no tactile/Braille signage mounted on the latch side of the doors.</p> <p><i>Observed on all interior doors.</i></p>

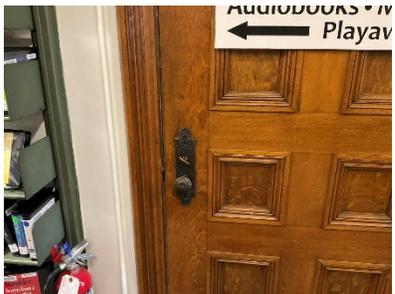
<p>15.</p>	<p><b>Door Hardware - Typical</b></p> <p>The door hardware requires tight grasping, pinching, or twisting of the wrist to operate.</p> <p><i>Observed on most interior doors.</i></p>

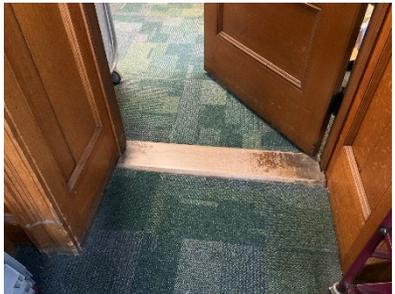
<p>16.</p>	<p><b>Door Thresholds - Typical</b></p> <p>Some of the door thresholds are &gt; ½” high, @ up to 1 ½” AFF.</p> <p><i>Observed on most interior doors.</i></p>

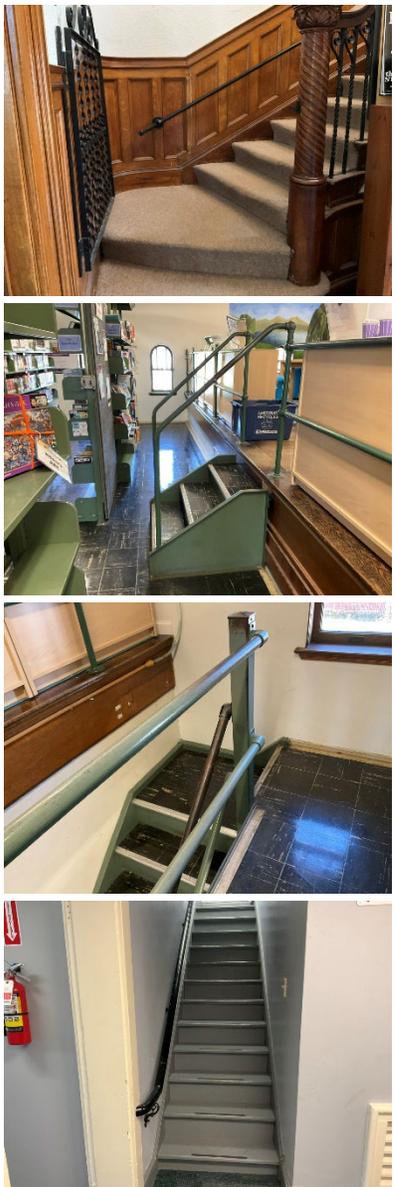
<p>17.</p>	<p><b>Interior Stairs</b></p> <p>The stairs lack the required handrails on one or both sides.</p> <p>The handrails lack the required extensions at the top and bottom.</p> <p>The handrails are not 34”-38” measured to the top of the gripping surface, @ as low as 26” AFF.</p> <p>The stair handrails are not continuous.</p> <p>The stair nosing is &gt;½”, @ ¾”.</p> <p>Some stair handrails cross sections are not rounded.</p> <p>The clear space between the handrail and the wall is &gt;1 ½”, @ as little as 1”.</p>

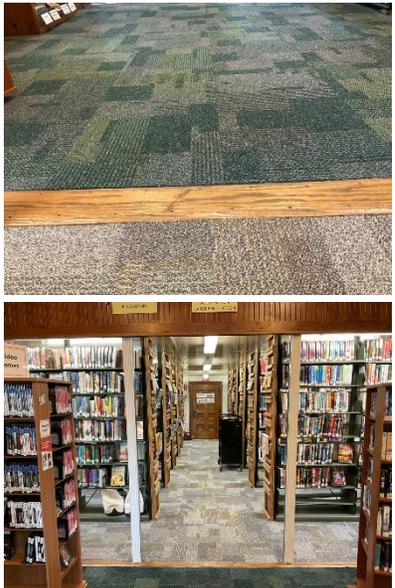
<p>18.</p>	<p><b>Interior Routes</b></p> <p>Some portions of the floor have excessive slopes, @ up to 22.9%.</p> <p>Some thresholds are &gt; ½” high, @ up to 1 ½” AFF.</p> <p><i>Observed in Basement and 1<sup>st</sup> Floors corridors.</i></p> <p>The headroom under the beam provides &lt;80” vertical clearance, 78” AFF.</p> <p><i>Observed in the 1<sup>st</sup> Floor corridor at Fiction area entrance.</i></p> <p>The door connecting Teen Loft and Youth Services areas is &lt;32” wide, @ 27”.</p>

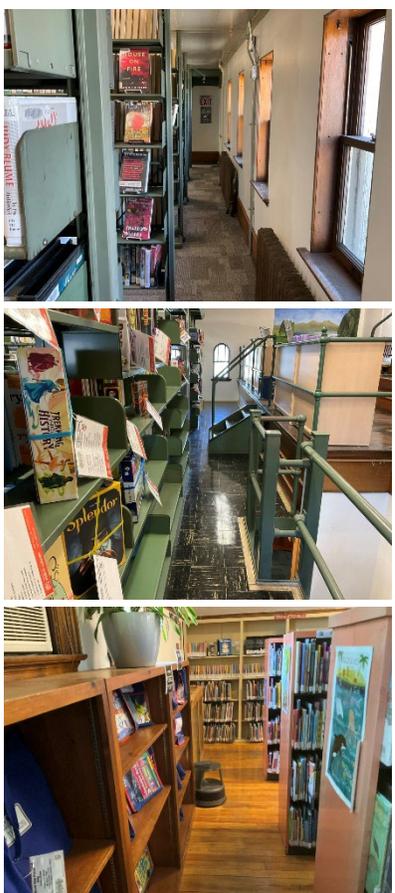
<p>The top photograph shows a close-up of a carpet tile floor transitioning to a wooden floor at a threshold. The bottom photograph shows a perspective view of a library aisle with bookshelves on both sides and a carpeted floor.</p>
<p>19.</p>	<p><b>Stacks Areas</b></p> <p>Routes within the stack areas provide &lt;36” clear width, @ as little as 17”.</p> <p><i>Observed on all floors.</i></p>

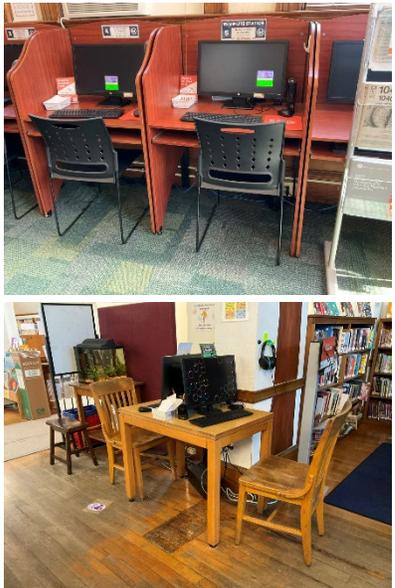
<p>20.</p>	<p><b>Tables and Computer Desks</b></p> <p>Some of the tables and computer desks lack the required knee and toe clearances for a forward approach, @ as little as 25" AFF.</p> <p><i>Observed in Offices, Reference Room, Youth Services area and Staff Break Room.</i></p>

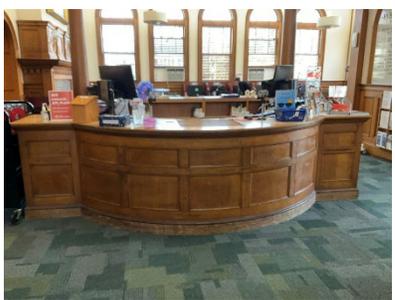
<p>21.</p>	<p><b>Counters</b></p> <p>The counters are mounted &gt;36" AFF, @ up to 43".</p> <p><i>Observed in Reception and Reference room.</i></p>

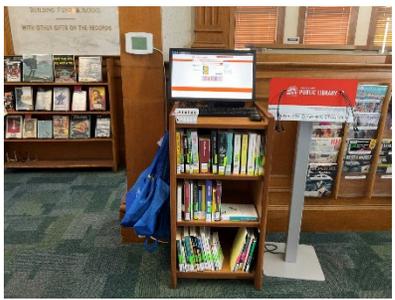
<p>22.</p>	<p><b>Library Catalog Table</b></p> <p>The library catalog table is &gt;36" AFF, @ 39" and lacks the required knee/ toe clearance for a forward approach.</p>

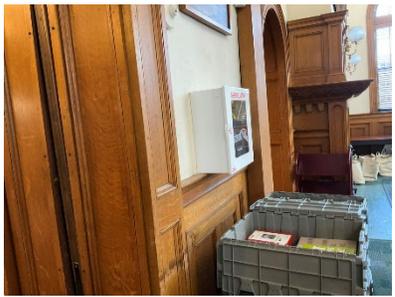
<p>23.</p>	<p><b>AED Box</b></p> <p>The AED box protrudes &gt; 4" into the circulation space, @ 6", and is mounted &gt;48" AFF, @ 58" to the highest operable part.</p>

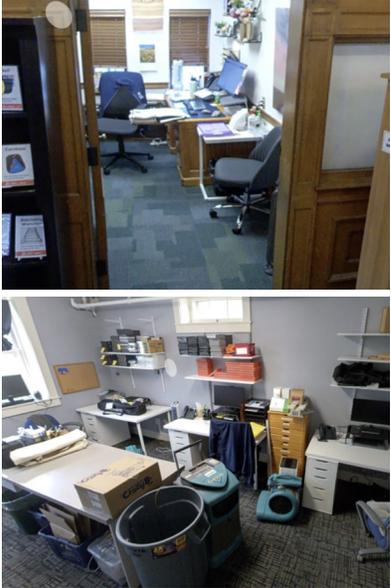
<p>24.</p>	<p><b>Director's Office</b></p> <p>The door maneuvering clearances is &lt;18" on the latch pull-side of the door, @ 15".</p>	<p>No Image</p>
<p>25.</p>	<p><b>Furniture Placement</b></p> <p>The placement of furniture in Amesbury Room, offices, and printer/copier room reduces the 36" minimum path of travel and obstructs the required door maneuvering clearances.</p>

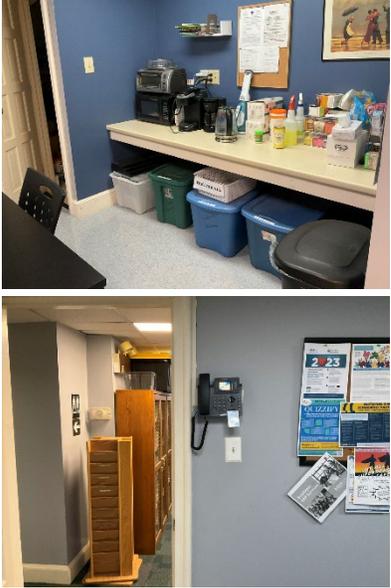
<p>26.</p>	<p><b>Staff Break Room</b></p> <p>The knee clearance at the work surface is &lt;27" AFF, @ 24".</p> <p>The coat hooks are mounted &gt;48" AFF, @ 66".</p> <p>The phone is mounted &gt;48" AFF, @ 66" measured to the highest operable part.</p>

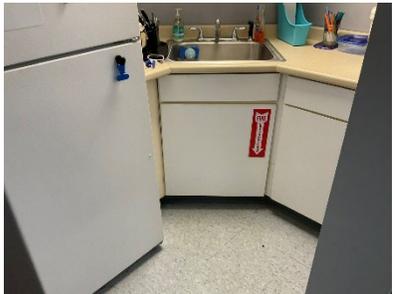
<p>27.</p>	<p><b>Kitchen in Staff Break Room</b></p> <p>The room lacks the required minimum 60” turning space.</p> <p>The sink counter is &gt;34” AFF, @ 36”, and lacks the required knee clearance for a forward approach.</p>

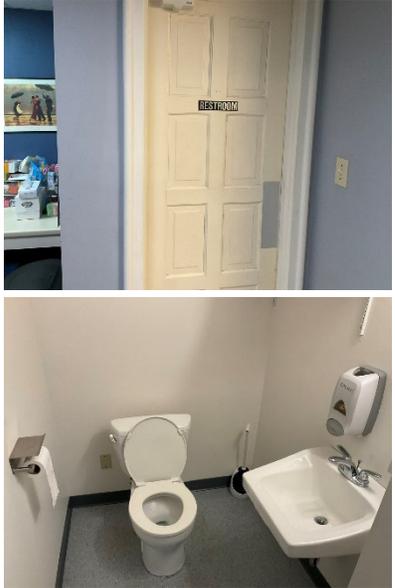
<p>28.</p>	<p><b>Staff Toilet Room</b></p> <p>The room lacks the 72”x90” required footprint, @ 62”x53” and accessible elements for an accessible toilet room.</p> <p>The pull-side door maneuvering clearance is &lt;60” perpendicular to the doorway, @ 30”.</p> <p>The pipes underneath the lavatory are not insulated.</p> <p>The mirror is mounted &gt;40” AFF measured to the bottom of the reflective surface.</p> <p>The toilet centerline is not 18” from the side wall, @ 22”.</p> <p>The flush control is not located on the open side of the toilet.</p> <p>The toilet paper is not located 7”-9” from the rim of the toilet.</p> <p>The centerline of the toilet paper dispenser is &gt;24” AFF, @ 41”.</p> <p>There are no grab bars provided.</p> <p>The coat hook is mounted &gt;48” AFF.</p> <p>The shelves protrude &gt;4” into the circulation route, @ 12”.</p>

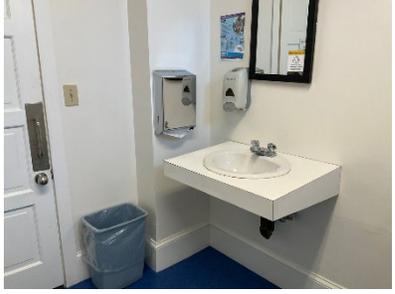
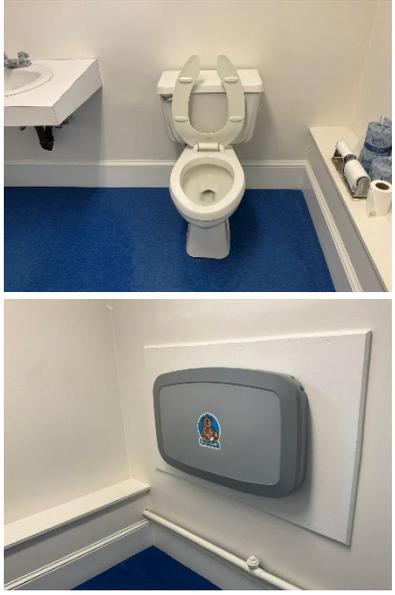
<p>29.</p>	<p><b>Toilet Room A (Basement)</b></p> <p>The room lacks the 72”x 90” required footprint, @ 89 ½”x 84” and accessible elements for an accessible toilet room.</p> <p>The pipes underneath the lavatory are not insulated.</p> <p>The lavatory faucet control requires tight grasping, pinching, or twisting of the wrist to operate.</p> <p>The mirror is mounted &gt;40” AFF measured to the bottom of the reflective surface, @ 50”.</p> <p>The toilet centerline is not 18” from the side wall, @ 22”.</p>

<p>The clearance around the water closet is &lt;60" measured perpendicular from the side wall, 46" to the lavatory.</p> <p>The toilet seat is not 17"-19" AFF, @ 16 ½".</p> <p>The toilet paper is not located 7"-9" from the rim of the toilet.</p> <p>There are no grab bars provided.</p> <p>The coat hook is mounted &gt;48" AFF, @ 63".</p> <p>The changing table is mounted &gt;48" AFF, @ up to 50" to the highest operable part.</p> <p>The changing table hardware requires tight grasping, pinching, or twisting of the wrist to operate.</p>

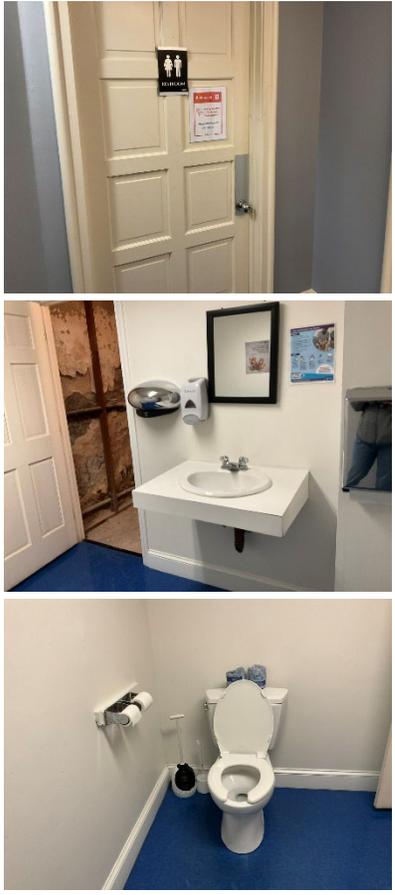
30.	<p><b>Toilet Room B (Basement)</b></p> <p>The room lacks the 72"x 90" required footprint, @ 110"x 85" and accessible elements for an accessible toilet room.</p> <p>The pipes underneath the lavatory are not insulated.</p> <p>The lavatory faucet control requires tight grasping, pinching, or twisting of the wrist to operate.</p> <p>The mirror is mounted &gt;40" AFF measured to the bottom of the reflective surface, @ 50".</p> <p>The toilet centerline is not 18" from the side wall, @ 23".</p> <p>The flush control is not located on the open side of the toilet.</p> <p>The toilet seat is not 17"-19" AFF, @ 16 ½".</p> <p>The centerline of the toilet paper dispenser is &gt;24" AFF, @ 32".</p> <p>The toilet paper is not located 7"-9" from the rim of the toilet.</p> <p>The hand dryer protrudes &gt;4" into the circulation route, @ 8".</p>

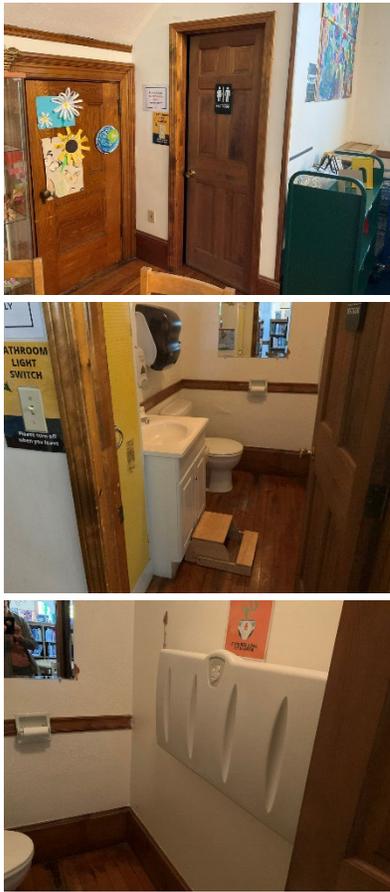
<p>31.</p>	<p><b>Toilet Room (2<sup>nd</sup> Floor)</b></p> <p>The room lacks the 72”x 90” required footprint, @ 51”x 88” and accessible elements for an accessible toilet room.</p> <p>The door maneuvering clearances is &lt;18” on the latch pull-side of the door, @ 7”.</p> <p>The lavatory lacks the required knee and toe clearance for a forward approach.</p> <p>The toilet centerline is not 18” from the side wall, @ 17”.</p> <p>The clearance around the water closet is &lt;60” measured perpendicular from the side wall.</p> <p>The toilet paper is not located 7”-9” from the rim of the toilet.</p> <p>The centerline of the toilet paper dispenser is &gt;24” AFF.</p> <p>There are no grab bars provided.</p> <p>The towel paper dispenser protrudes &gt;4” into the circulation route, @ 9”.</p> <p>The coat hook is mounted &gt;48” AFF.</p> <p>The changing table is mounted &gt;48” AFF, @ up to 53” to the highest operable part.</p> <p>The changing table hardware requires tight grasping, pinching, or twisting of the wrist to operate.</p>
